PULP MILL BRIDGE
(Paper Mill Bridge)
Seymour Street, Middlebury/Pulp Mill Bridge Road, Weybridge,
spanning Otter Creek
Middlebury
Addison County
Vermont

WRITTEN HISTORICAL AND DESCRIPTIVE DATA

PULP MILL BRIDGE
(Paper Mill Bridge)

HAER No. VT-31

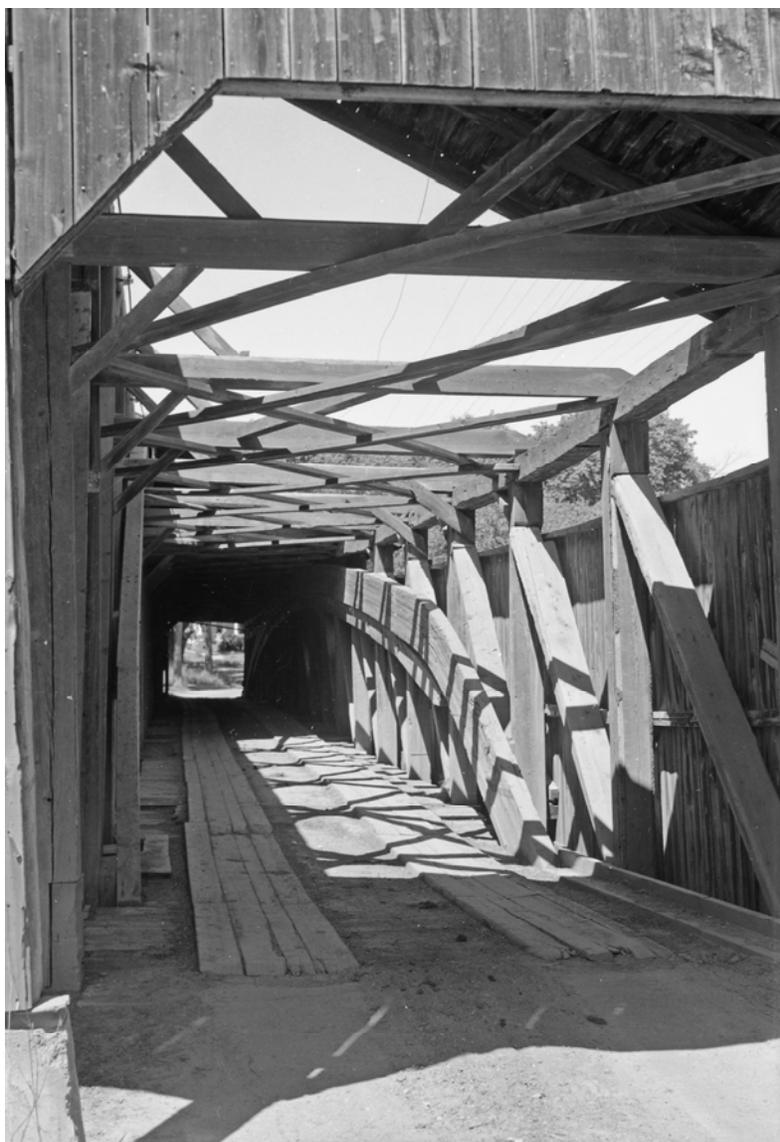
Figure 1. Interior of Pulp Mill Bridge with some of the roofing removed, view looking west. Note the remnant of the original solid arches, just underneath the laminated arches that were added later. Richard Sanders Allen, photographer, ca. 1948.

The principal structural components are four laminated timber arches, one on each side and two at the center, framed into two pairs of multiple kingpost trusses to create an indeterminate composite timber structure. The arches spring from skewbacks on the facewall of the abutments, span nearly 200' and rise 15' (side arches) and 21' (center arches) to the crown.⁴ The side arches are composed of nine 3"x6" planks, notched around and bolted through the posts of the trusses. The center arches are composed of ten 3"x6" planks, notched and bolted on either side of the center truss. Each multiple kingpost truss has twenty-two panels, spaced 9'-0" on center. The upper chord is composed of 8"x10" timbers, scarfed along its length, with vertical posts tenoned into it. The lower chord is composed of two laminae, 7"x13" that clasp the posts. There are 4"x10" diagonal timbers in between the posts. These diagonal have notched and bolted connections and wooden thrust blocks at their upper and lower ends. The outside truss panels at midspan have X-bracing. Hangers, or tension rods, measuring 1" diameter pass through the arch at each panel point and down through the lower chords where the threaded end is fastened with a plate and nut.

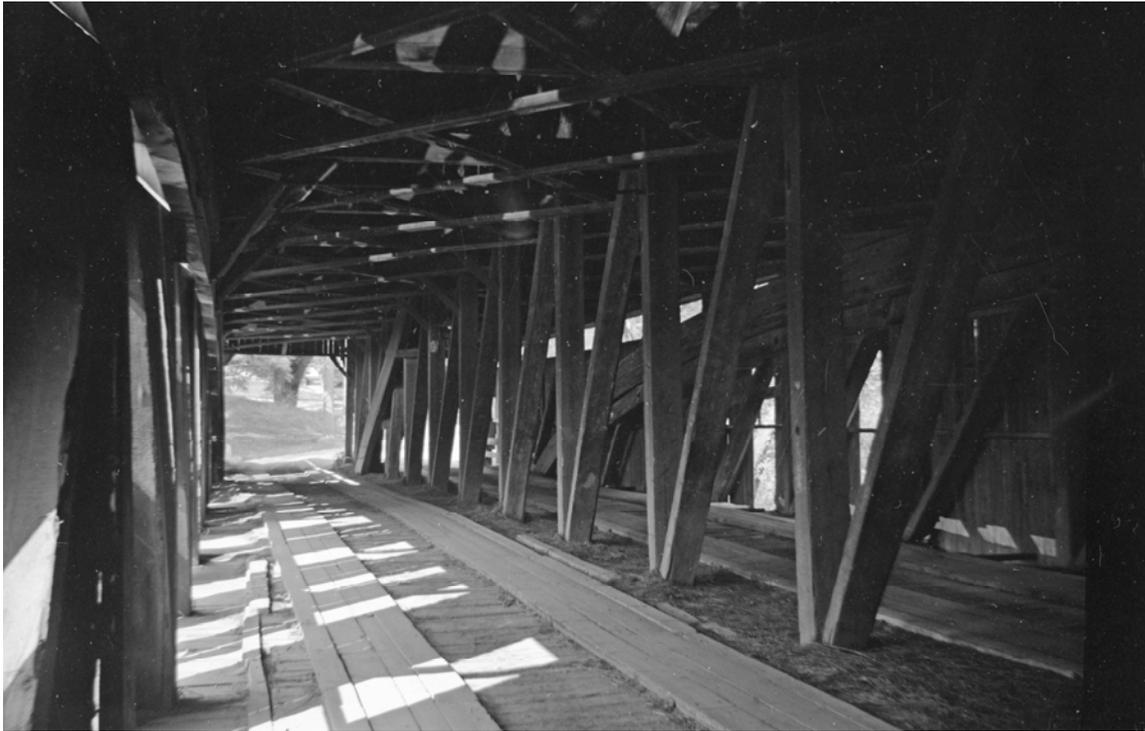
Figure 2. Interior view showing south lane of bridge, view looking west. Richard Sanders Allen, photographer, ca. 1940.

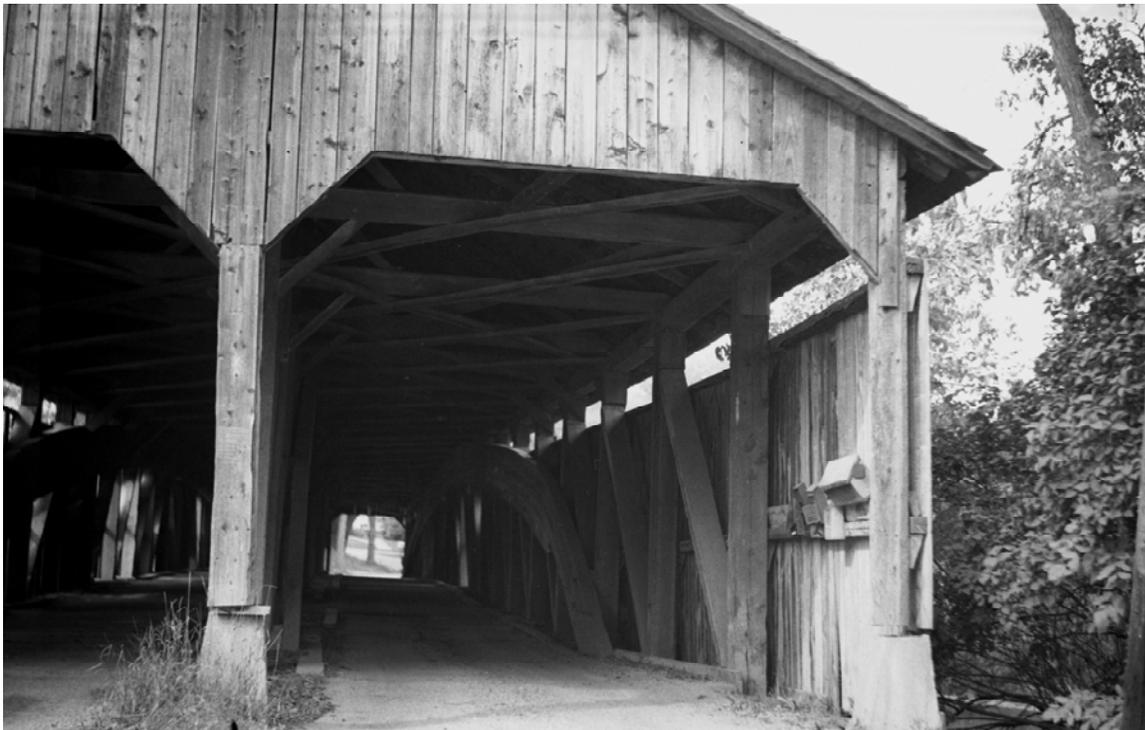
Figure 3. East portal, view looking west. Richard Sanders Allen, photographer, October 1939.

Vertical board siding covers the exterior of the bridge to about 1' below the upper chord. The sheathing is fastened to nailers on the outer faces of the trusses. The portals are straight with rectangular openings. In the early 1990s, a glue-laminated timber pedestrian bridge was installed on beams cantilevered from the piers on the southerly side of the bridge (offset about 5'). A metal truss between the pedestrian bridge and the covered bridge carries a 6" utility pipe. The original stone slab abutments have been faced with concrete. The piers (added sometime prior to the 1930s) were originally dry laid stone with timber cribbing on top and cutwaters on the upstream side. They have also been covered with concrete.⁵

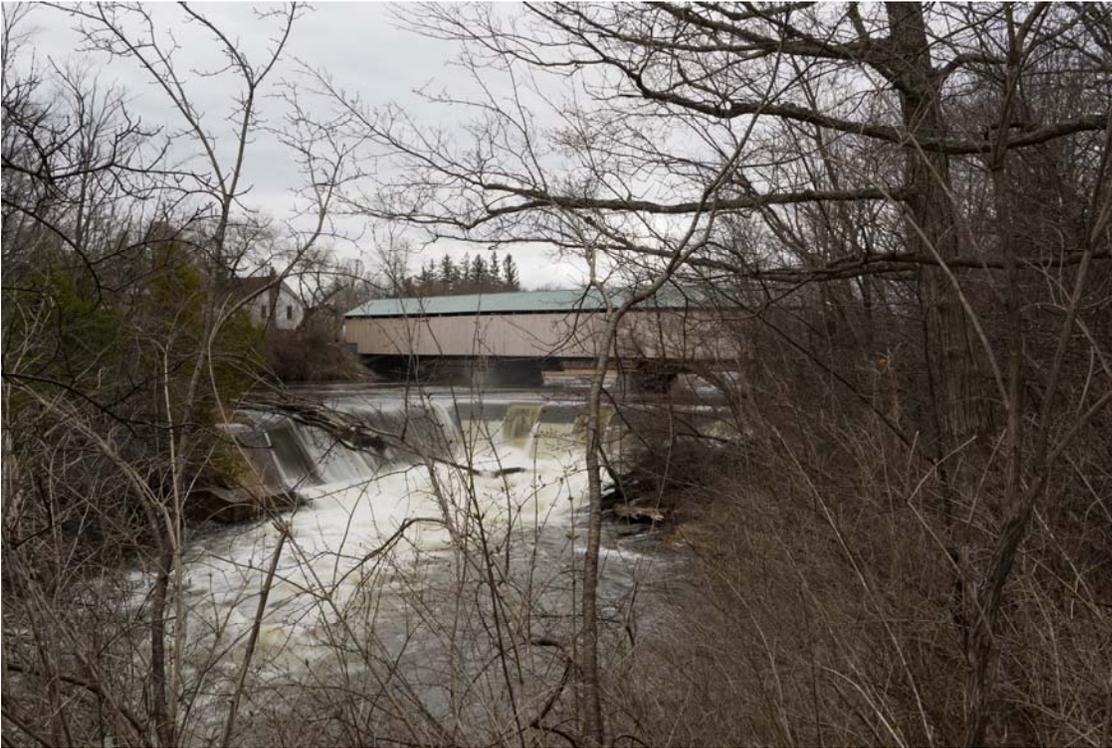
Figure 4. General view from downstream, view to south.

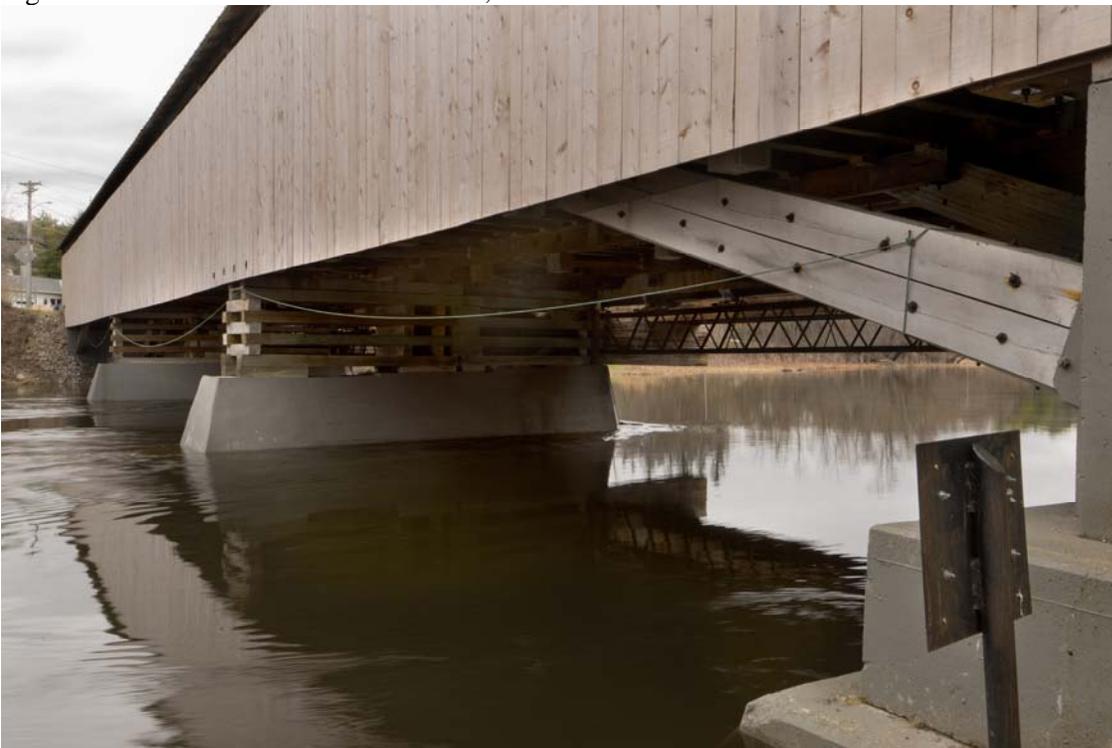
Figure 5. General view of sub-deck showing 2012 reconstruction: piers, arch detail, vertical plank cladding; view from west bank of Otter Creek to east. (The steel lattice beam is a free-standing structure that carries a water pipe beneath the pedestrian walkway.)

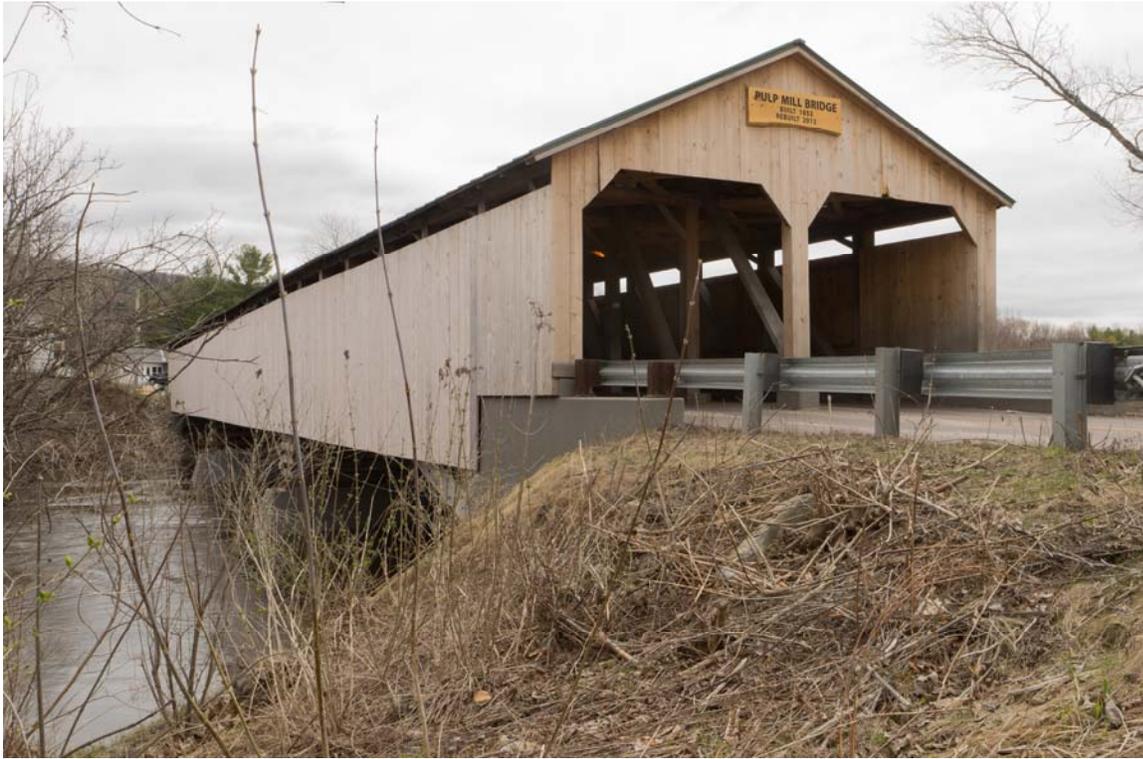
Figure 6. General view of west portal showing north side, view to southeast.

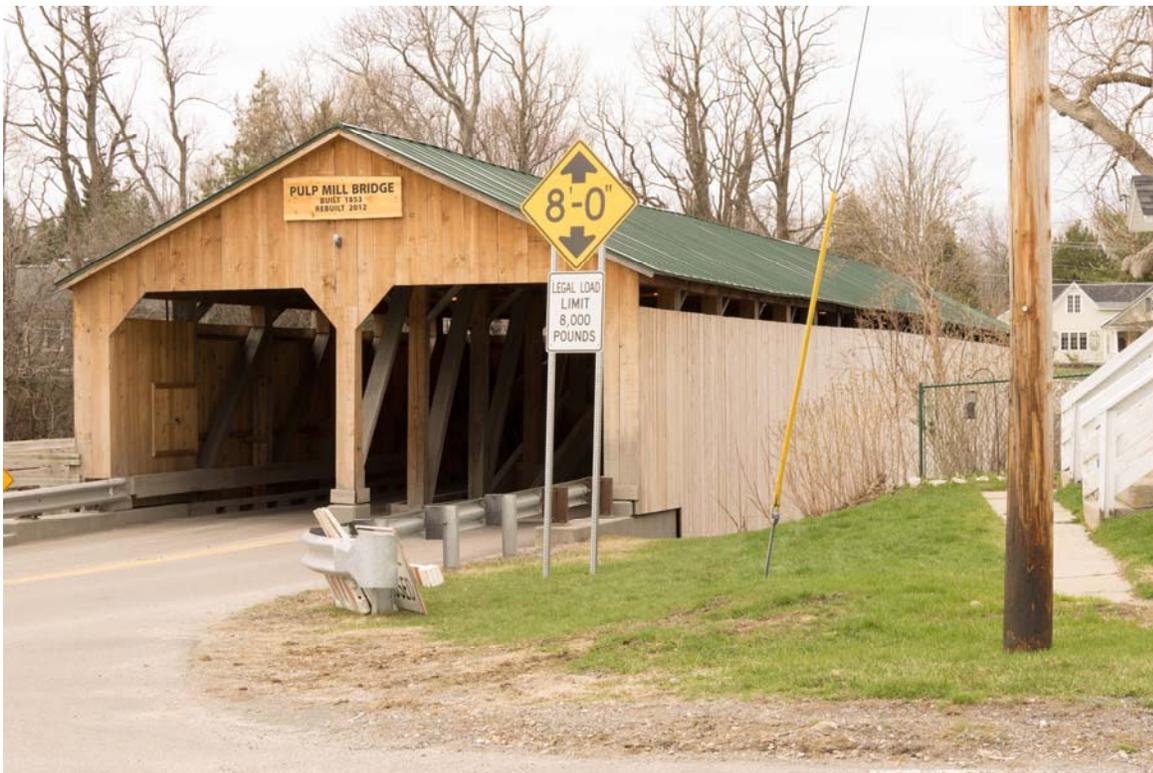
Figure 7. General view of double barrel east portal; view to west.

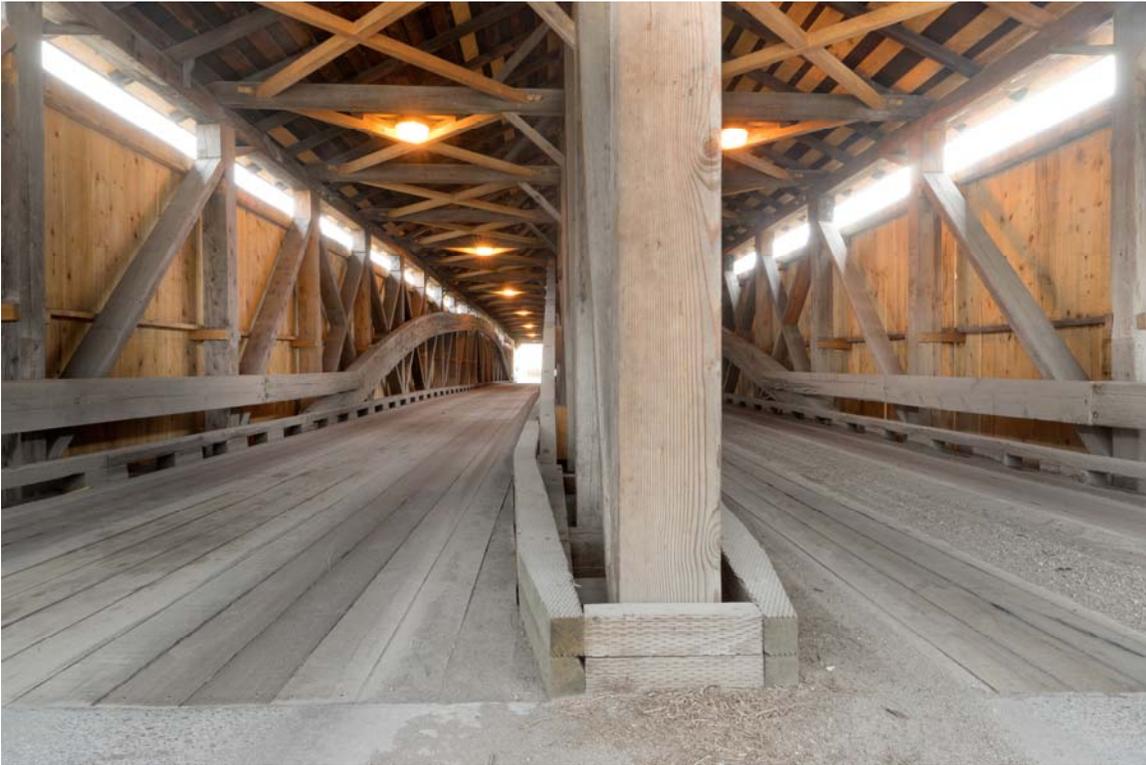
Figure 8. Detail west portal showing center post, view to east.

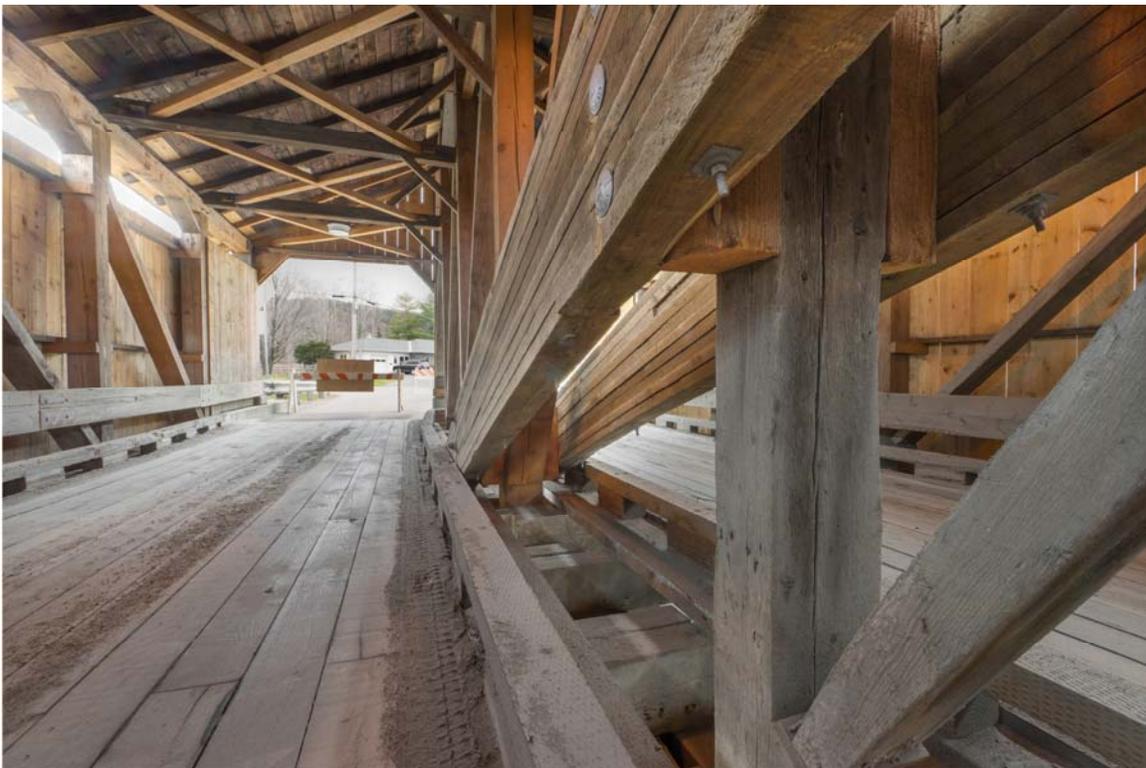
Figure 9. Detail, north land to east.

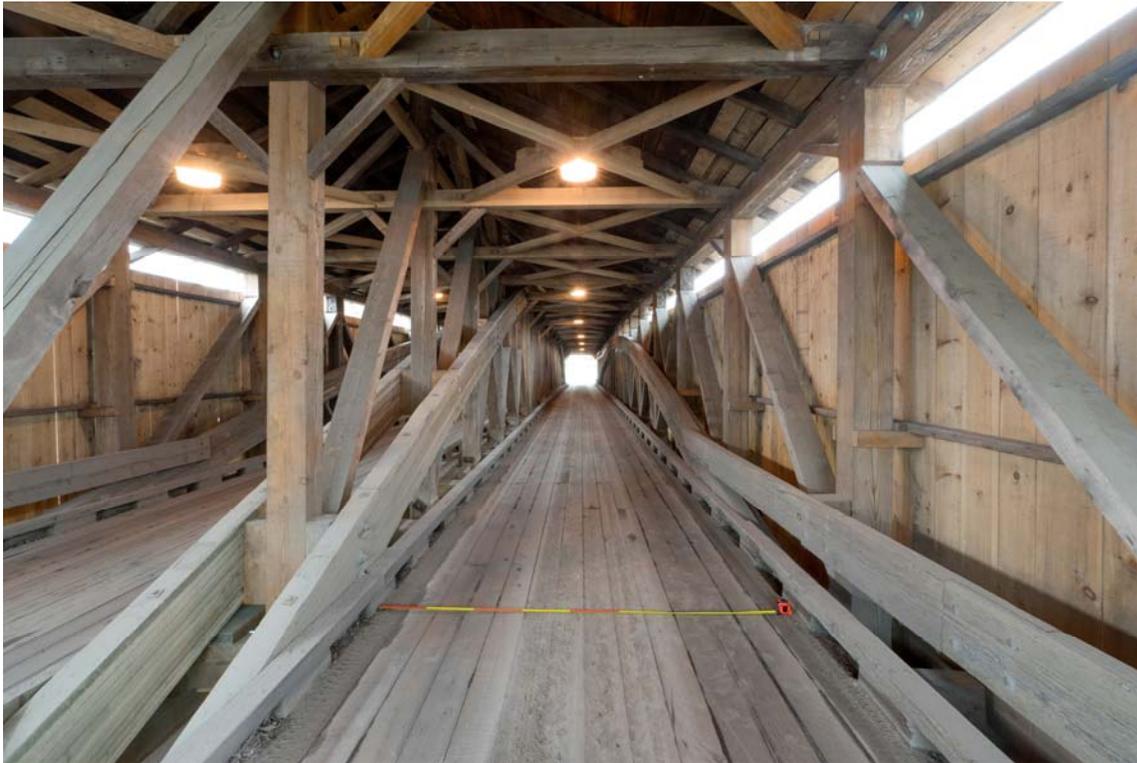
Figure 10. Interior north (westbound) lane showing scale on deck.

beams support twelve lines of 6"x6" stringers spaced at 2'-10". The floor is 3" planks laid transversely on the stringers, with longitudinal running boards on top. There are timber wheelguards along the roadways.

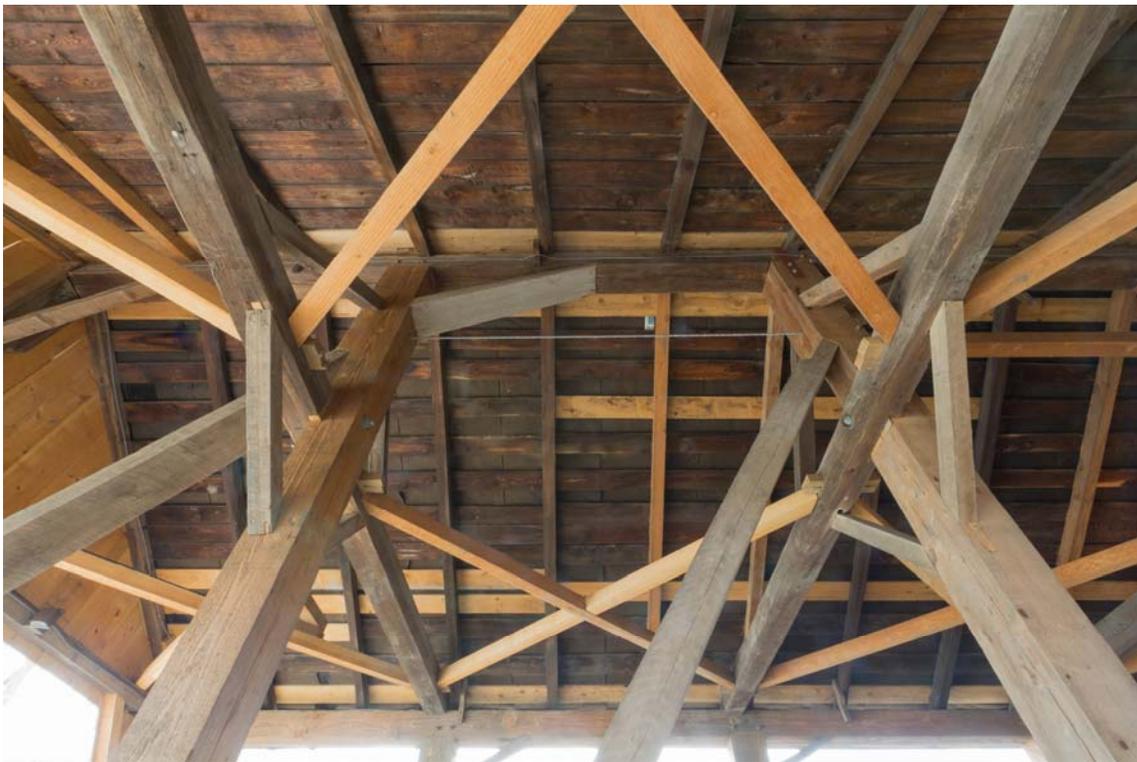
Figure 11. Interior detail center posts and roof with truss and deck.

The upper lateral system consists of 8"x8" tie beams resting on the upper chord at each panel point, and 2"x7" lateral diagonal bracing with variable spacing between the upper chords. There are transverse metal tie rods between every other panel point and wooden sway braces between the tie beams and the posts. Rafters measuring 4"x4", spaced approximately 2' on center, frame onto the upper chord. The rafters tie into an 8"x10" ridgepole supported on posts along the center of the bridge. Standing-seam metal roofing, fastened to spaced board sheathing on top of wooden purlins, covers the gable roof.

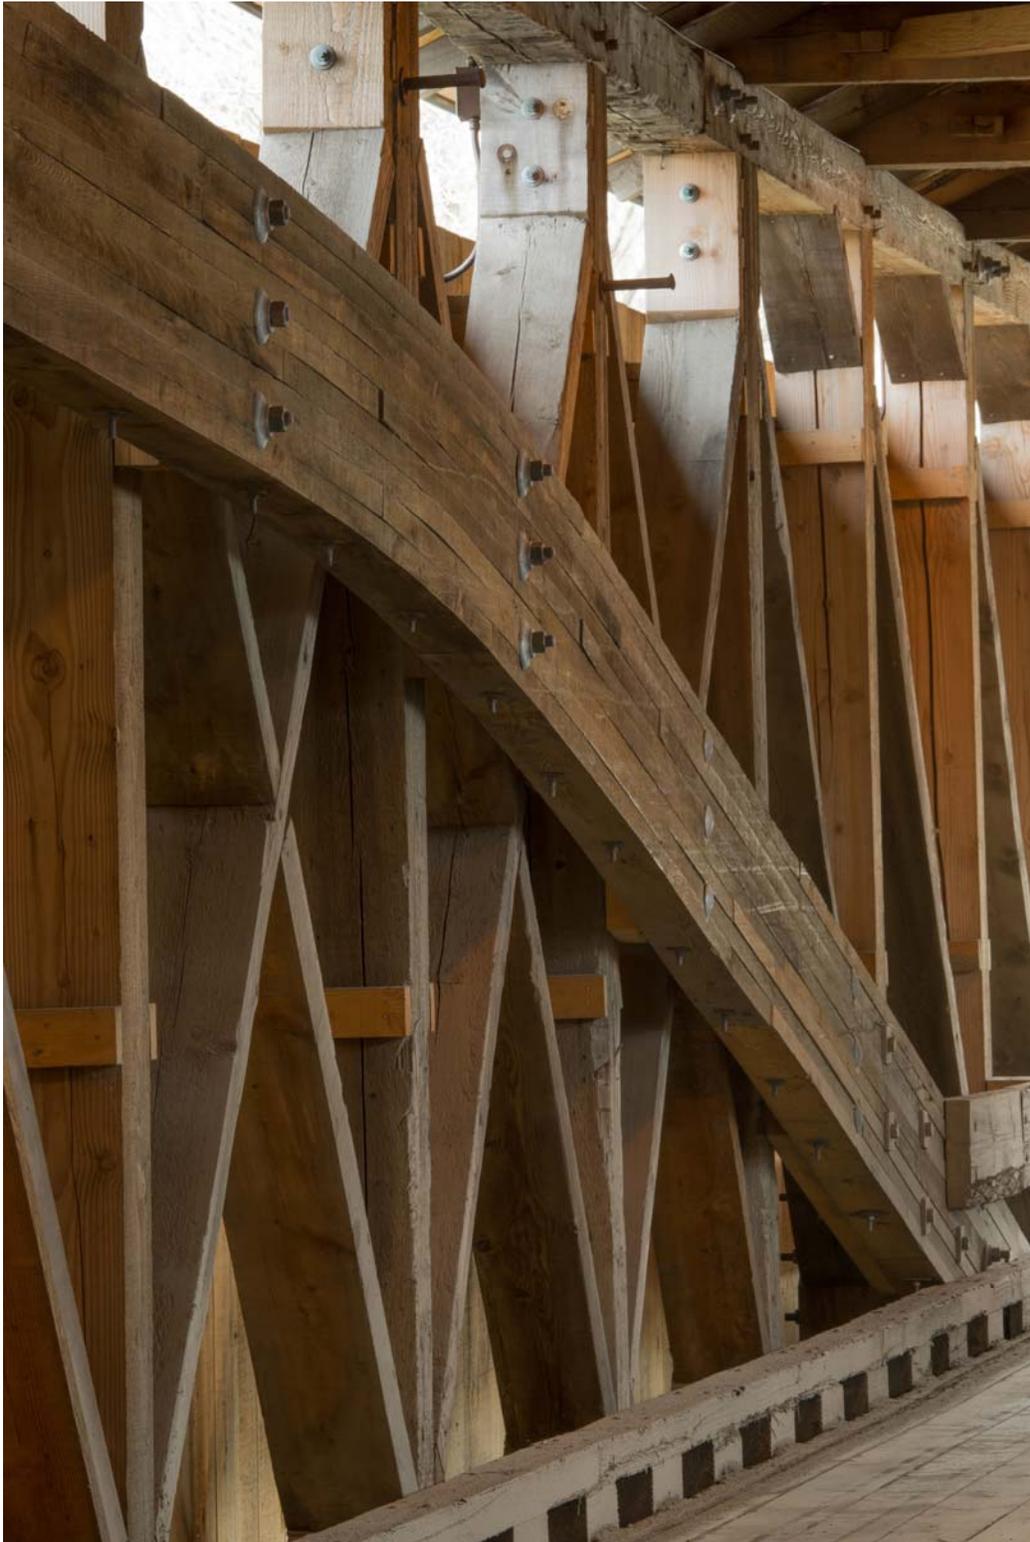
Figure 12. North truss detail, view to east.

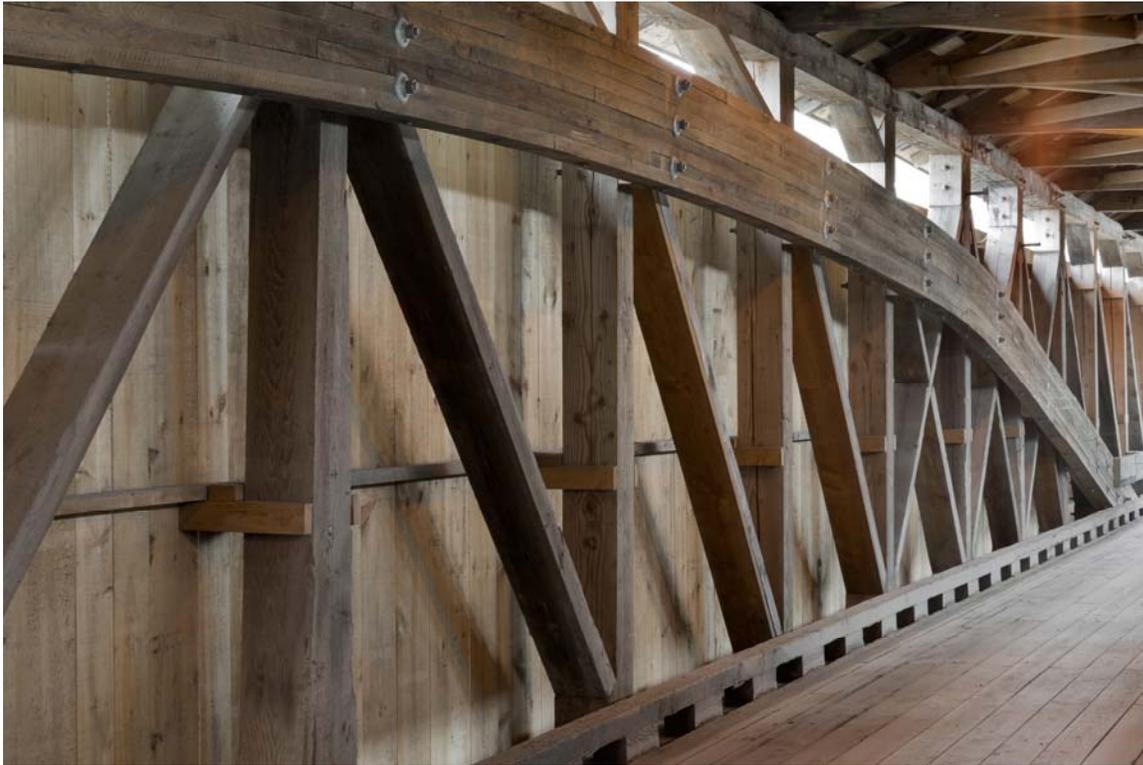
Figure 13. North truss showing clerestory and deck, view to east.

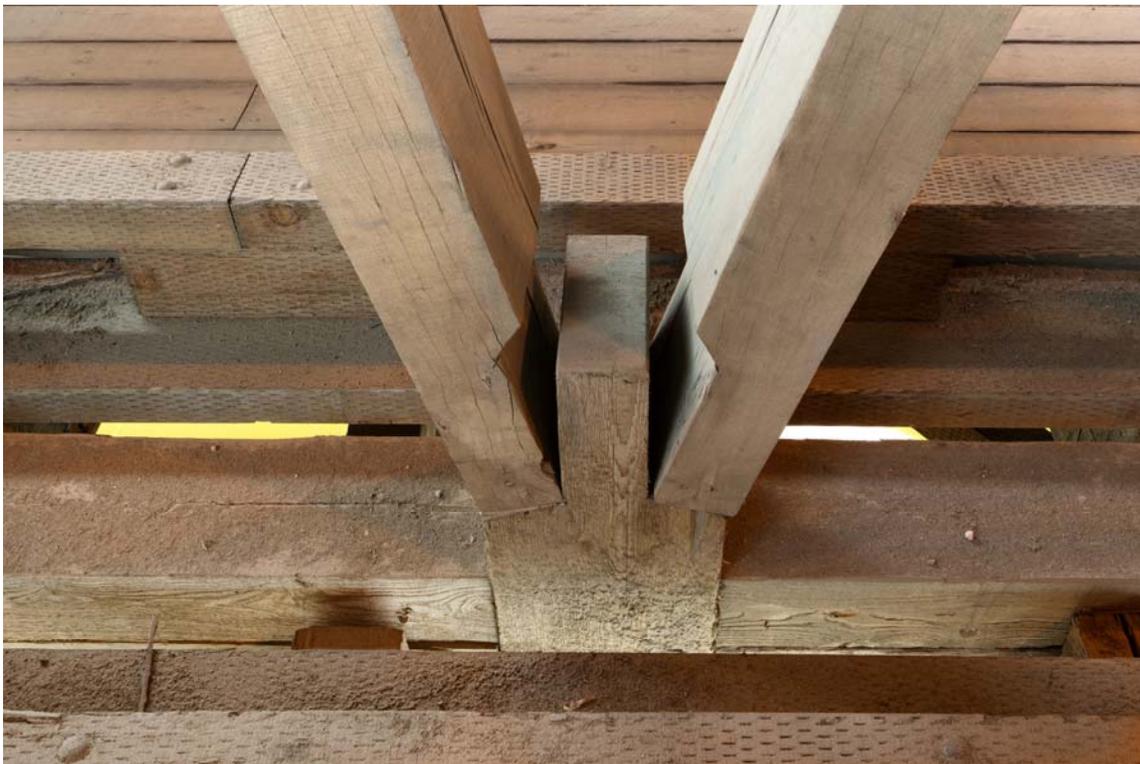
Figure 14. Interior, center deck detail showing post and diagonal bracing.

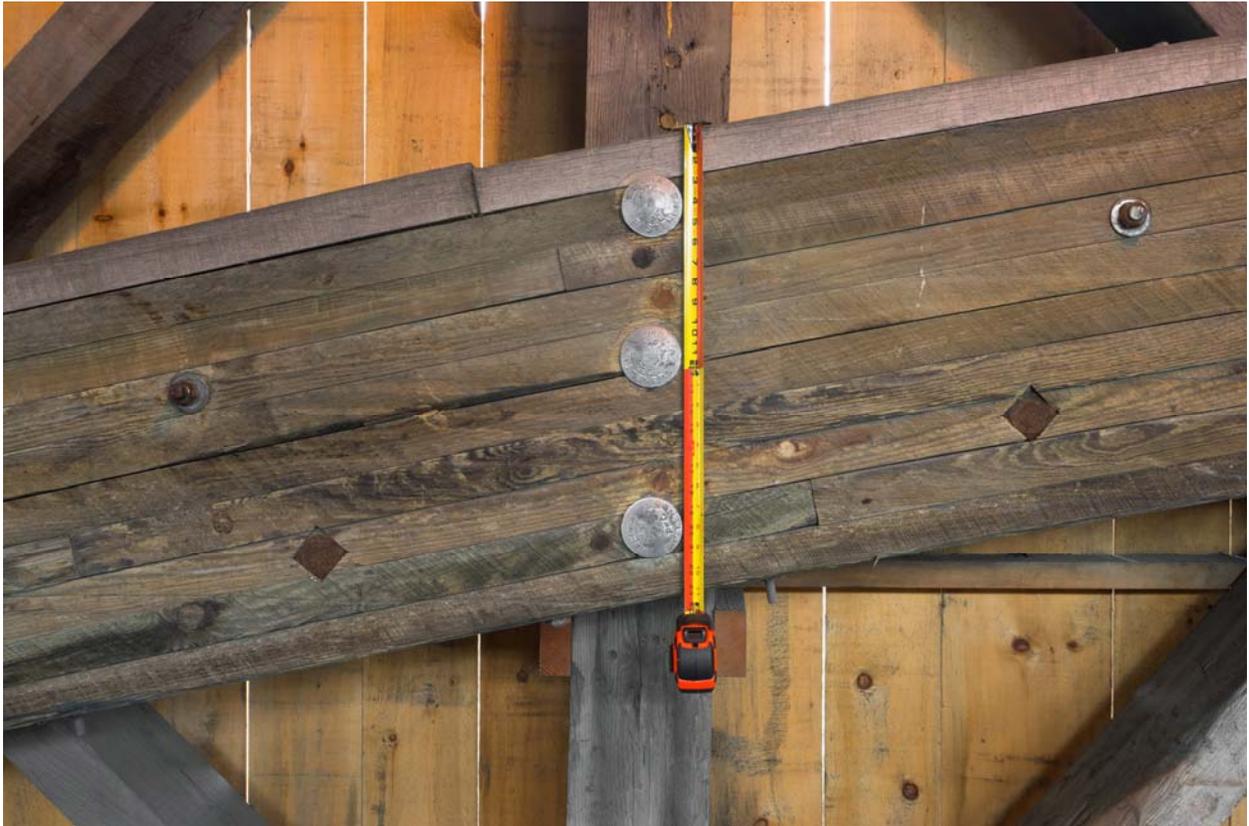
Figure 15. Interior detail of segment of north outboard Burr Arch showing three fastener types: capped through-bolt (center), recessed bolt in square chiseled recess (lower left and right), conventional nut/bolt/washer (upper left and right); note scale; view to north.
