Superior Coal Mines,
Frame House
Sections 28, 29, T21N, R102W
Horse Thief Canyon
Old Superior Mines and Townsite
about 1/4 mile north of South Superior
Sweetwater County *South Superior Vicinity*
Wyoming

HAER No. WY-51-R

Superior Coal Mines, Frame House
HAER No. WY-51-R

Frame House: 48SW4068, Structure R (SE/SE/NE/NE Section 29, T21N, R102W 12/668360E/4625940N).

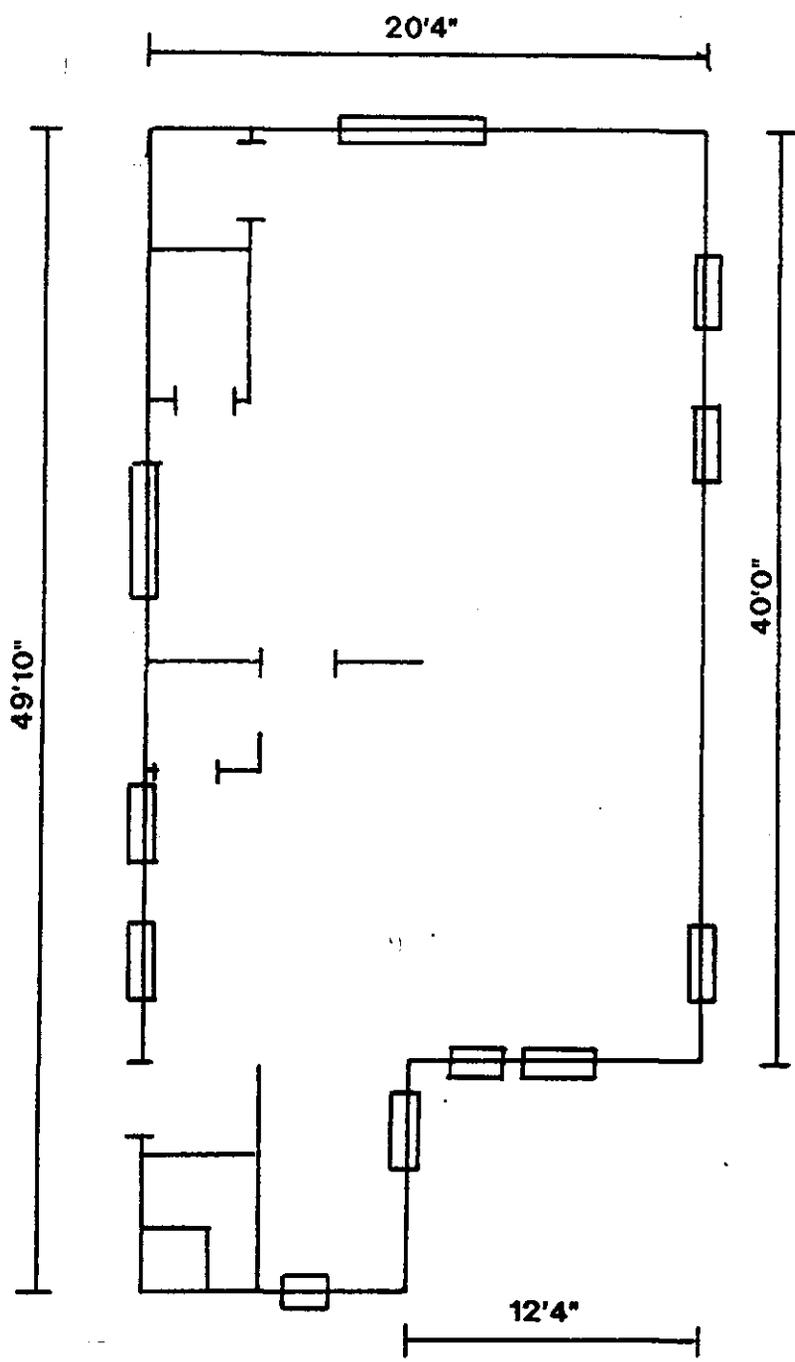
↻ Frame House
Superior Coal Mines,
HAER No. WY-51-R
(Page 4)

The structure is a wood frame house which has been partially disassembled through abandonment and vandalism. The house is an L-shaped wood frame structure on a concrete foundation. The house is basically rectangular with the long axis running north to south. A small south wing extends south from the south end of the house. The overall dimensions are, including the south wing, 49 feet 10 inches north to south, by 20 feet 4 inches east to west. The south wing is 9 feet 10 inches long north to south by 8 feet 0 inches east to west. The roof of the structure is a hipped roof with a smaller hipped roof covering the south wing and merging with the main roof.

The interior of the frame house contains a ground floor and a basement. The ground floor floor plan has been impacted through the removal of several internal dividing walls either as a result of abandonment, or later by vandalism. The internal walls consist of pink painted plaster and lathe while the flooring is tongue and grooved wood planking. The ground floor consists of two large rooms, one covering most of the north half of the structure and one covering much of the south half. The dividing wall between the two has been largely removed, although small sections of it may reflect closets. The north room measures 11 feet 6 inches north to south by 20 feet 1 inch east to west. Two small rooms are located in the northwest corner of the house adjacent to the north room. Both have access to the north room, however, because most of the exterior wall in the north end of the west elevation is missing, it is not known if these rooms provided access from outside. The northernmost of the northwest rooms is 6 feet 9 inches long north to south by 4 feet 3 inches wide. A doorway 2 feet 11 inches wide by 6 feet 6 inches tall is located at the north end of the east wall providing access to the north room. The south room is 10 feet 6 inches long north to south by 4 feet 3 inches wide. A doorway 2 feet 11 inches wide by 6 feet 6 inches tall is located in the center of the south wall.

The frame house is in poor condition. Much of the wooden siding as well as exterior frames and interior dividing walls have been removed. Doors and windows have also been removed as has been sections of the floor. This has compromised the structural integrity of the building, causing it to be a hazard to passersby.

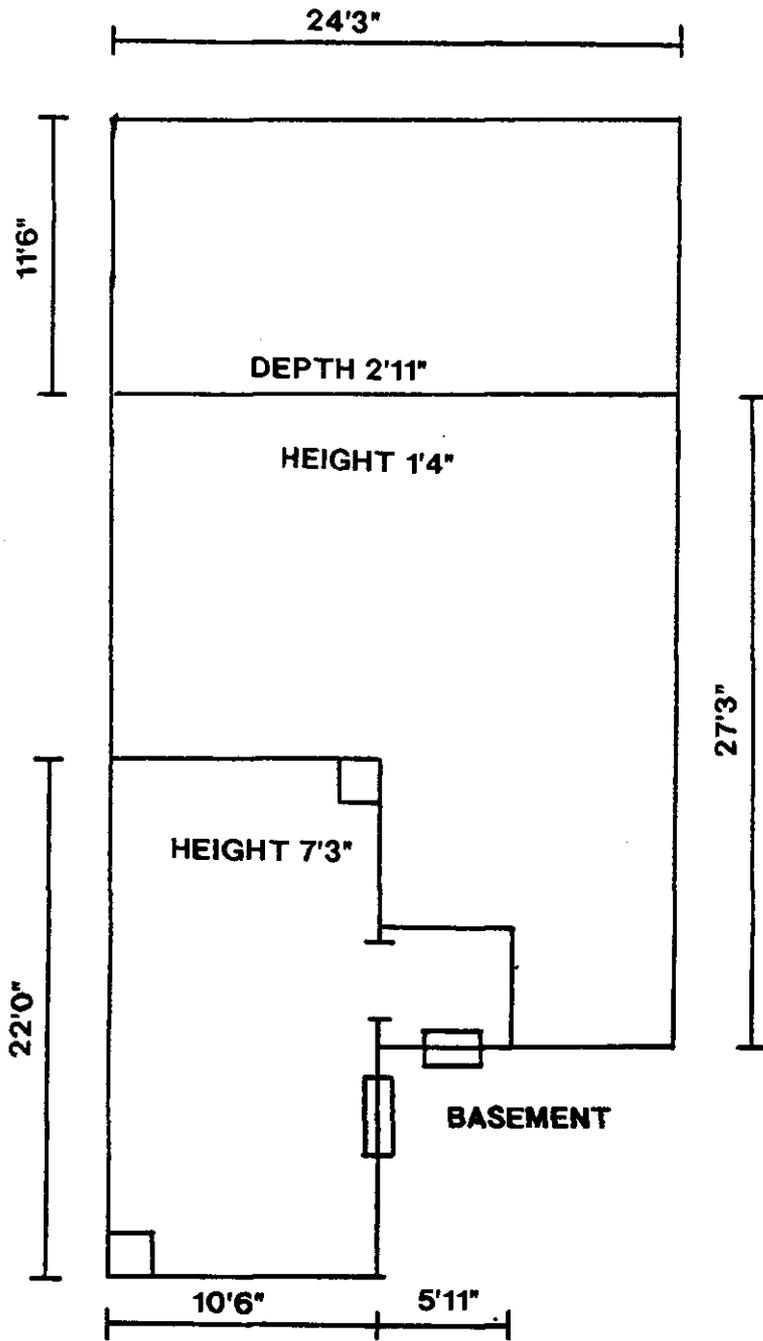
In addition to the ground floor, the frame house also has a basement which runs the length of the structure. The basement is divided into four sections. The northernmost is a shallow cement lined crawl space comprising the northern section of the north room. This portion of the basement has concrete walls on all four sides preventing access to the remaining sections of the basement. The depth of this portion of the basement is 2 feet 11 inches. Most of the flooring above this crawl space has been removed.

South of this enclosed crawl space is the largest portion of the basement. Its overall length is 27 feet 3 inches and its width is 24 feet 3 inches. This area is largely filled with earth and the gap between the floor and ground level is slightly more than one foot. The main portion of the basement is found under the south wing and southwestern portions of the house. This consists of two rooms, a larger western room measuring 10 feet 6 inches east to west by 22 feet 0 inches north to south and a smaller east room measuring 5 feet 11 inches by 5 feet 11 inches. Access to the basement was via wooden steps in the southwest corner. These steps have collapsed. Access from the west basement room to the east room was through a doorway 11 feet 9 inches north of the southeast corner of the west room. The doorway was 3 feet 3 inches wide by 6 feet 6 inches tall. The east room contains a wooden pallet on the floor. No other features were found in the basement.
