FORT HUACHUCA, CAVALRY STABLE
(Building No. 30025)
(Building No. 87)
(Building No. 123)
(Building No. 3036)
Clarkson Road
Sierra Vista vicinity
Cochise County
Arizona

HISTORIC AMERICAN BUILDINGS SURVEY

HABS NO. AZ-210-C

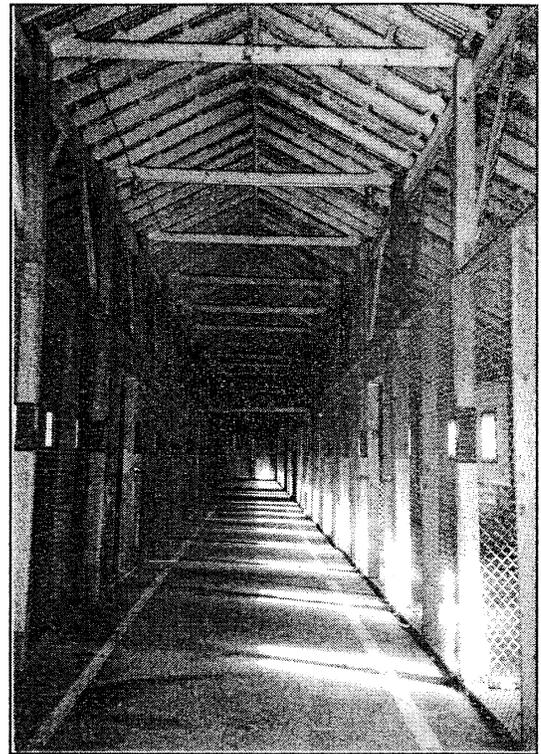
1. Floor plan: Today this single-story, former stable building is a long, vacant hall zoned so that the former storage rooms—either missing aisle and end walls or reduced in size—occupy the east end on either side of a 10-ft-wide aisle. Defined by posts, the aisle courses through an extensive area once devoted to the stabling of mules and horses. Wood posts form a repetitive pattern of bays, each formerly a stall. The stable area is now divided into framed, wire-mesh, storage cages. Generally three bays in size, they line the aisle and typically have a central door opening. There was once a partition, probably with a gate, installed across the aisle approximately nine bays from the west end (Figure C.10; HABS No. AZ-210-C-4).

FIGURE C.10. VIEW DOWN CENTRAL AISLE LOOKING EAST SHOWING STRUCTURE AND ALIGNMENT OF POSTS USED TO DEFINE STORAGE CAGE BAYS (PHOTOGRAPH BY JANET PARKHURST, JANUARY 2005).

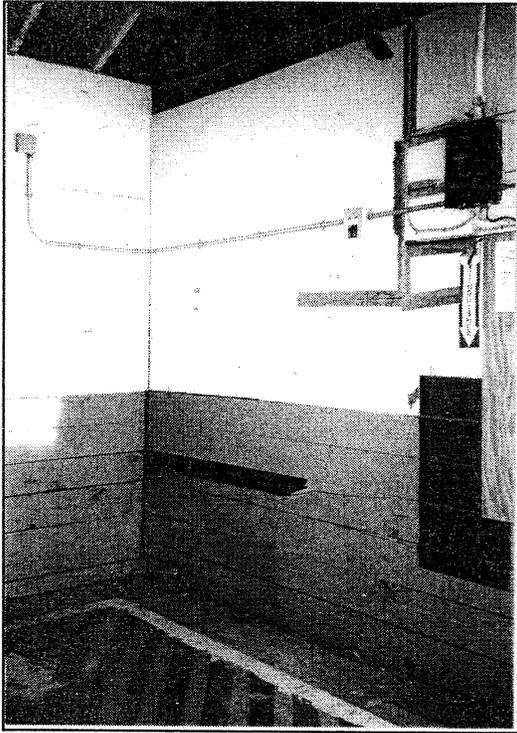
FIGURE C.11. EARLY 1950S WALL CLADDING WITH A HORIZONTAL BOARD WAINSCOT AND GYPSUM WALLBOARD ABOVE (PHOTOGRAPH BY JANET PARKHURST, JANUARY 2005).

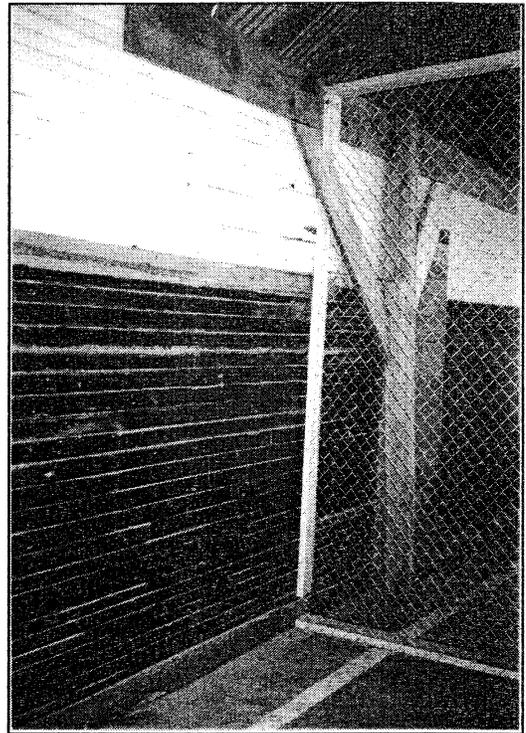
The walls in the former storage room zones have a variety of treatments. As noted, only the east and south perimeter walls remain of the formerly enclosed south saddle room (Figure C-S.1). The interior faces of the perimeter walls are sheathed in 1-inch horizontal boarding of variable width. The boards on the east wall are painted gray, and those on the south wall are painted black and white (Figure C.12).

FIGURE C.12. ORIGINAL HORIZONTAL BOARD SHEATHING ON SOUTH WALL OF FORMER SADDLE ROOM (PHOTOGRAPH BY JANET PARKHURST, JANUARY 2005).
