FORT HUACHUCA, CAVALRY STABLE
(Building No. 30026)
(Building No. 88)
(Building No. 124)
(Building No. 3037)
Clarkson Road
Sierra Vista vicinity
Cochise County
Arizona

HISTORIC AMERICAN BUILDINGS SURVEY
National Park Service
U.S. Department of the Interior
1849 C Street NW
Washington, DC 20240-0001

FORT HUACHUCA, CAVALRY STABLE
(FORT HUACHUCA, BUILDING 30026)
(FORT HUACHUCA, BUILDING 88)
(FORT HUACHUCA, BUILDING 124)
(FORT HUACHUCA, BUILDING 3037)

HABS NO. AZ-210-D

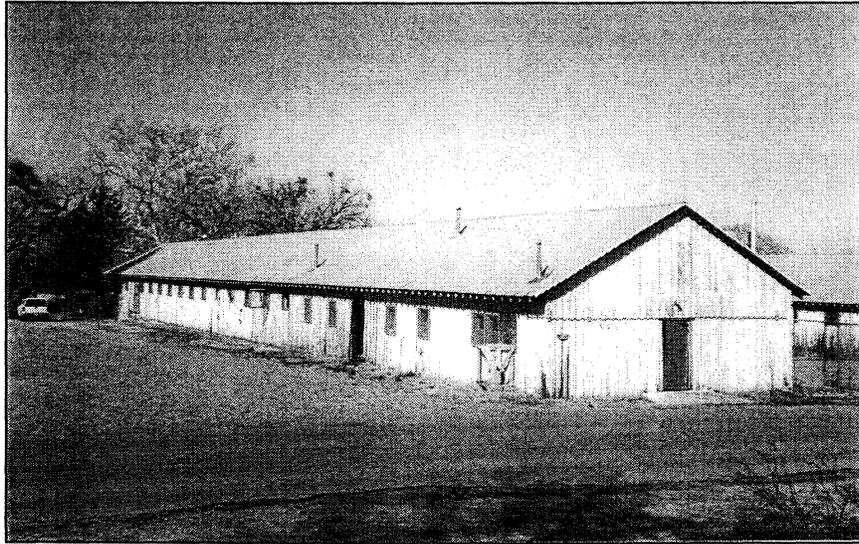
FIGURE D.3. BUILDING 30026, THREE-QUARTER VIEW FROM SOUTHEAST, SHOWING ITS GABLED FORM AND WINDOW RHYTHM (PHOTOGRAPH BY JANET PARKHURST, JANUARY 2005).

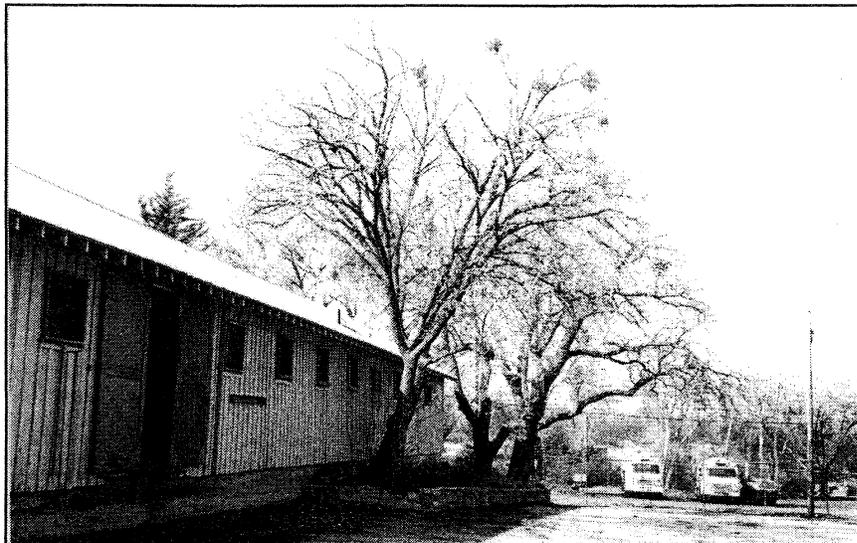
Most of the former paddock and rear zone is currently surfaced in asphalt pavement. However, there is an elevated area of earth adjacent to the foundation on the west façade and west end of the north façade. In the 1941 photograph, an earth berm can be seen toward the west end of the stable (Figure D-S.1). Currently the earth is contained by a mortared stone retaining wall that may relate to Depression-era W.P.A. work at Fort Huachuca (Parkhurst and Thiel 2005). Rooted in this earth pad near the northwest corner are three old deciduous trees. The stone wall is approximately 10 inches wide and capped with mortar. It is approximately 2 ft, 0 inches high on the north and 2 ft, 6 ½ inches high on the west where it incorporates the stone stairs (Figure D.12).

FIGURE D.12. OLD DECIDUOUS TREES IN EARTH PAD CONTAINED BY STONE RETAINING WALL, POSSIBLY BUILT DURING THE W.P.A. ERA. PHOTOGRAPH IS TAKEN AT THE WEST END OF THE NORTH FAÇADE (PHOTOGRAPH BY JANET PARKHURST, JANUARY 2005).
