FARR COTTAGE
(Blenheim)
Main Street
Fairfax
Independent City County
Virginia

HABS No. VA-1388

WRITTEN HISTORICAL AND DESCRIPTIVE DATA

HISTORIC AMERICAN BUILDINGS SURVEY
National Park Service
U.S. Department of the Interior
1849 C St. NW
Washington, DC 20240

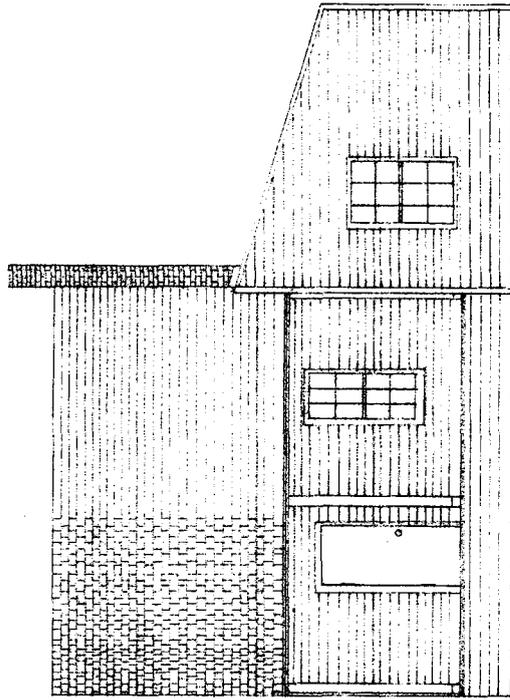
At some point in the 1940s the east porch was enclosed. A small bedroom, bathroom, and walk-through closet were built in the space. In a small attic that was created by this enclosure over the porch roof, it is possible to see the original circular-sawn weatherboards. Also visible are marks where the rafters for the rear porch were cut off during the renovation (fig. 6).

Figure 6. Weatherboard on east wall that was covered when rear porch was enclosed
