WELLTON-MOHAWK IRRIGATION SYSTEM, RELIFT STATION,  
TEXAS HILL CANAL 2.5  
Northern Terminus of Avenue 51 East, approximately .5 mile south of  
Union Pacific Railroad  
Wellton vicinity  
Yuma County  
Arizona

Wellton-Mohawk Irrigation System, Relift Station, Texas Hill Canal 2.5

HAER No. AZ-68-D

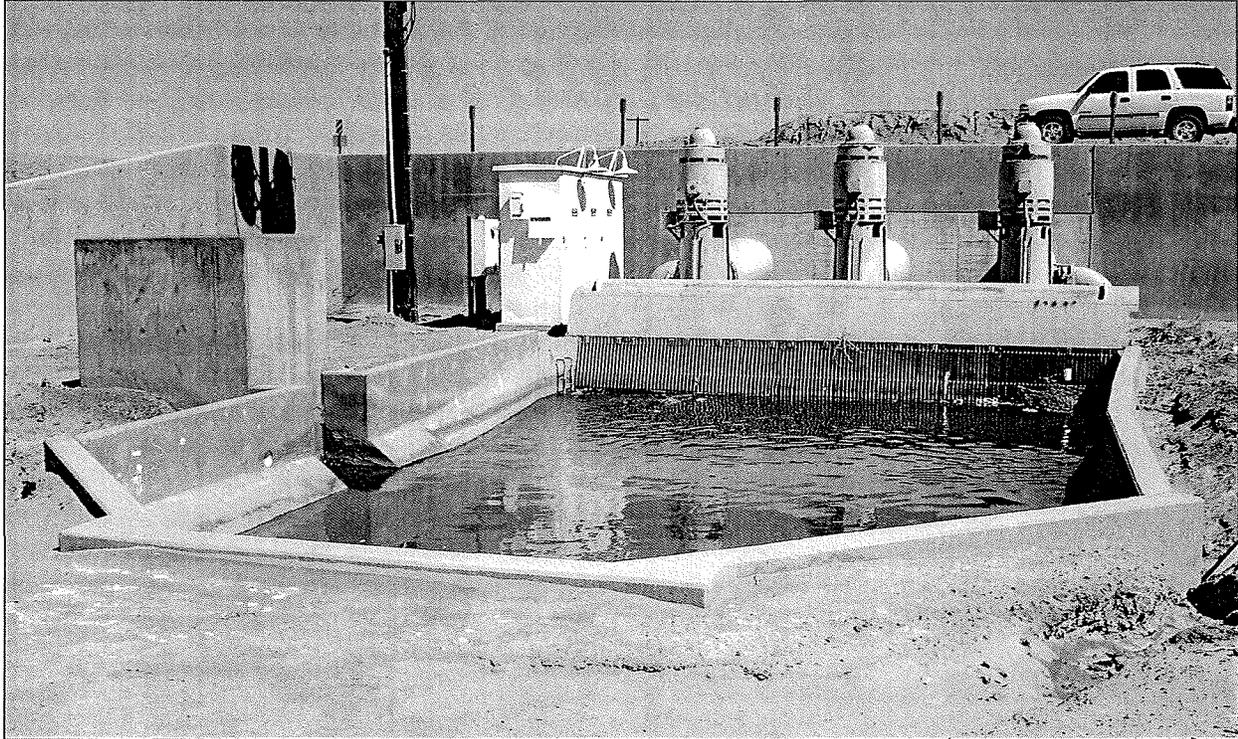
Figure 2. Relift station, Texas Hill Canal 2.5, view to the east, October 2005.

The entire irrigation system can best be described as gravity fed, using large and small pumping stations only when elevation corrections are necessary. The relift station at Mile 2.5 on the Texas Hill Canal (Figures 1 and 2) raises and regulates the flow of water along that section of the canal and functions in much the same manner as Pumping Plant Nos. 1-3 on the Wellton-Mohawk Canal (see AZ-68-A through AZ-68-C) but on a smaller scale.

In 2005, the WMIDD reconstructed approximately 3,000' of canal immediately upstream from the station. This section of the Texas Hill Canal had completely deteriorated into a natural stream and did not resemble a canal. Water from elevated farm land on either side of the canal migrated down and underneath the canal lining, resulting in massive erosion (Figure 8). To remedy the situation, this length of canal was converted to an underground culvert, aided by a sump-pump system to prevent water erosion (Figure 9). According to Charles Slocum (personal communication 2006), WMIDD Manager, altering this section of the canal did not have an impact on the integrity of the relift station. Workers tied in the new concrete with the concrete of the existing forebay structure, thus preserving the size and configuration of the forebay. That same year, the WMIDD raised the height of the concrete box associated with the spillway outlet and raised the wall along the north side of the forebay to mitigate the effects of splashing water when the spillway return is discharging at full capacity (Charles Slocum, personal communication 2006) (see Figure 2).

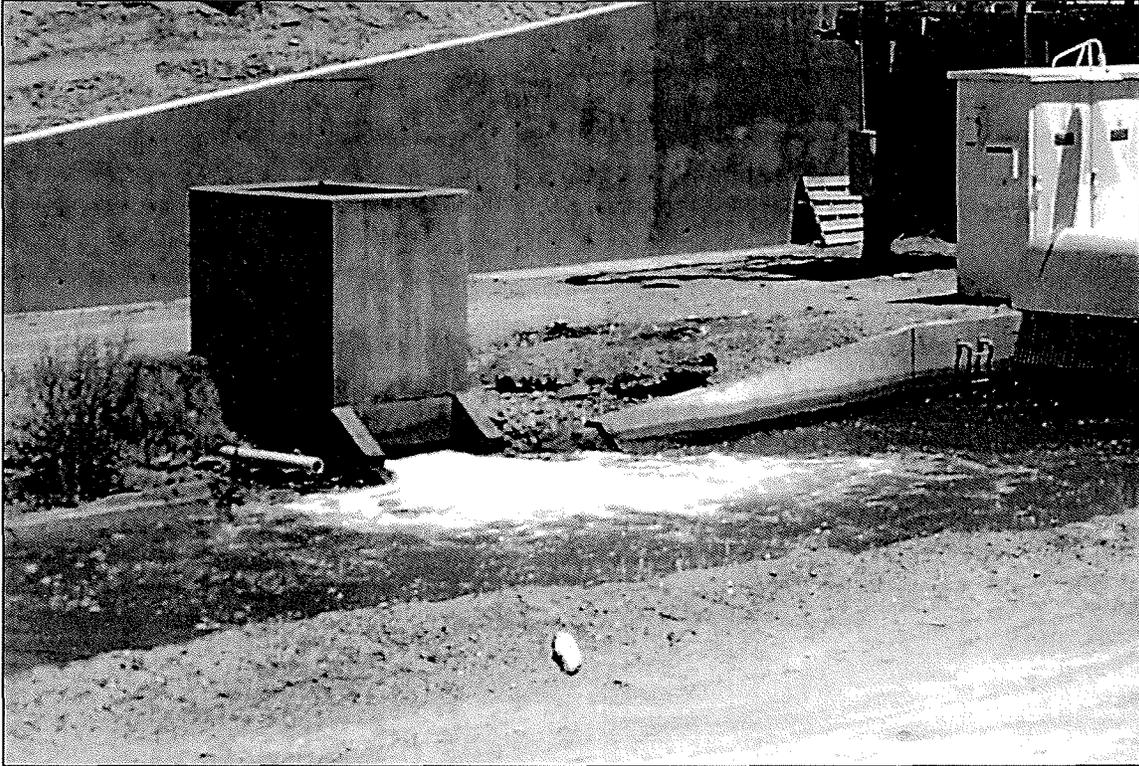
Figure 3. Outlet for spillway, June 2004.

concrete pipe connects the spillway to the outlet structure. A concrete box in place above the outlet functions as an energy dissipater to minimize return-flow turbulence (Figure 3).

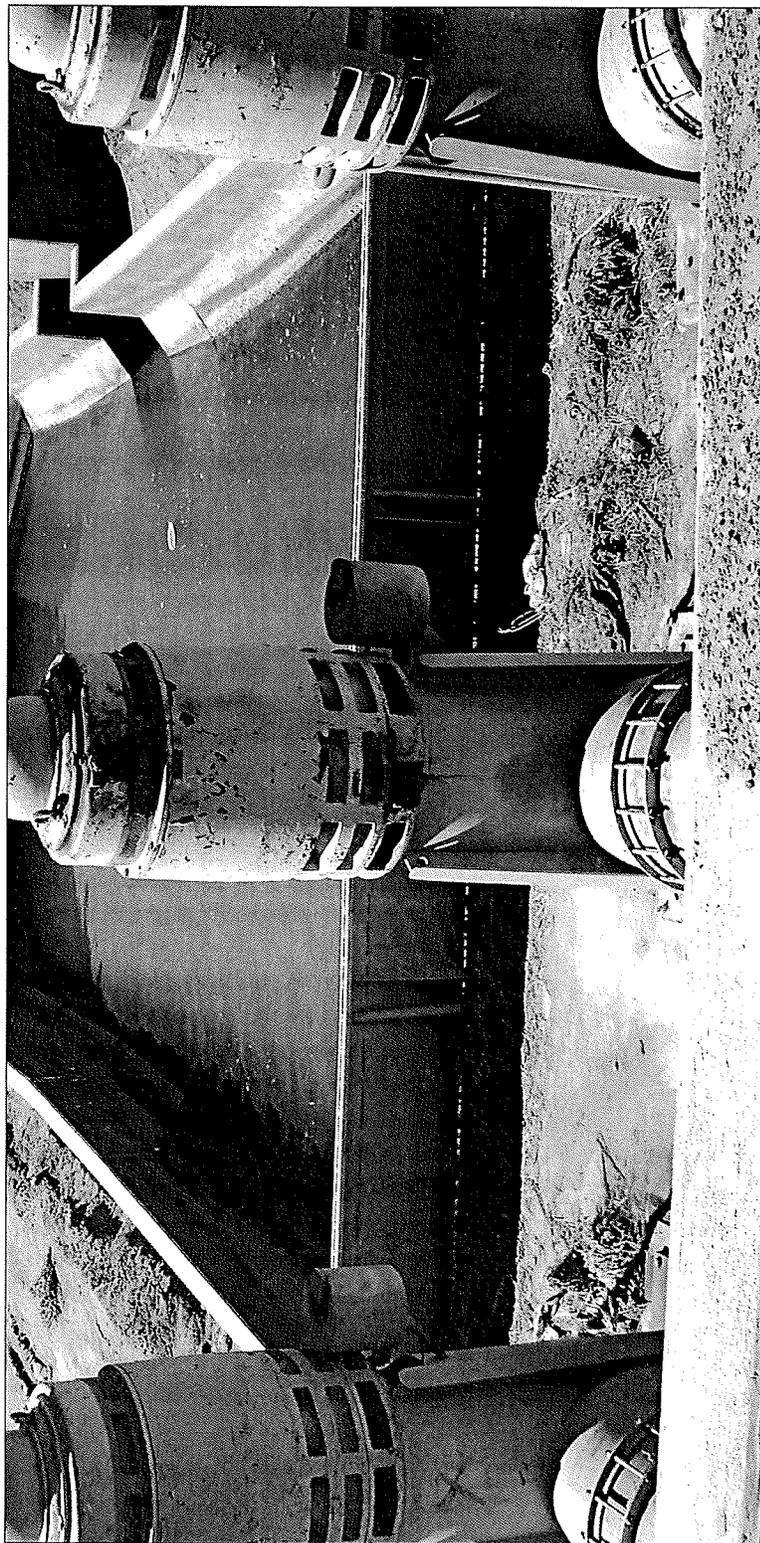
Figure 4. Operating deck of relift station showing metal railing and grates, view to the west, October 2005.

The concrete operating deck above the intake supports the pumping units and provides access to the trash rack on the intake side. It is rectangular in plan and measures 13'-4" x 29'-0". A solid-metal railing spans the deck directly above the trash rack. Metal grates cover the stop-log slots on the portion of the deck behind the trash rack (Figure 4). Stop logs are placed in the slot to seal off the pump intake opening when a pumping unit is taken out of service for maintenance, repair, or inspection.

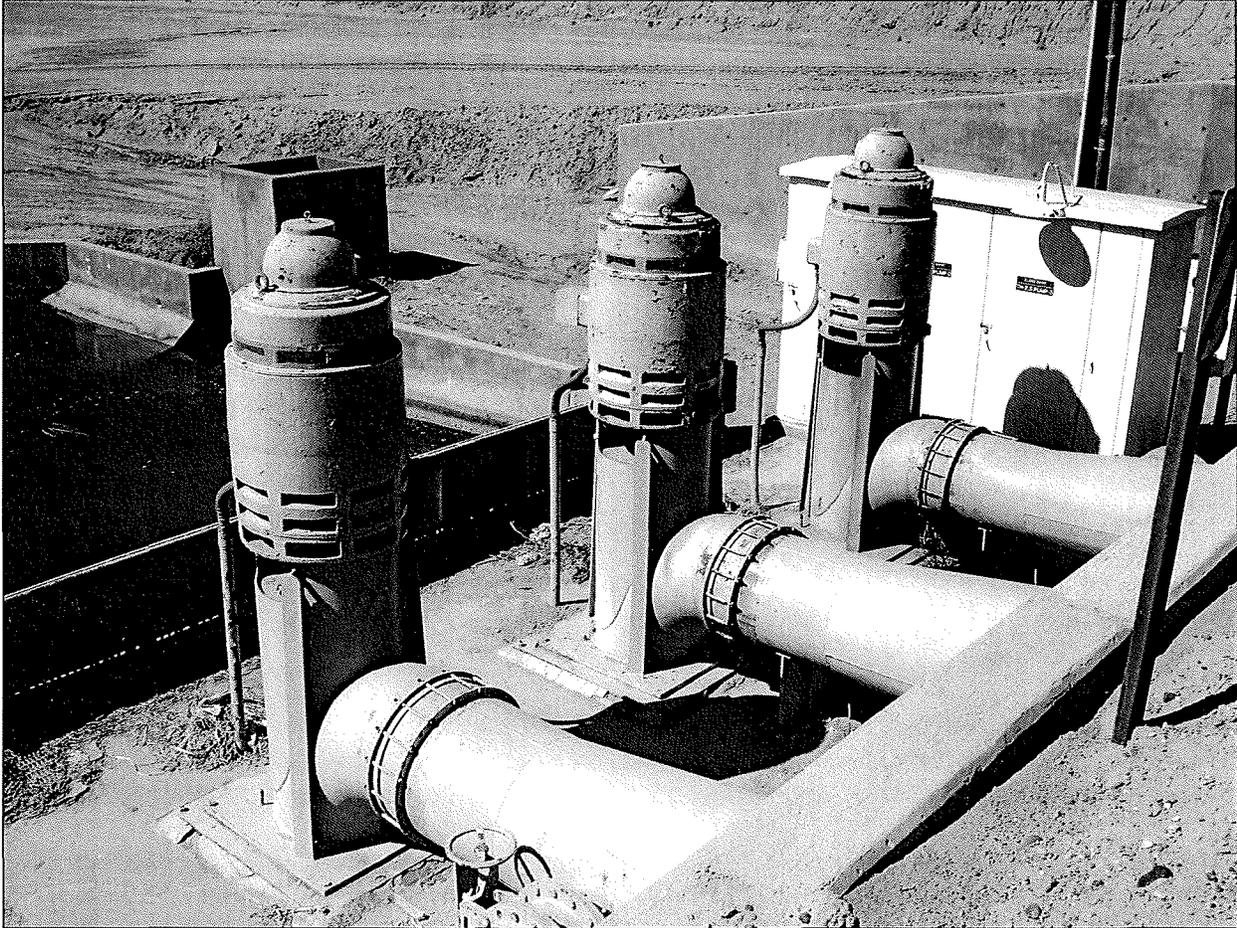
Figure 5. Vertical turbine-type pumps and motors, view to the northwest, October 2005.

The relift station incorporates three vertical turbine-type pumps. Each unit has a capacity of 41 cfs and is powered by a 125-horsepower electric motor (Figure 5). The turbine pumps pull water from the canal forebay and deliver it to the canal afterbay through three 42"-diameter, steel discharge pipes that are connected to precast-concrete discharge pipes of the same diameter. The steel discharge pipes pass through a 9'-0"-high concrete retaining wall where they then connect with the buried, concrete discharge pipes, the latter of which empty into the afterbay section.

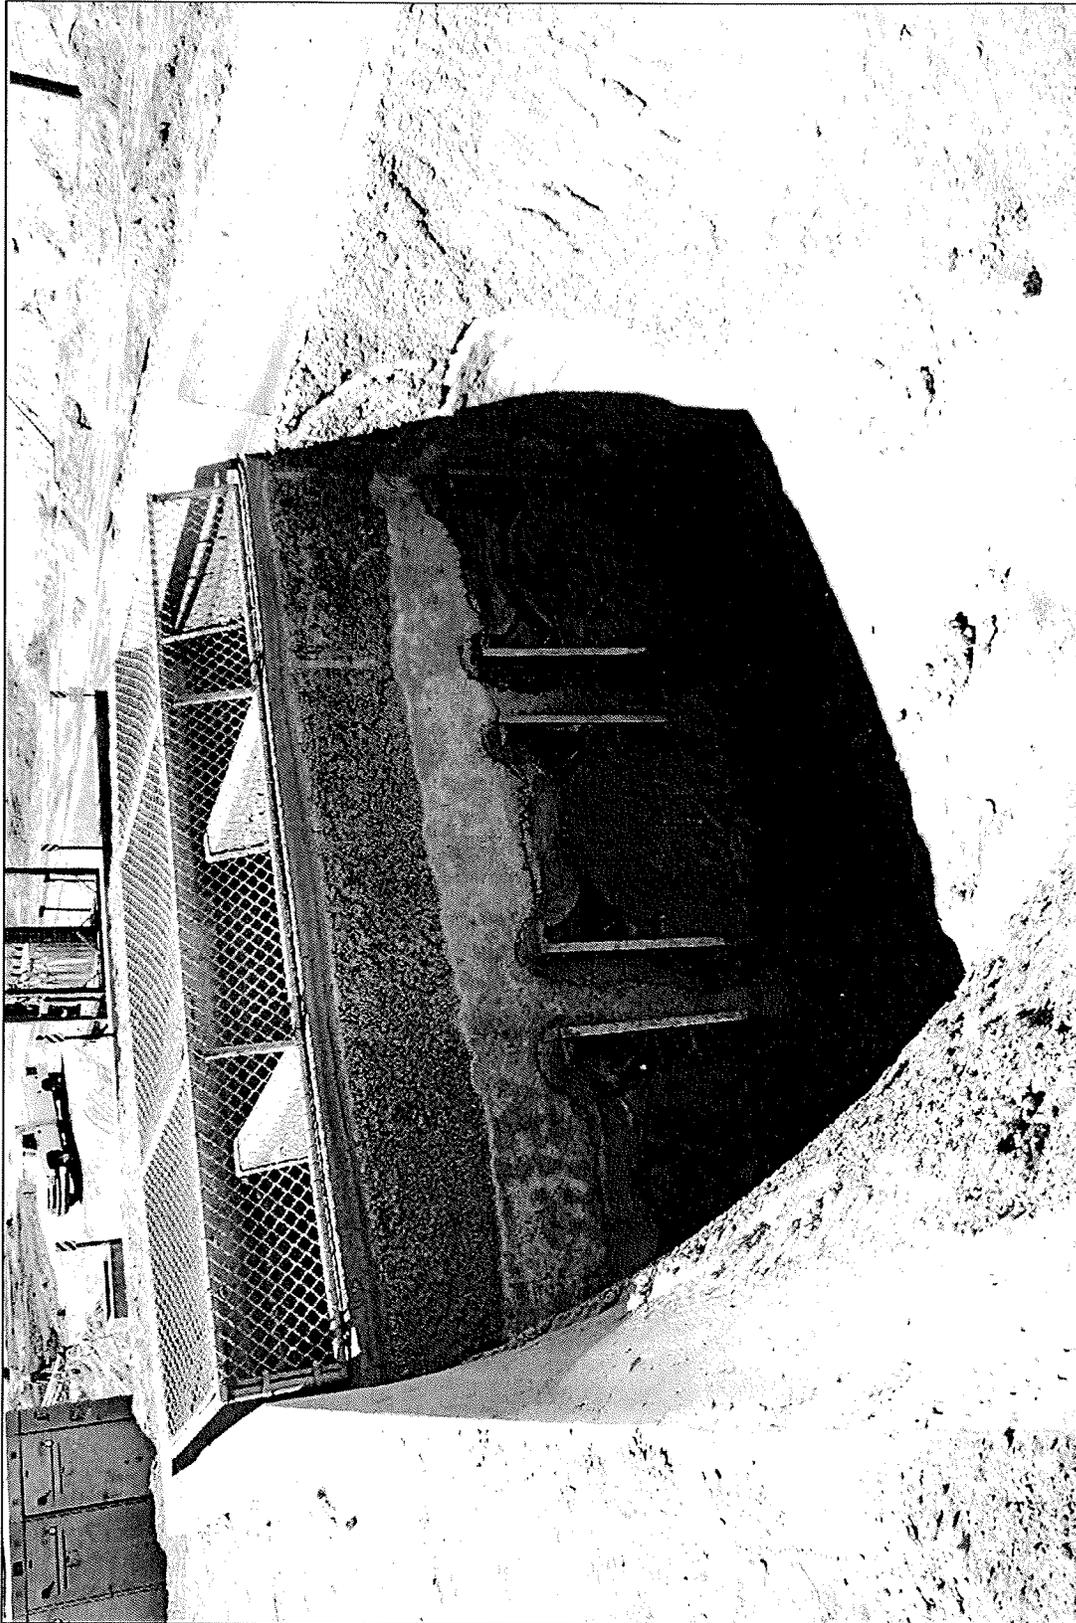
Figure 6. Flap gates on outlet structure, view to the west-northwest, September 2004 (photograph courtesy of the WMIDD).

Water is lifted from the canal forebay about 19' in elevation and is then discharged into the afterbay. The afterbay section consists of three discharge channels, one for each of the discharge pipes connected to the turbine-type pumps. The outlet structure is constructed of reinforced concrete. Similar to the intake, the outlet structure has three bays, or compartments, into which the pipes dump water. This structure consists of a bulkhead wall, two partition walls, and a downstream wall that spans the width of the canal. The structure does not have a deck and is open at the top. A chain-link screen covers the opening as a safety precaution. The bulkhead wall is 10'-3" high and contains the pipe openings. Two 8"-thick concrete walls divide the outlet structure into thirds. Both walls are 8'-8" high. The downstream wall measures 8" thick x 8'-8" high x 16'-0" wide. Incorporated at the base of the downstream wall are three circular openings; each opening is 48" in diameter. Three steel flap gates are attached to the downstream side of the wall above the openings (Figure 6). When a pump is operating, the corresponding flap gate is forced open by the flow of water being discharged into the afterbay. When the pump is shut down, the weight of the gate combined with the water pressure in the canal causes the flap gate to close. In its closed position, the flap gate prevents water from flowing back into the pump when the unit is shut down for repairs.

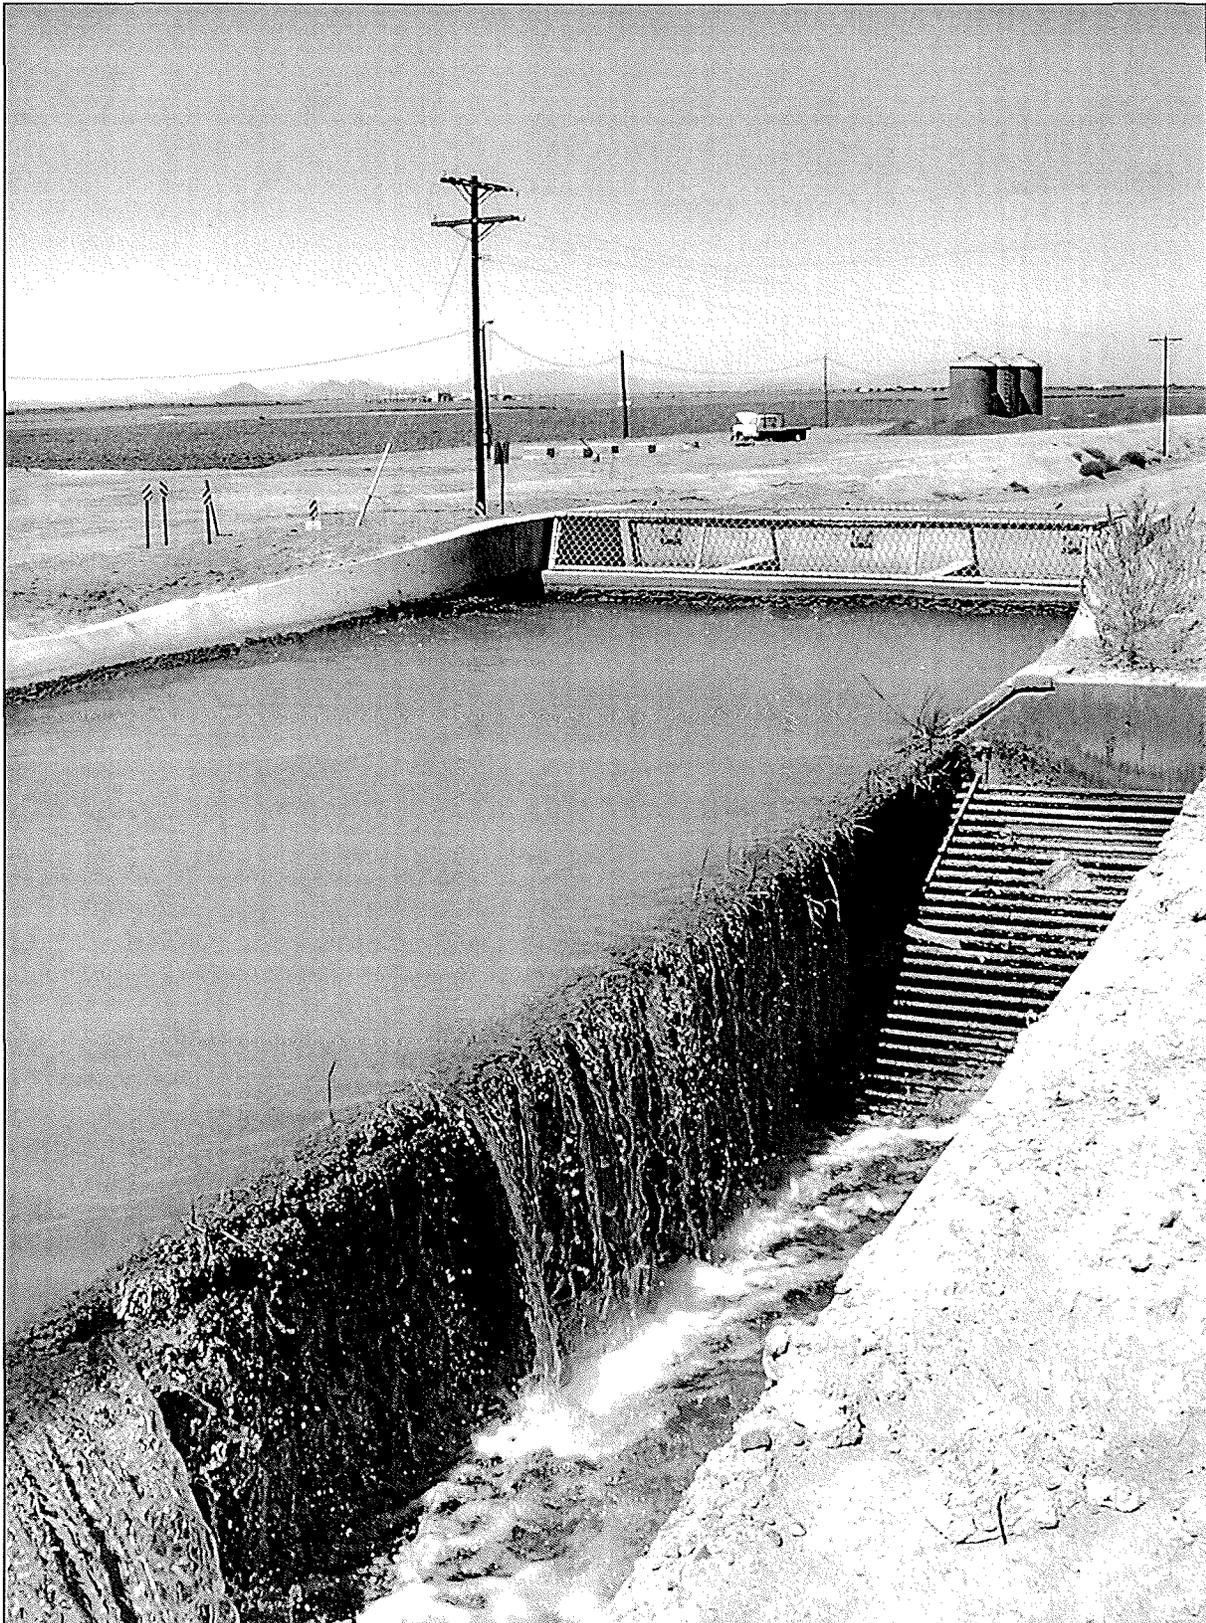
Figure 7. Spillway in afterbay section, view to the west-southwest, June 2004.

the water surface in the side channel is below the spillway crest and the side channel has a downward slope from the downstream end to the upstream end. At the upstream end of the feature is a 10'-0"-deep pool where the water flows into the discharge pipe. As a safety measure, a protective metal grate covers the opening to the pool (Figure 7).

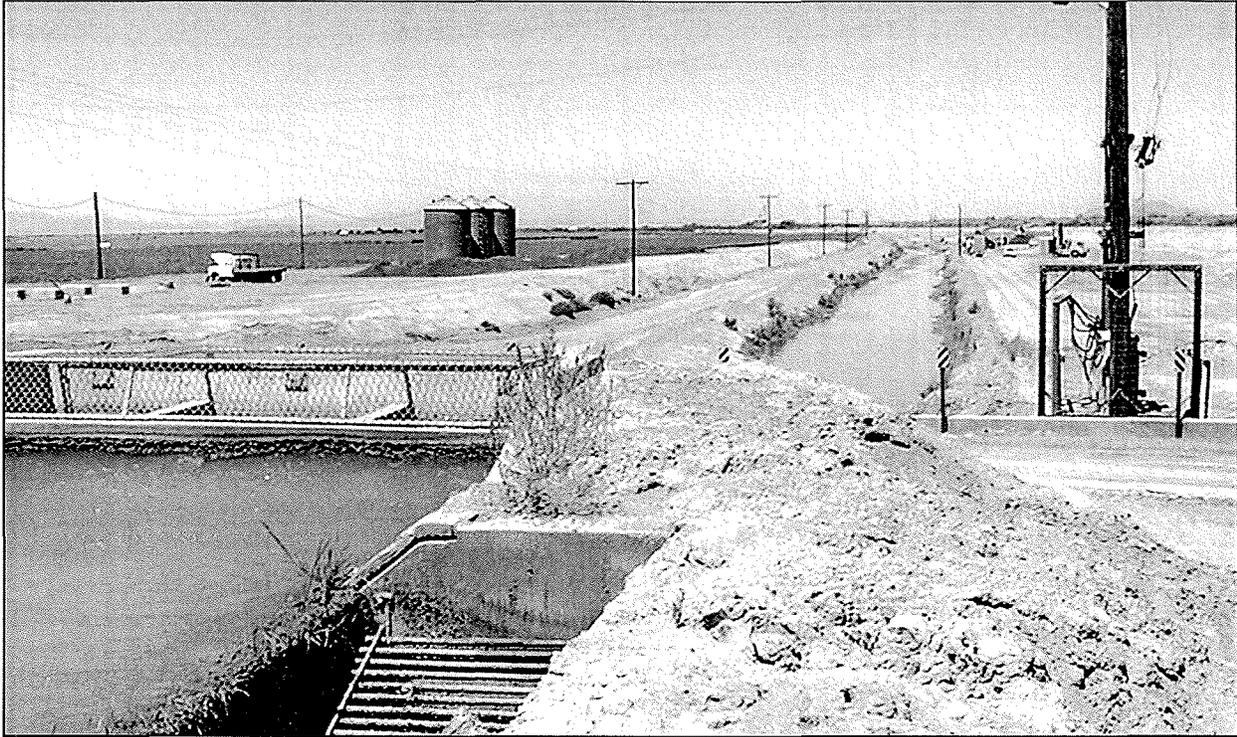
**Figure 8. Looking upstream from the afterbay, June 2004.  
Note the eroded canal banks in the background.**

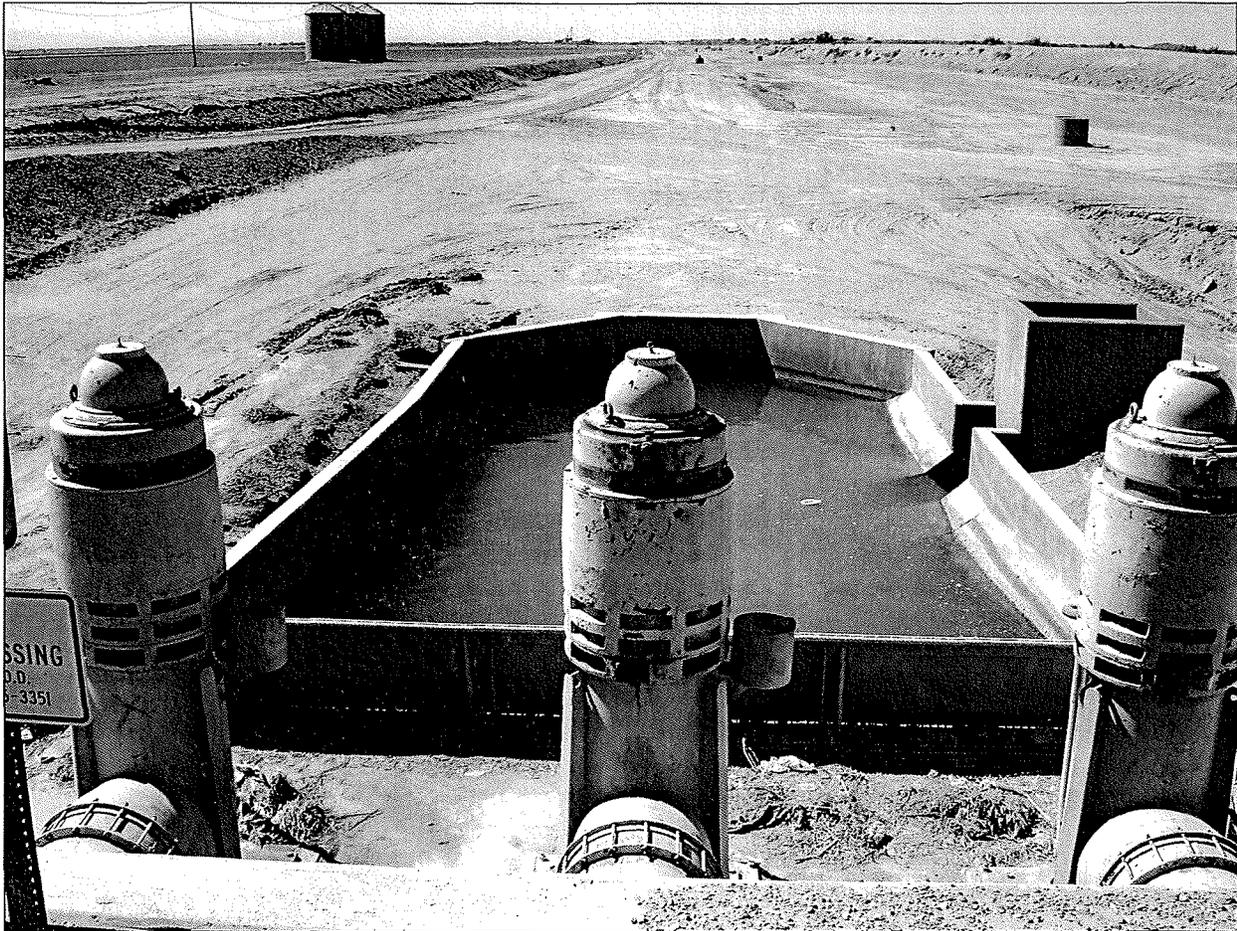
Figure 9. Looking upstream from the relift station, October 2005.
