ST. ELIZABETHS HOSPITAL, PINE  
(Building No. 6)  
539-559 Cedar Drive, Southeast  
Washington  
District of Columbia

HABS DC-349-AA  
*HABS DC-349-AA*

ST. ELIZABETHS HOSPITAL, PINE (BUILDING 6)

HABS NO. DC-349-AA

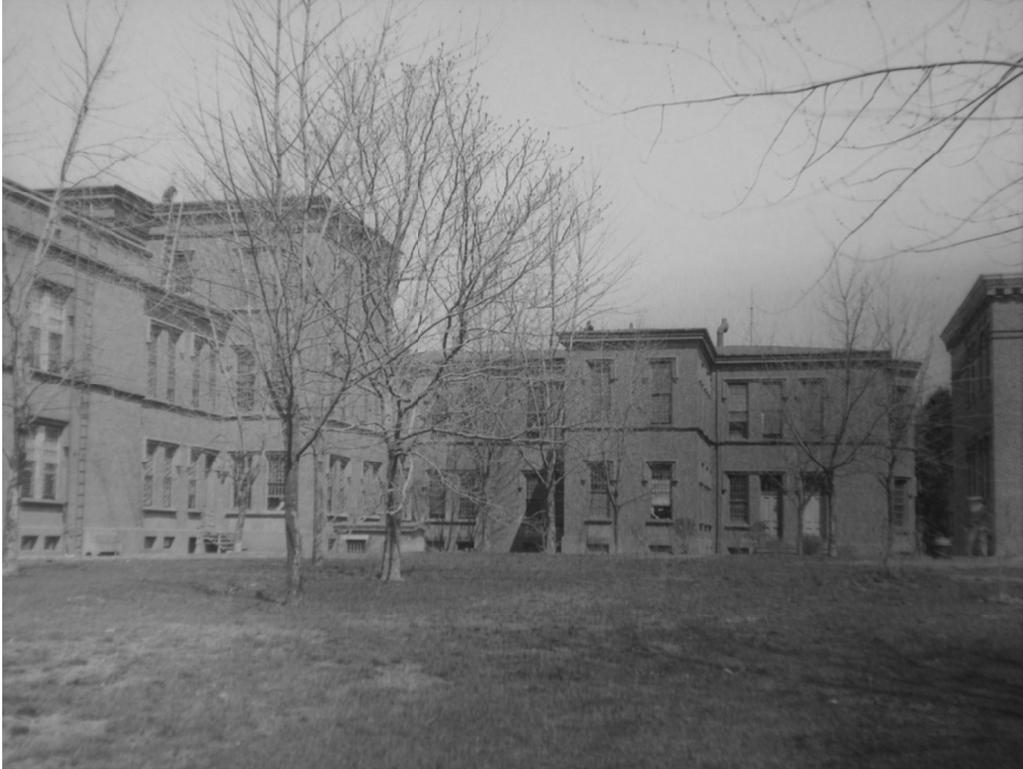
*Figure 1. View from southwest of Pine, 1899. Linden is at the right edge of the image, and the East Wing is at left.  
Source: National Archives, Record Group 418.*

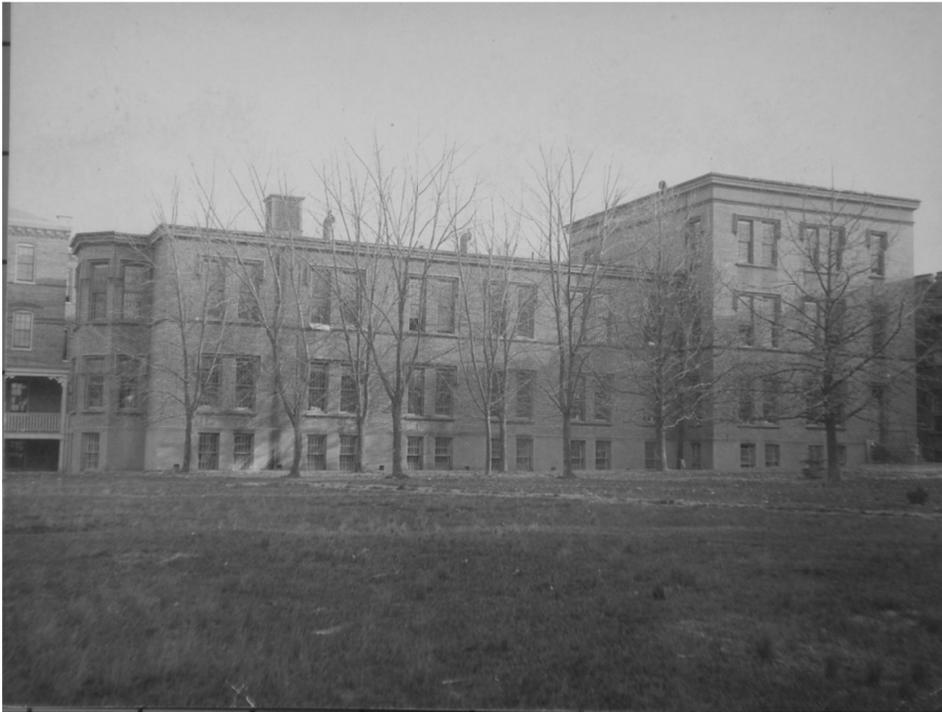
*Figure 2. View from the north of Pine, 1899. Source: National Archives, Record Group 418.*

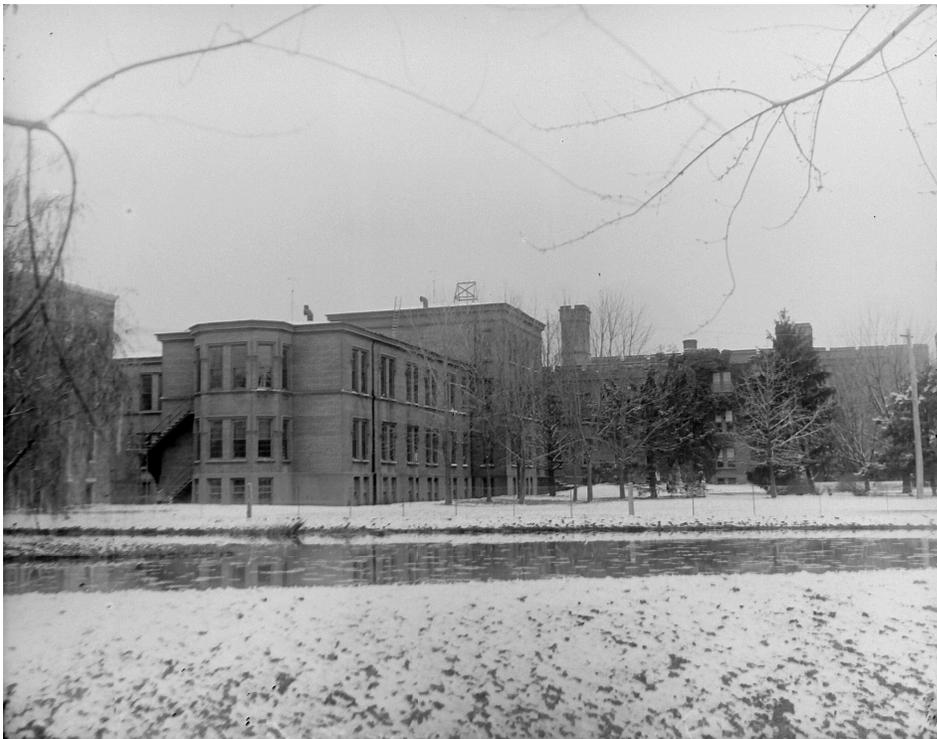
*Figure 3. View from the northeast of Pine, 1899. Source: GSA Archives, image DC1472SE0P024.*

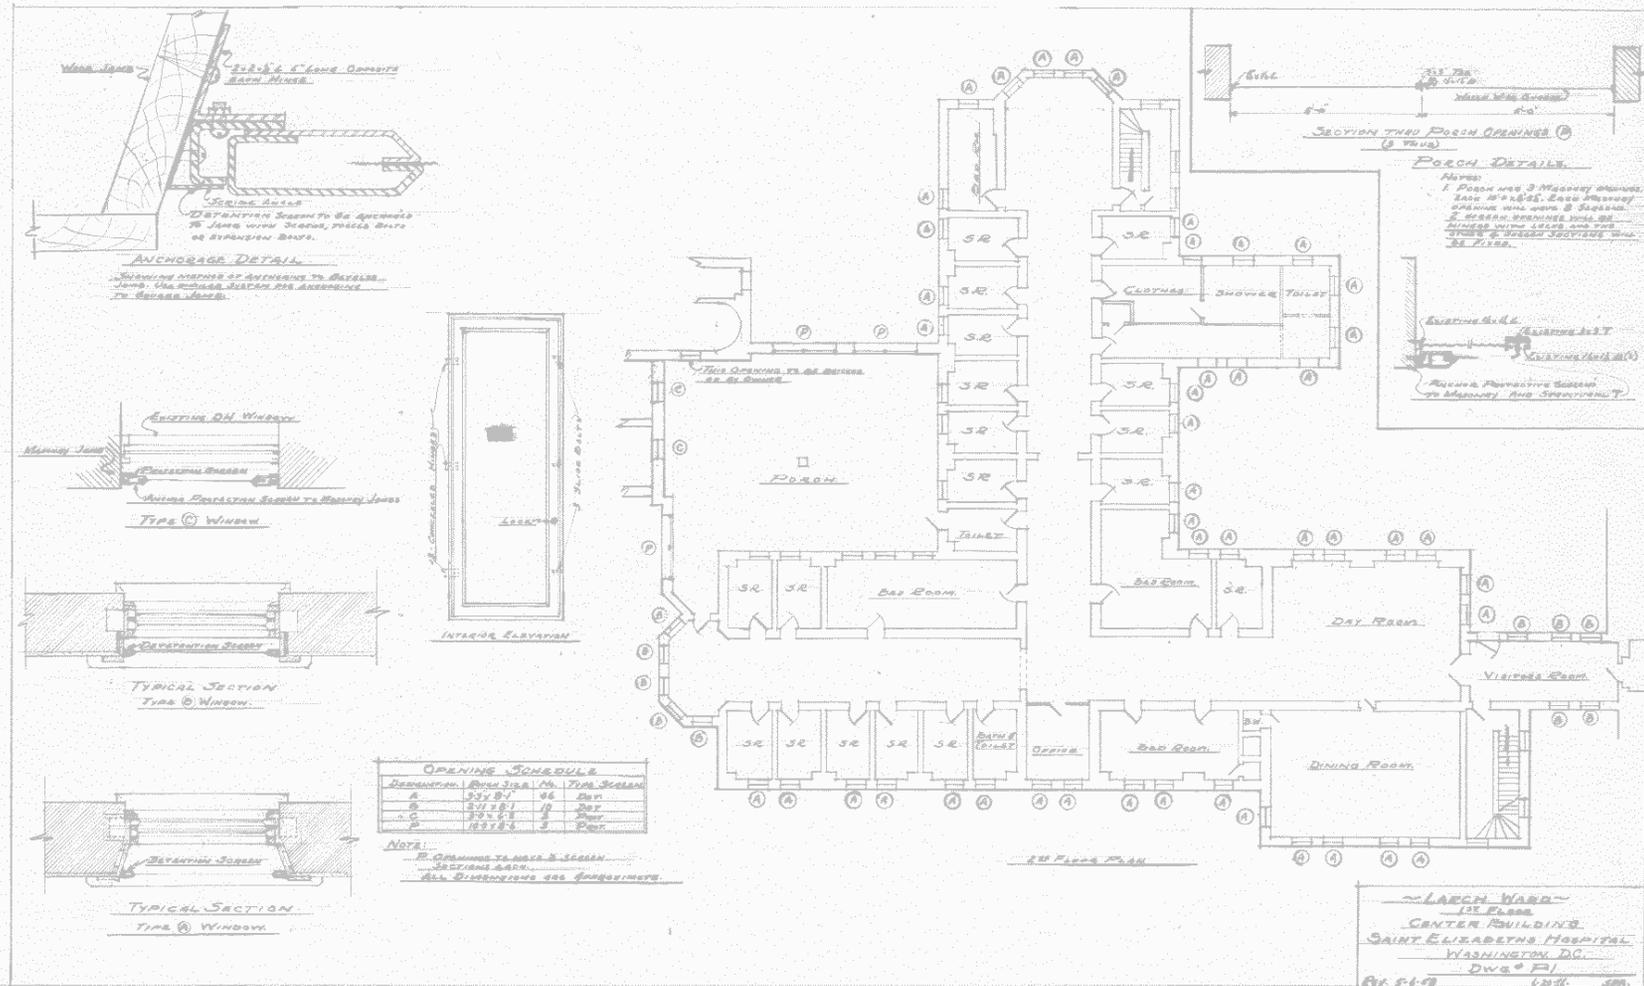
Figure 4. Second floor plan of Pine showing window replacement, 1956. Source: GSA Archives, image DC0080SE0120.

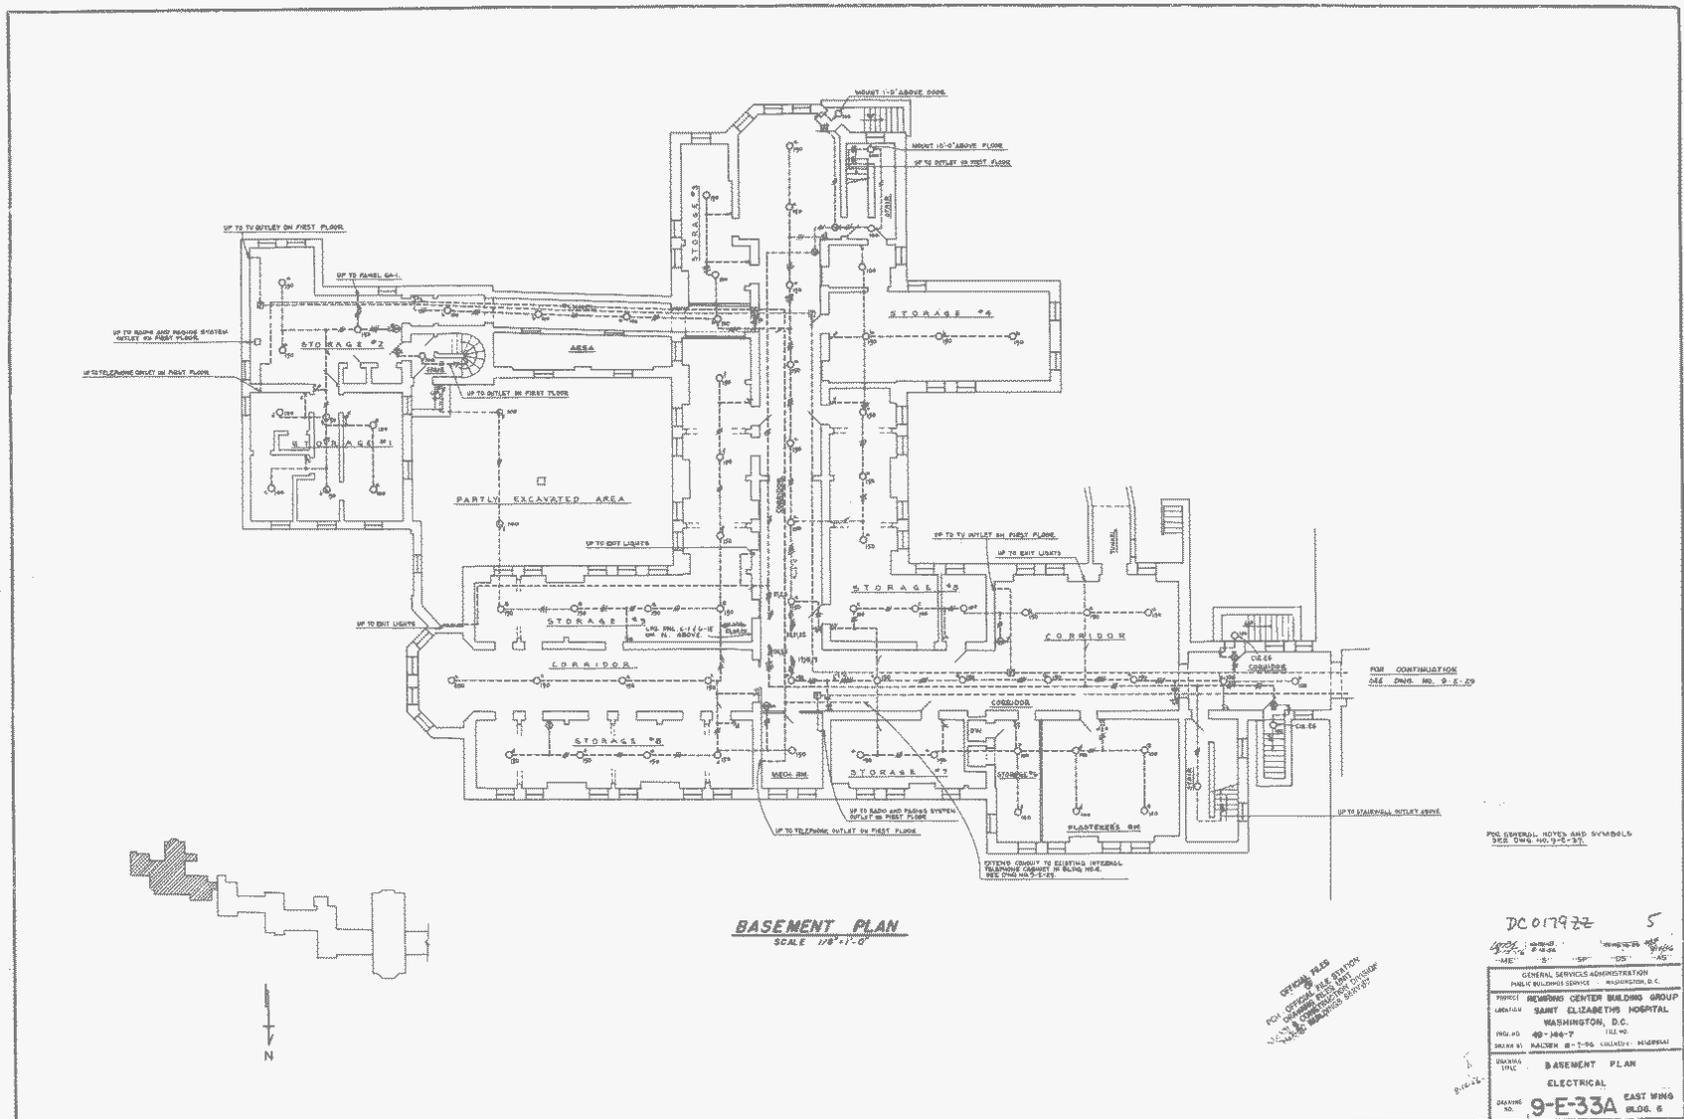
Figure 5. Basement plan of Pine showing electrical improvements, 1956. Source: GSA Archives, image DC0179SE0005

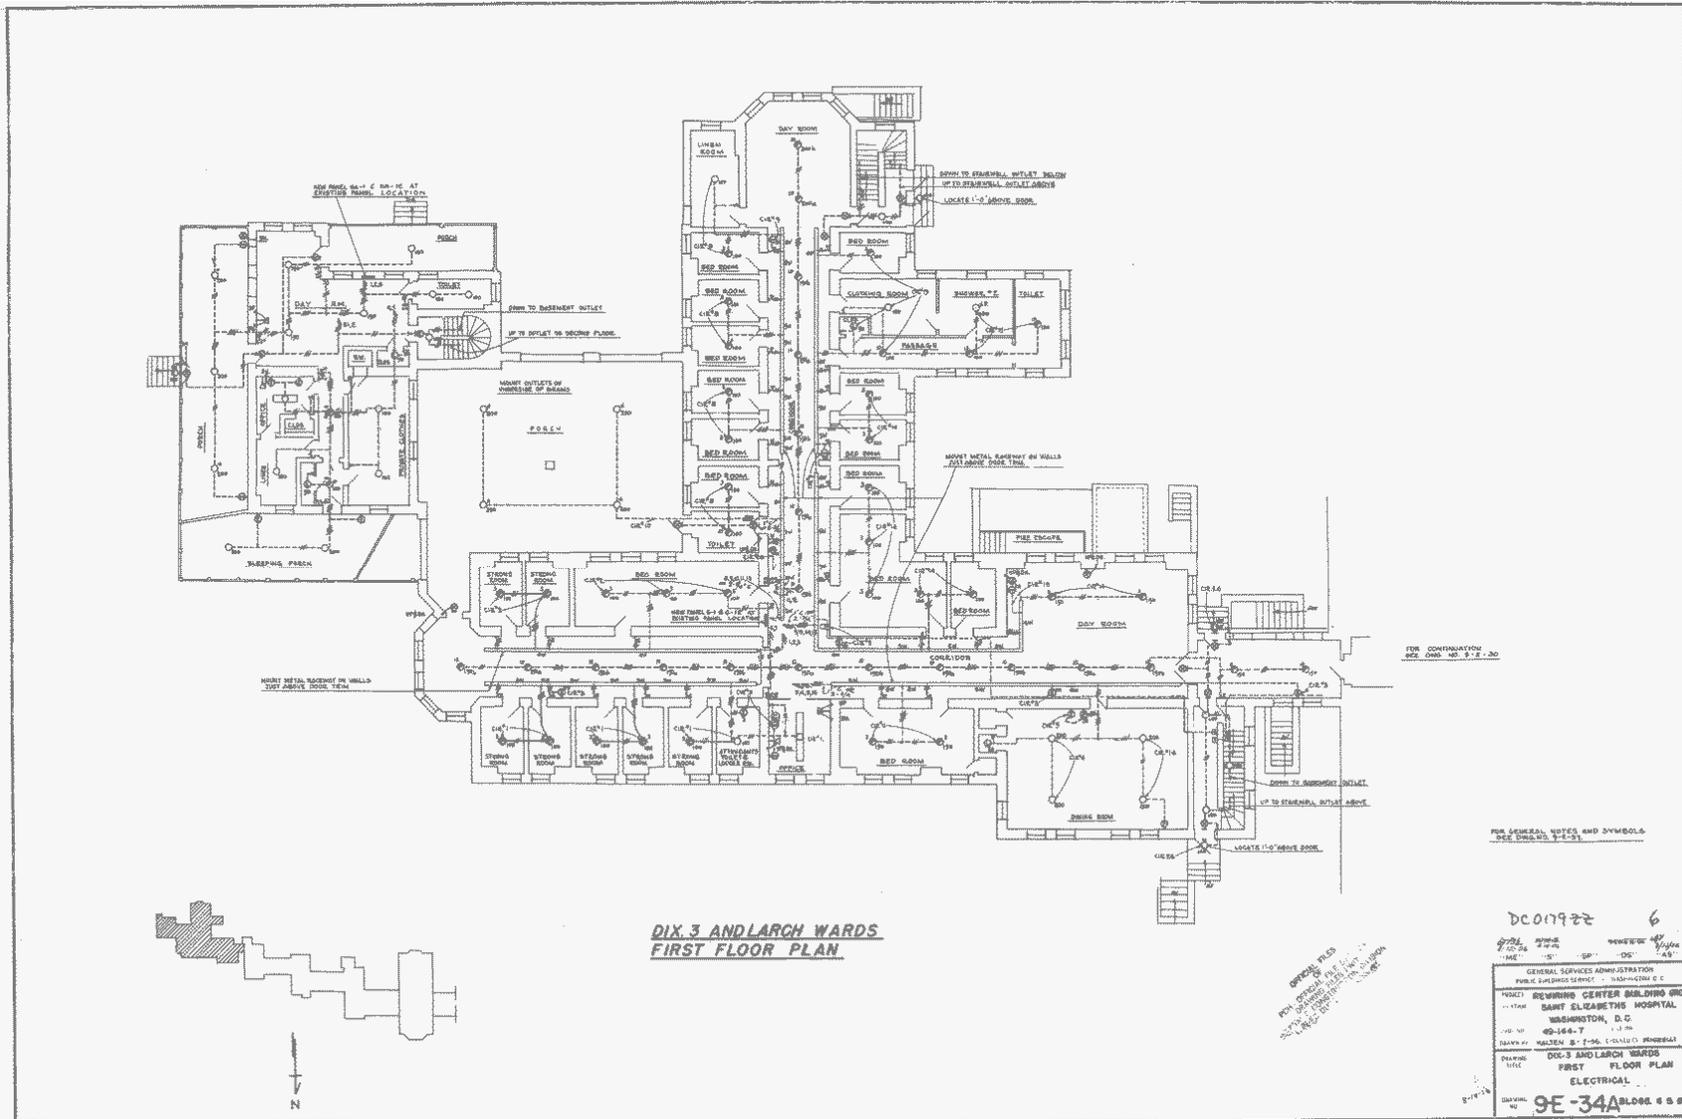
Figure 6. First floor plan of Pine showing electrical improvements, 1956. Source: GSA Archives, image DC0179SE0006.

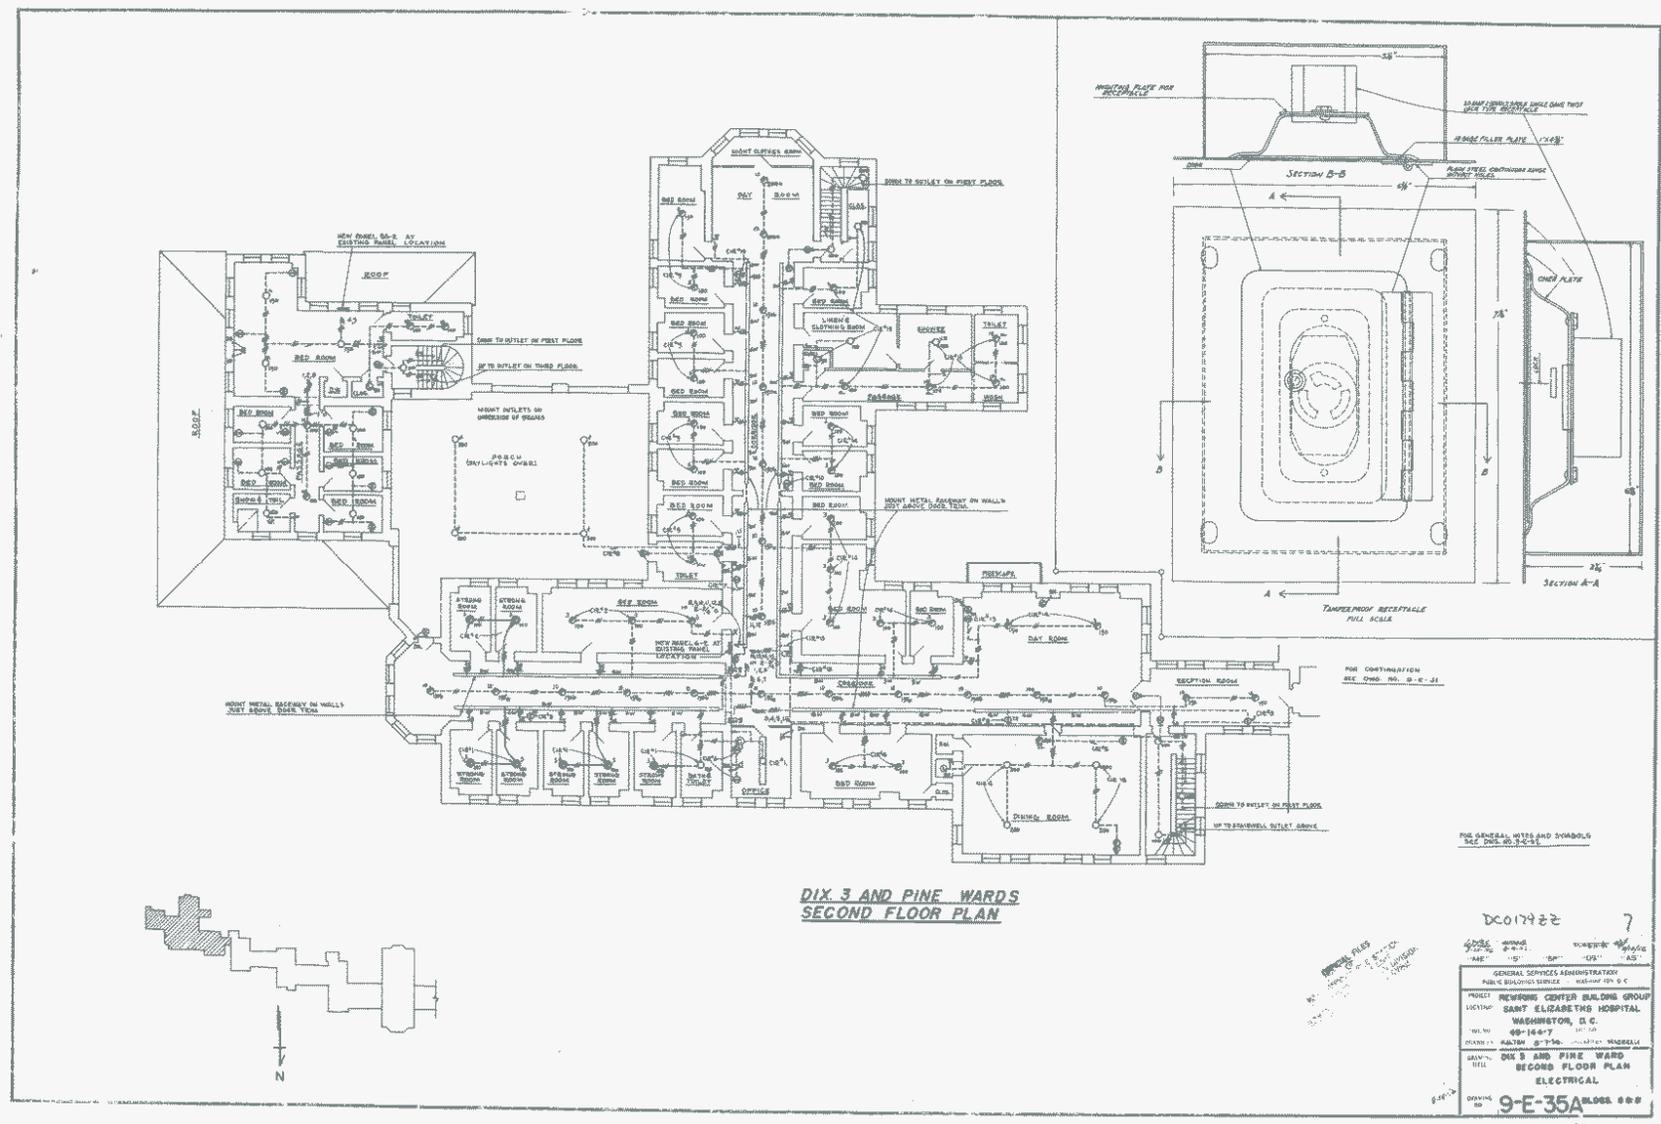
Figure 7. Second floor plan of Pine showing electrical improvements, 1956. Source: GSA Archives, image DC0179SE0007.

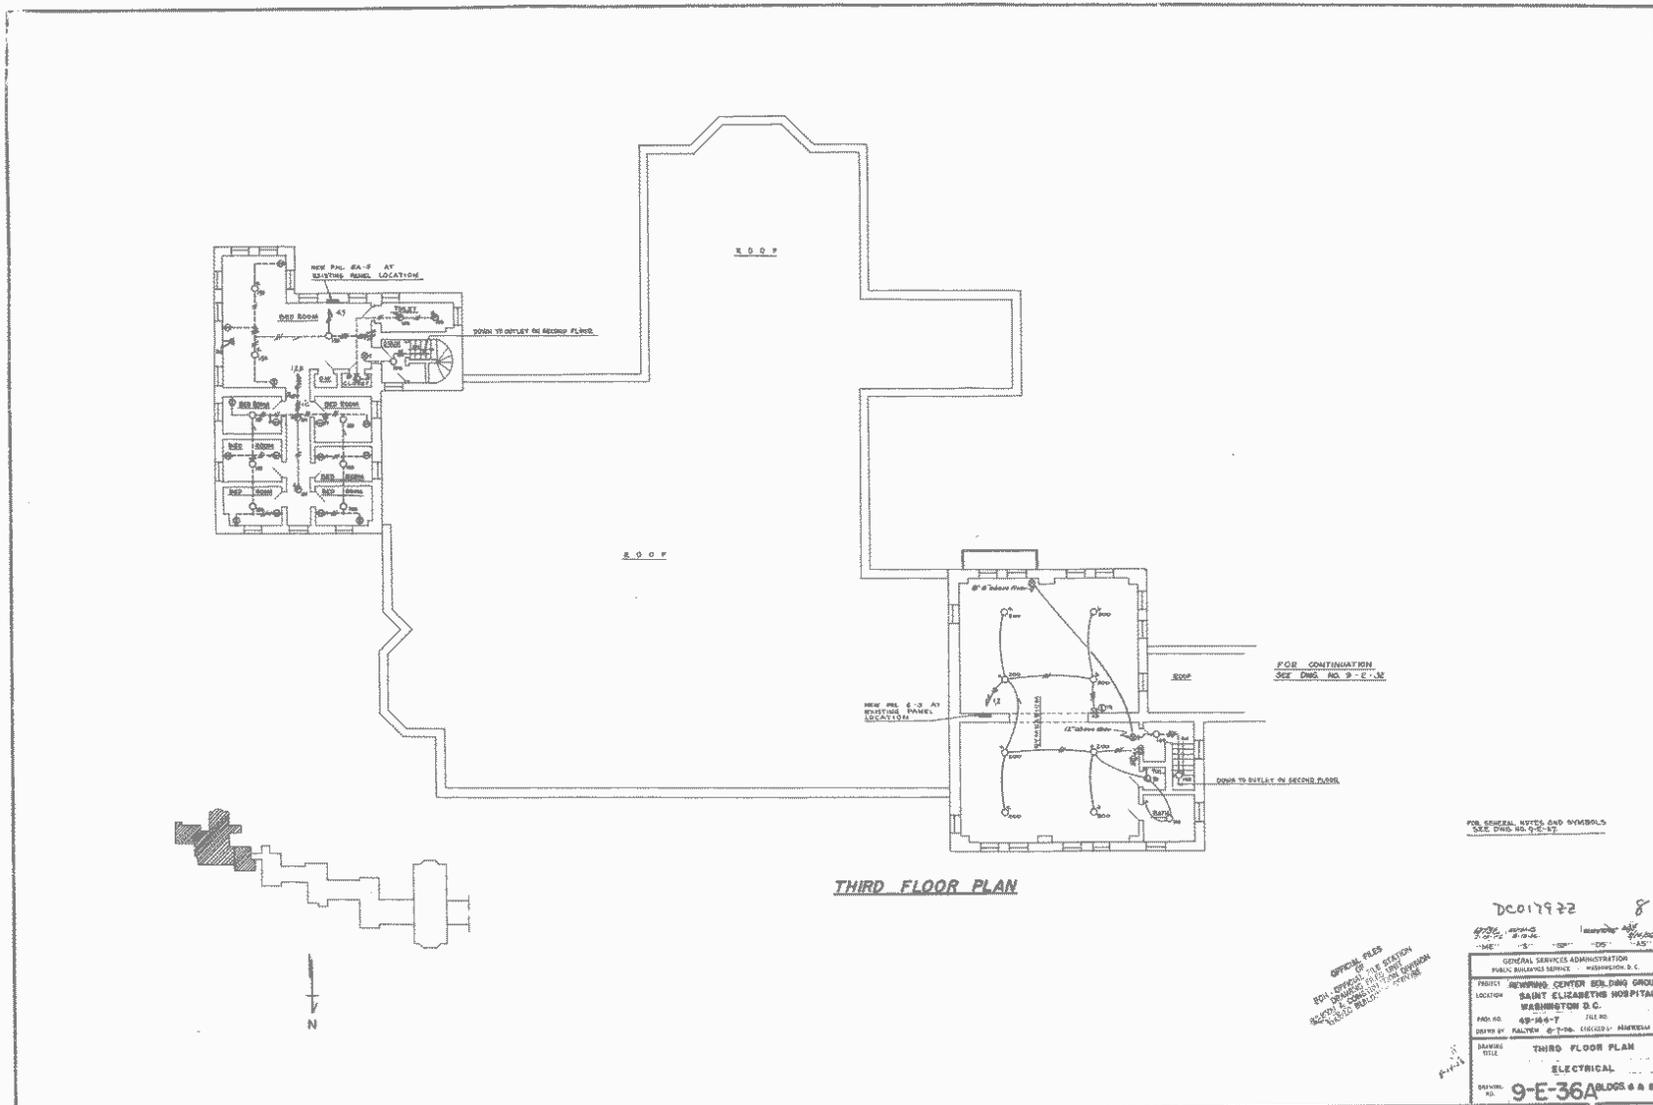
Figure 8. Third floor plan of Pine showing electrical improvements, 1956. Source: GSA Archives, image DC0179SE0008.

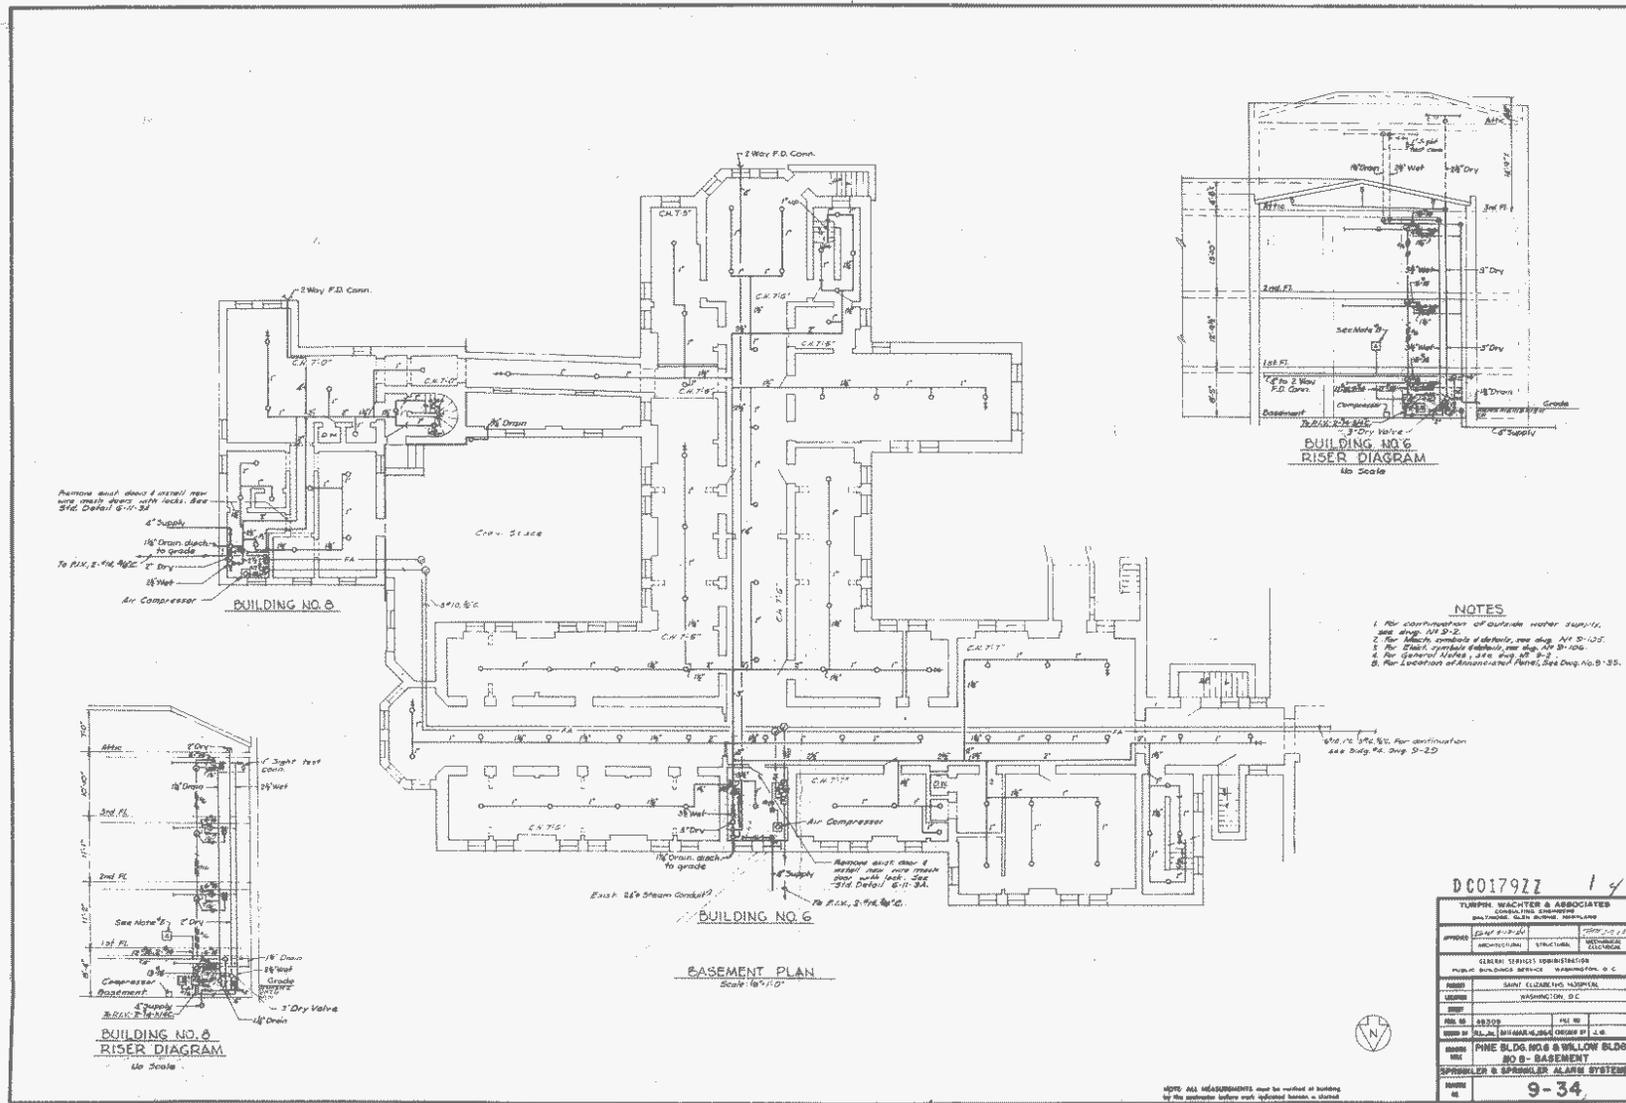
Figure 9. Basement plan of Pine showing fire suppression system improvements, 1964. Source: GSA Archives, image DC0179SE0001.

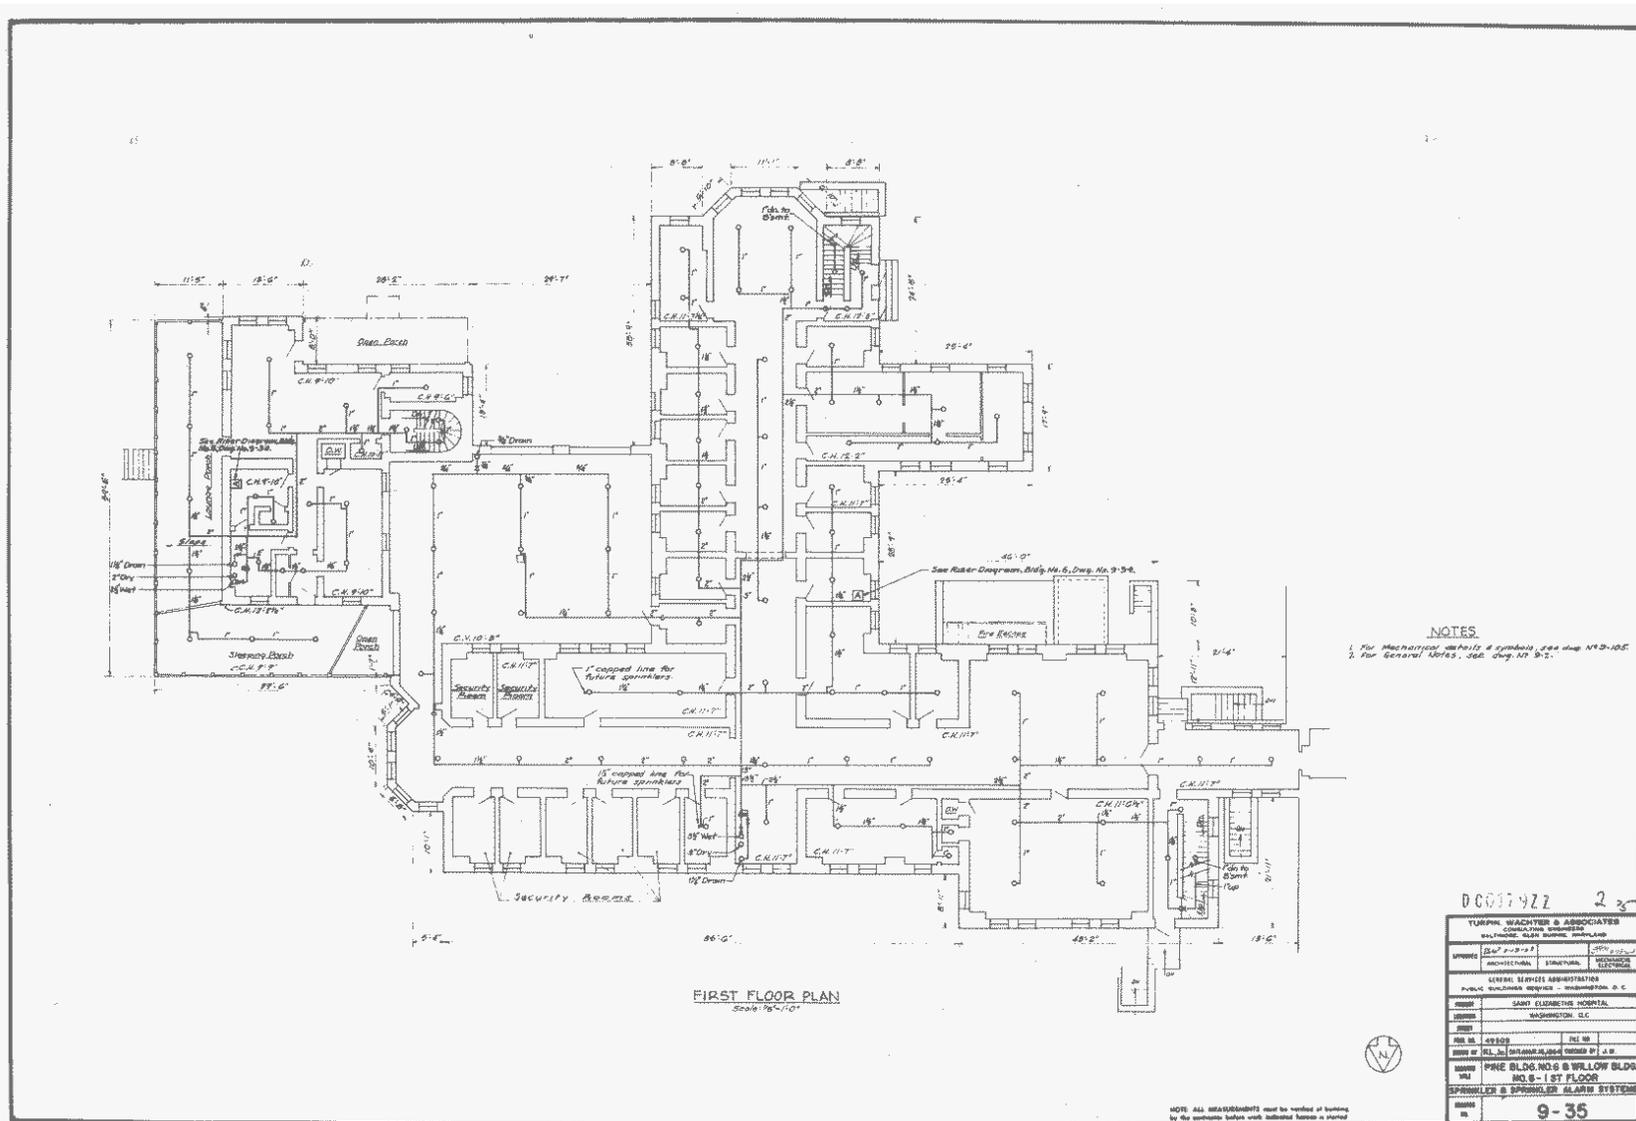
Figure 10. First floor plan of Pine showing fire suppression system improvements, 1964. Source: GSA Archives, image DC0179SE0002.

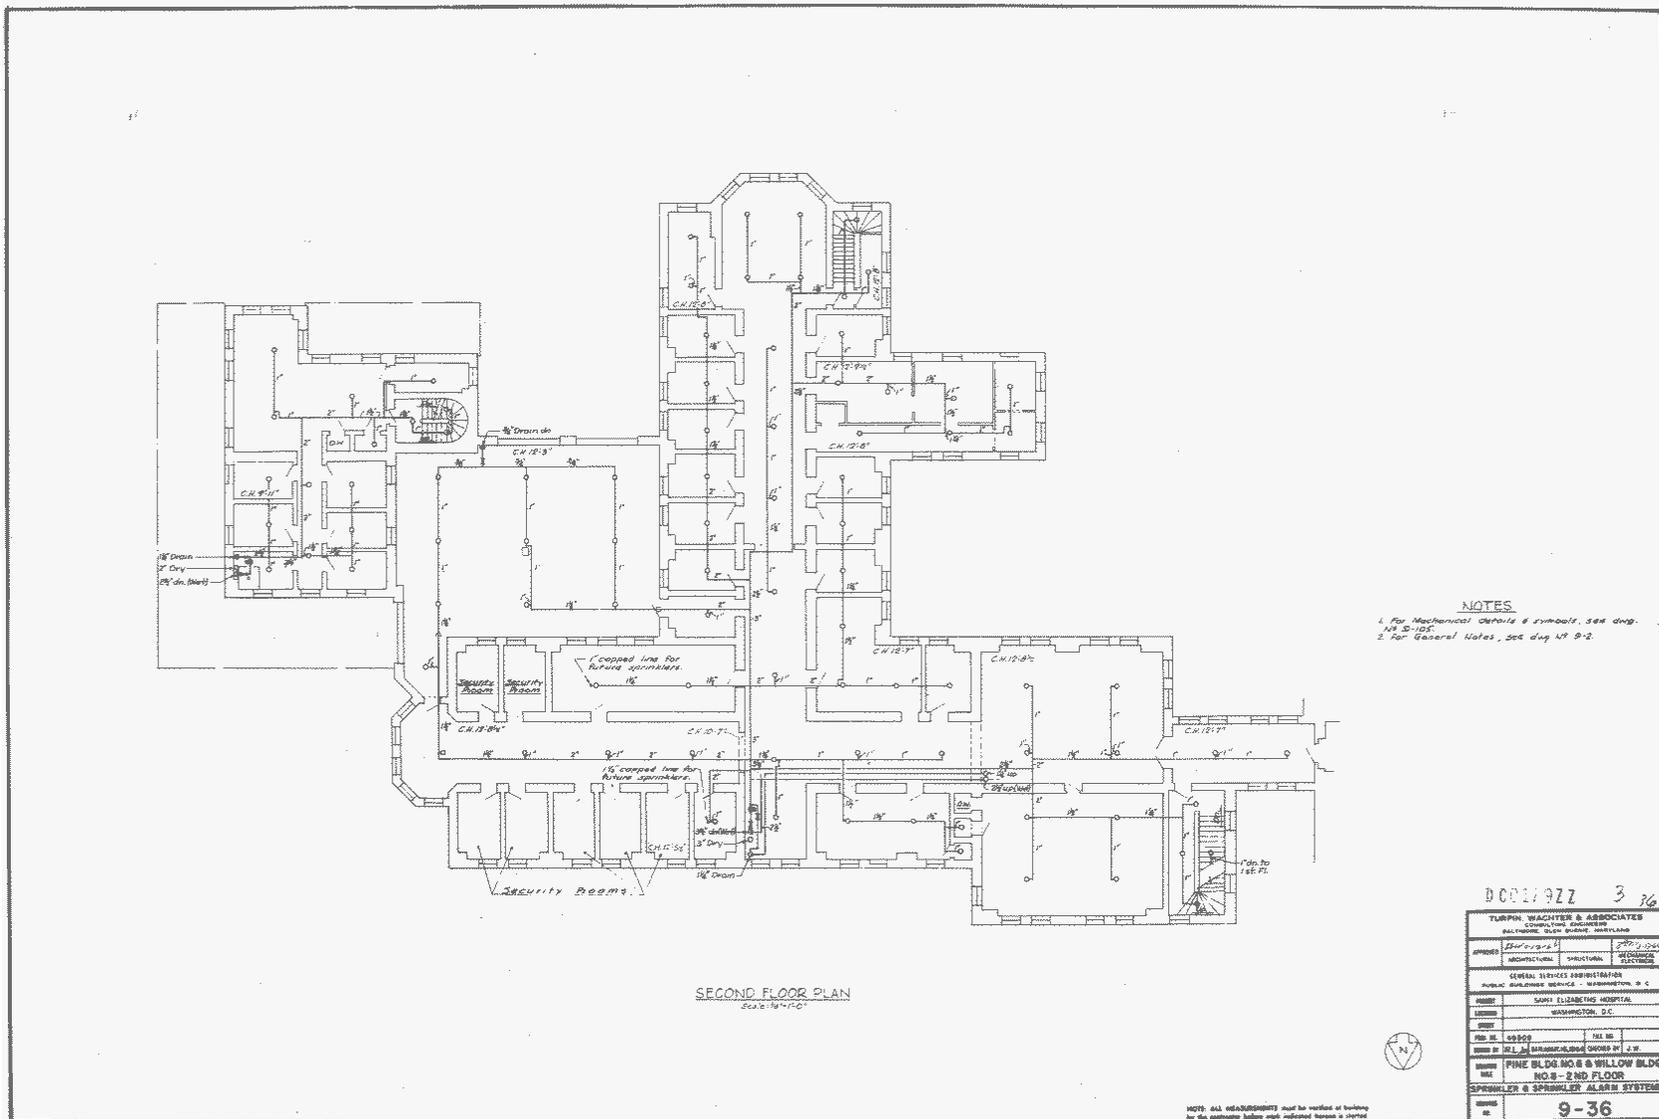
Figure 11. Second floor plan of Pine showing fire suppression system improvements, 1964. Source: GSA Archives, image DC0179SE0003.

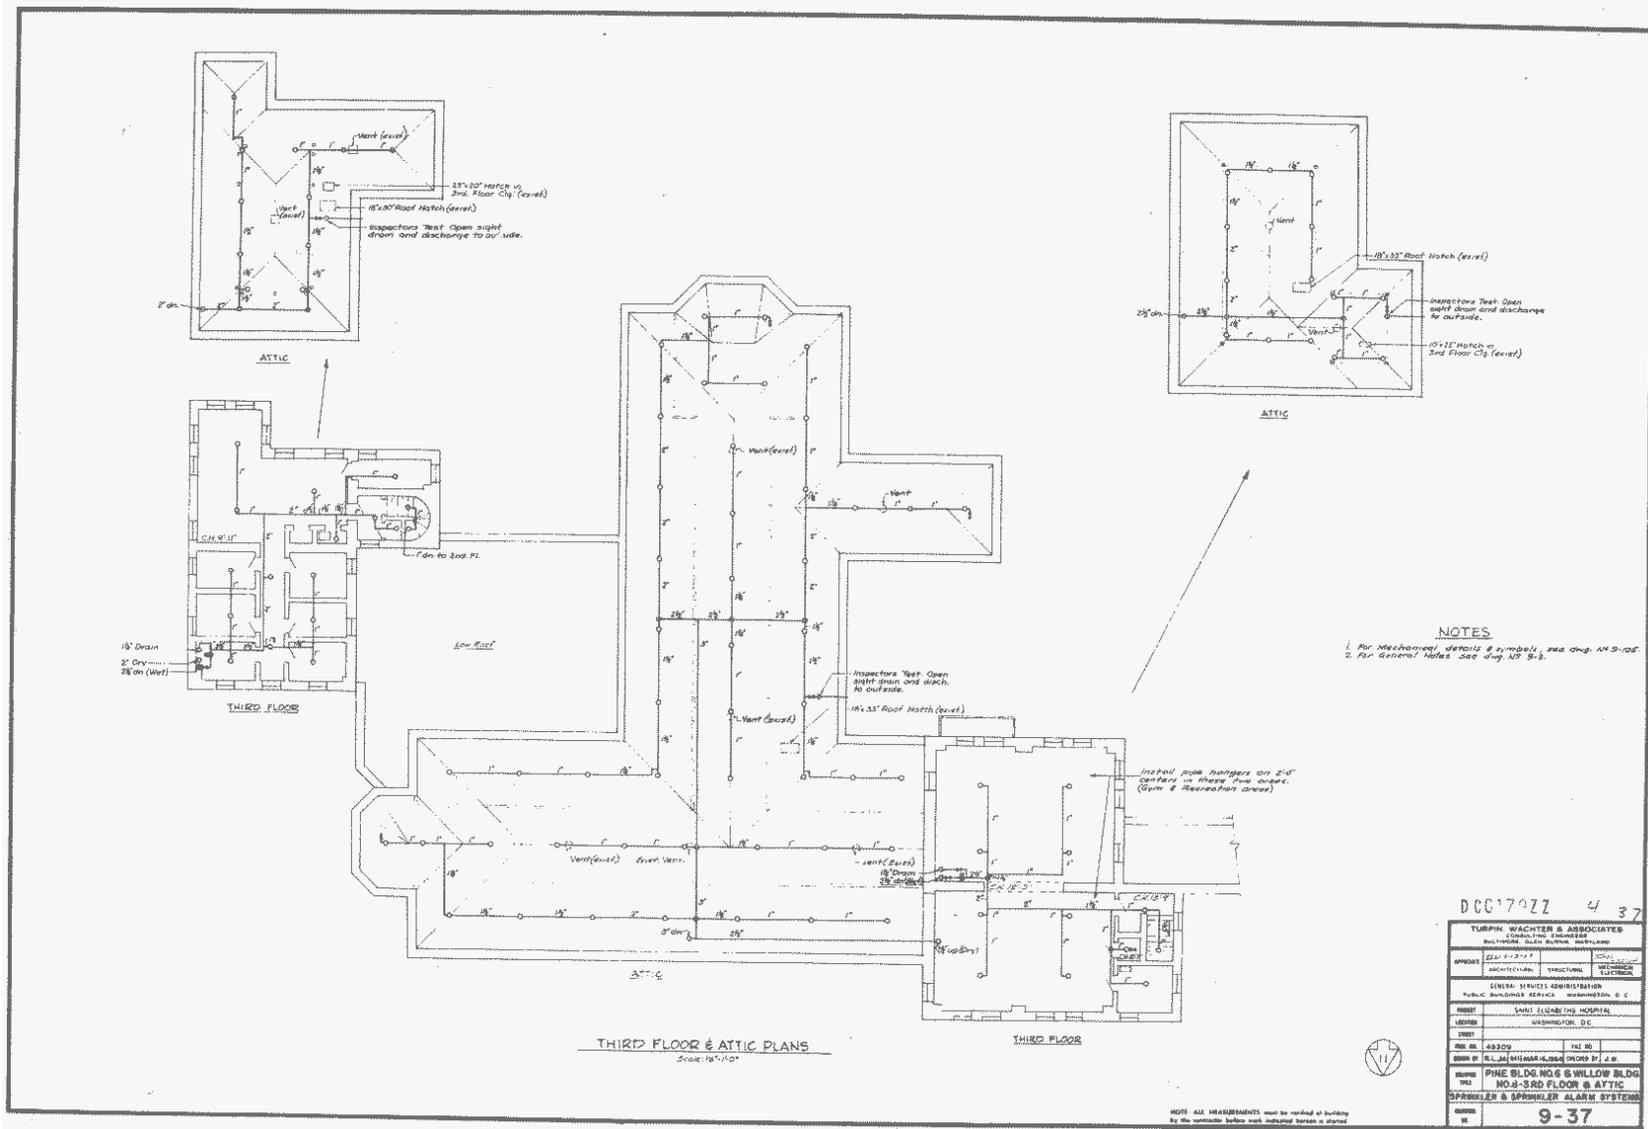
Figure 12. Third floor plan of Pine showing fire suppression system improvements, 1964. Source: GSA Archives, image DC0179SE0004.

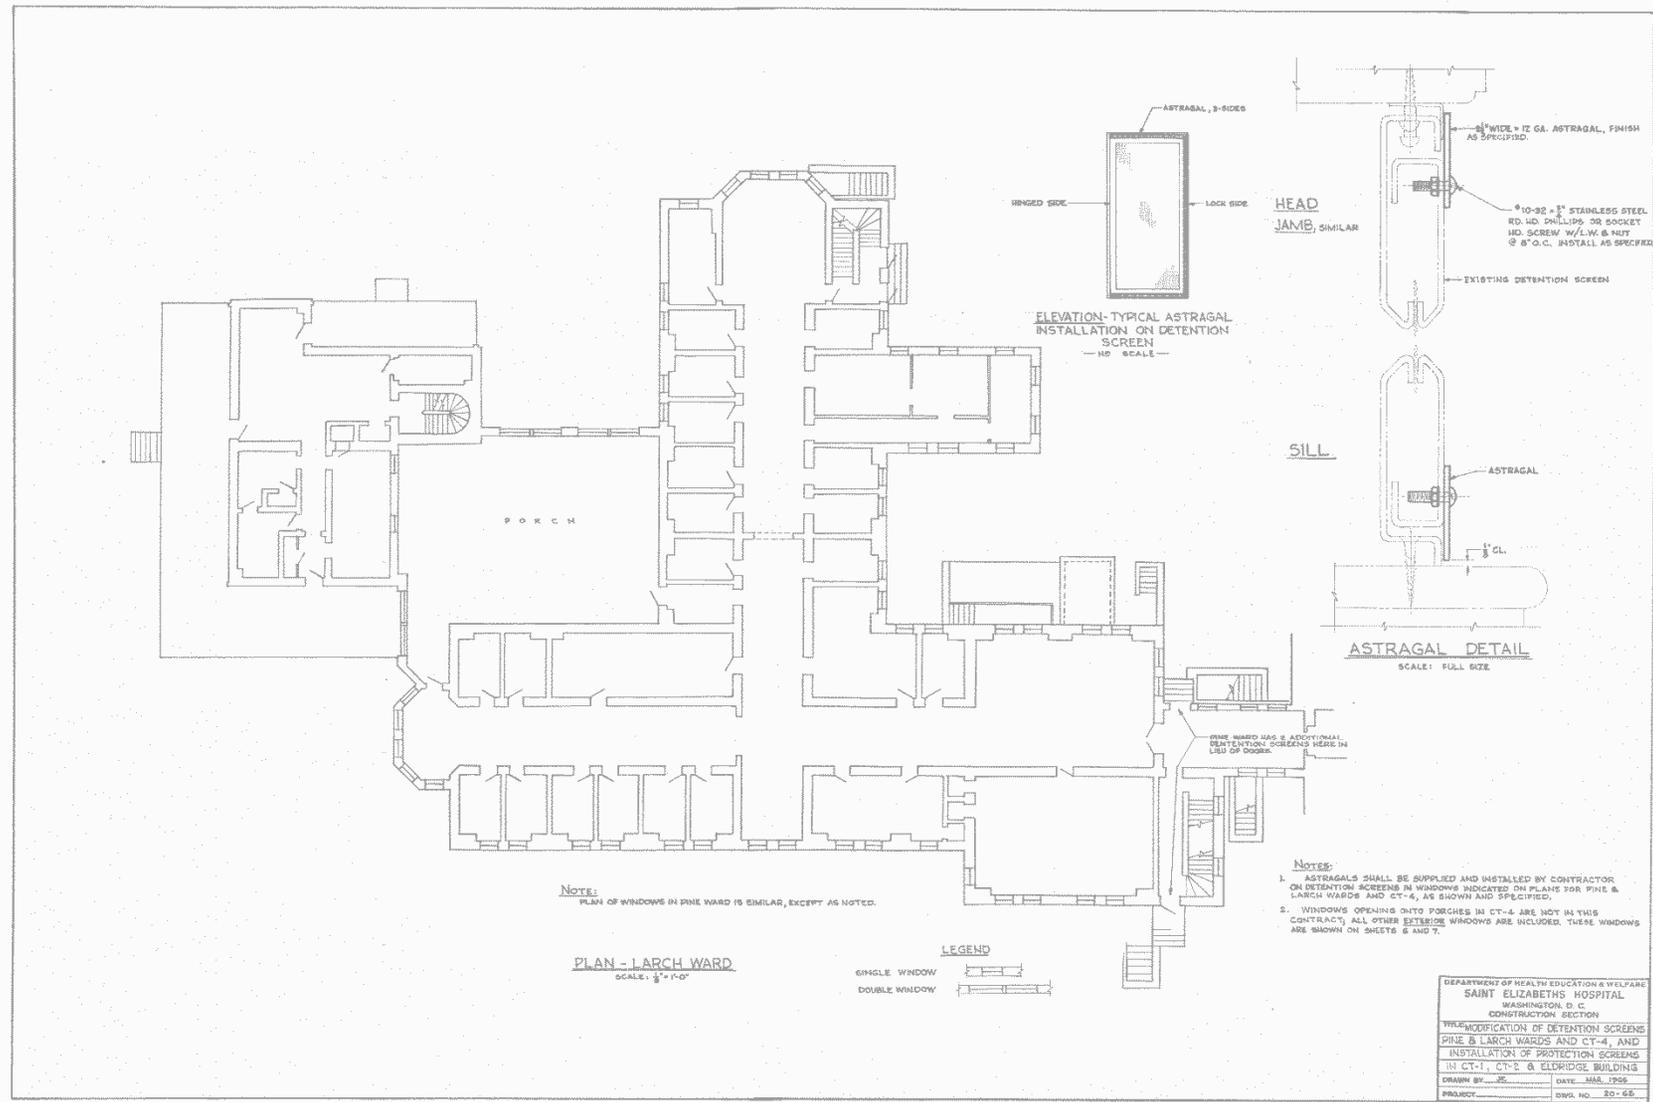
Figure 13. First floor plan of Pine showing detention screen installation, 1965. Source: GSA Archives, image DC0179SE0P001.

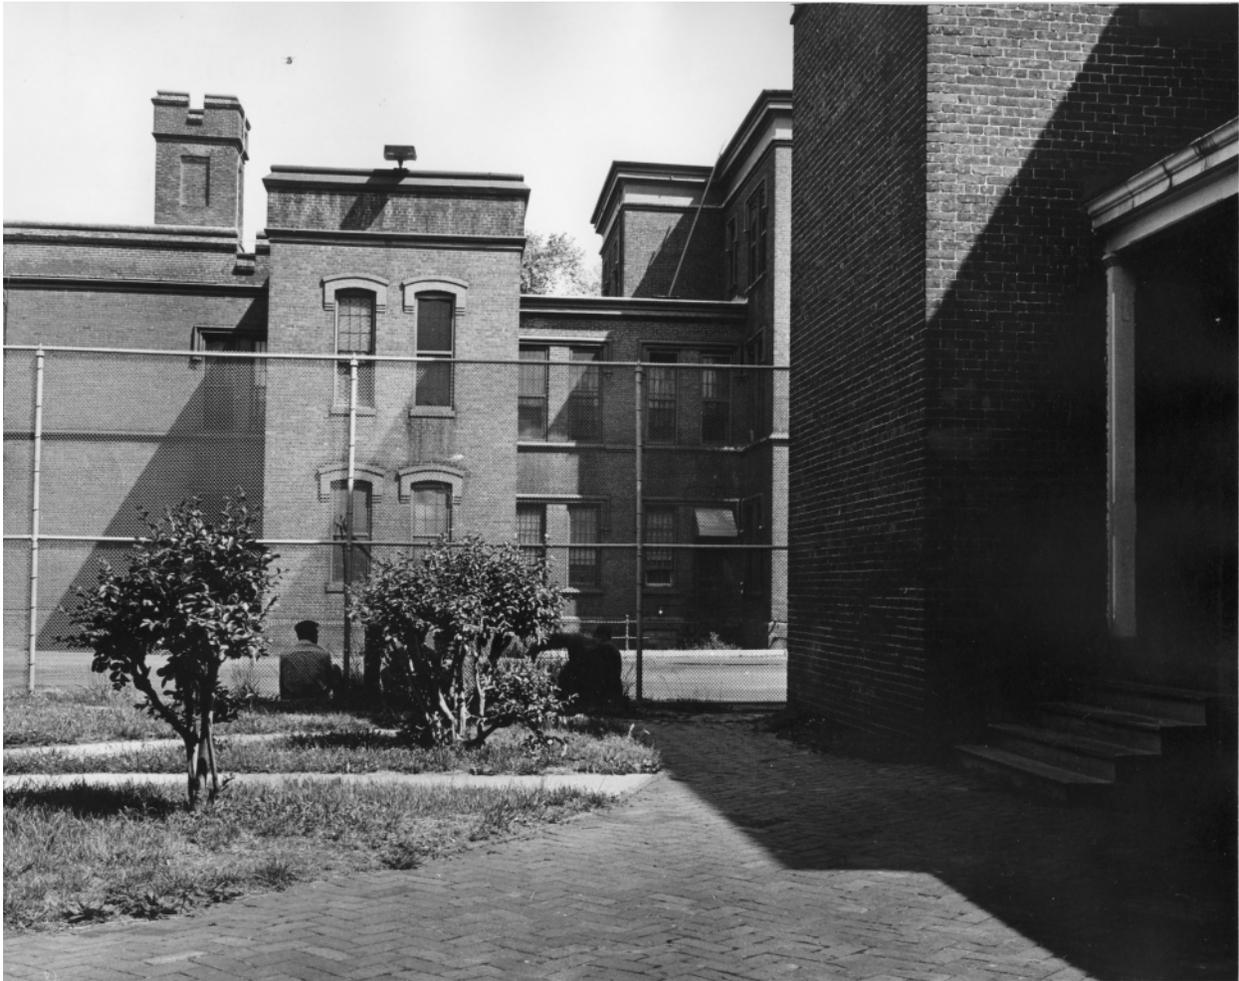
*Figure 14. Partial south elevation of Center Building with East Wing on the left hand side of the image, Pine on the right, 1964. Source: GSA Archives, image DC0179SE0001.*
