ST. ELIZABETHS HOSPITAL, WILLOW
(Building No. 8)
519-543 Redwood Drive, Southeast
Washington
District of Columbia

ST. ELIZABETHS HOSPITAL, WILLOW (BUILDING 8)

HABS NO. DC-349-AC

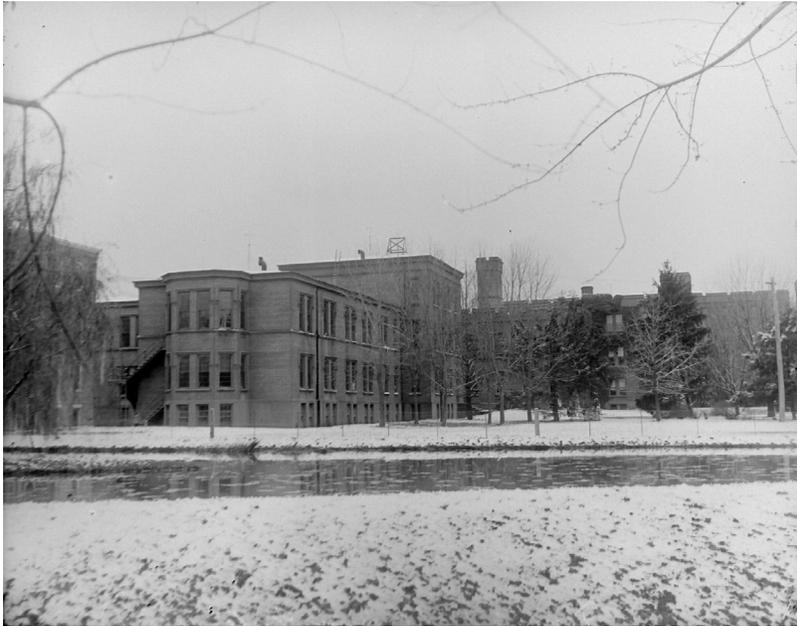
Figure 1. View of from the east of the Center Building group; Willow is at the extreme left of this view. This photograph was likely taken during construction of Willow circa 1898 because the north porch does not yet exist. Source: GSA archive, image DC1472SE0P024.

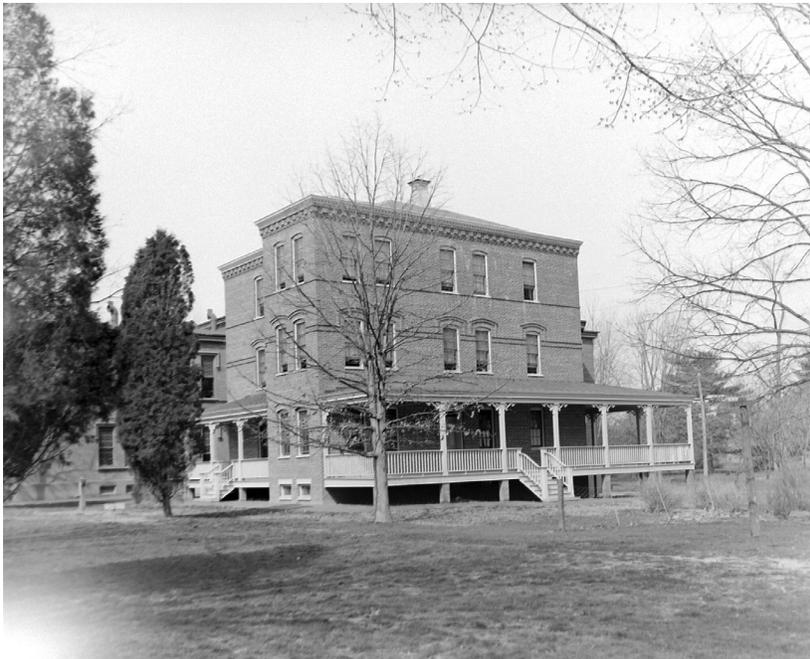
Figure 2. View of Willow shortly after its construction, circa 1900. Source: GSA archive, image DC0148SE0P002.

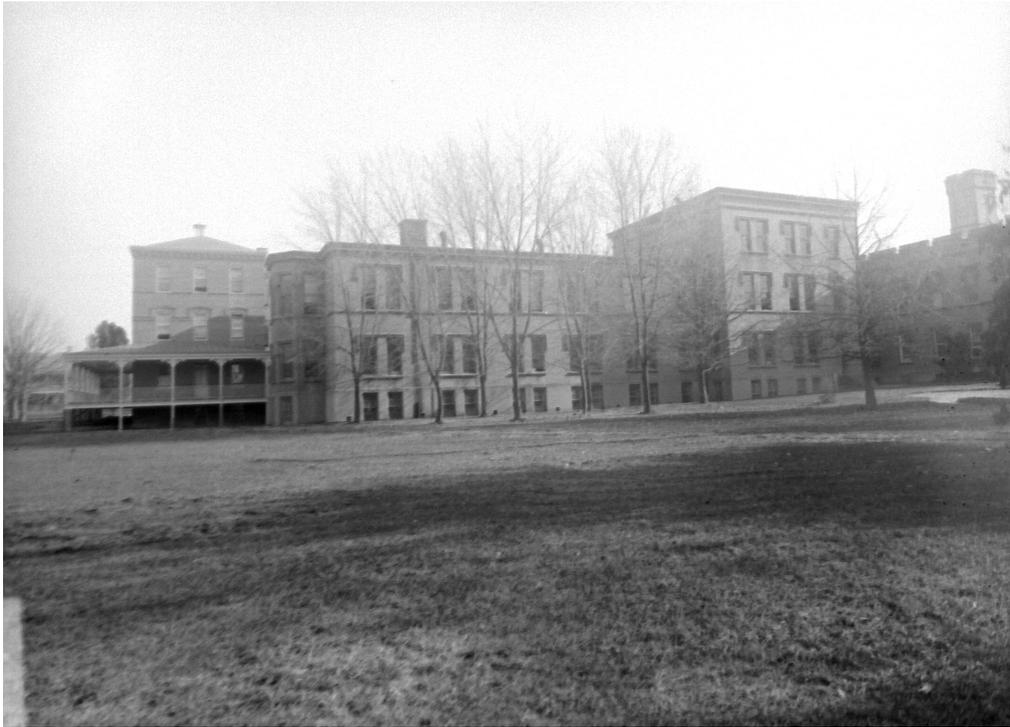
Figure 3. View of Willow from the north, at left beyond Pine (Building 6), circa 1900. Source: GSA archive, image DC0066SE0P010.

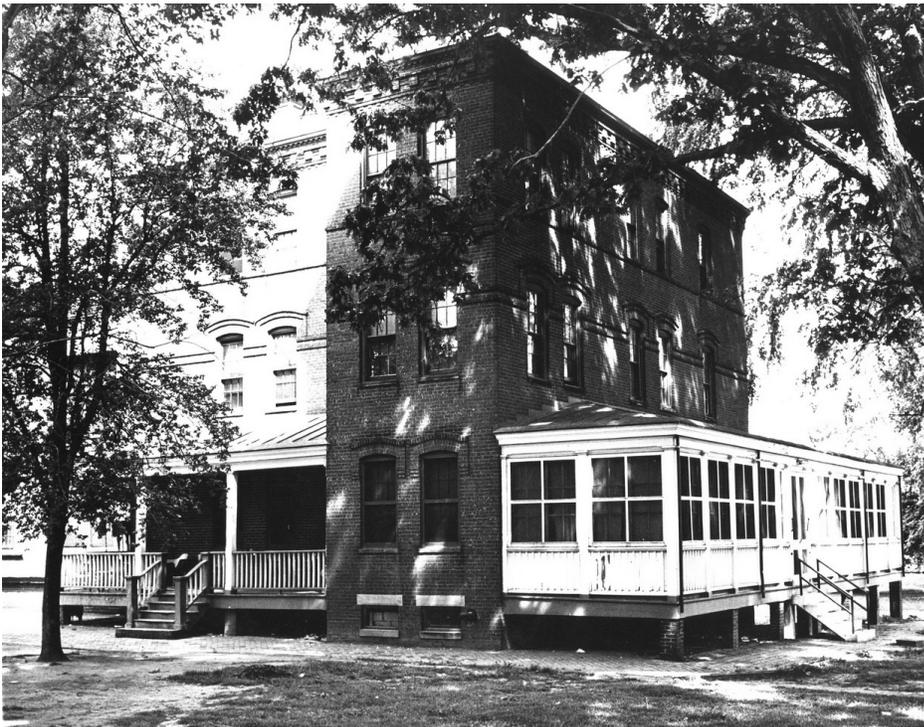
Figure 4. View of Willow from the southeast, 1968. In this view, note the screening on the exterior of the wood casement windows of the northeast porch. Source: GSA archive, image DC1442SE0P001.

The porch originally extended across the entire first floor at the north elevation, but the floor and wall structure were previously removed from the west half due to deterioration, and the porch roof is supported by temporary wood posts. A temporary wood stud and plywood wall encloses this end of the porch. When the 1925 addition was constructed, the glazed enclosure of the porch was apparently altered at its west end. A portion of the porch of Willow was reopened, and the glazed enclosure was relocated to a diagonal wall just west of the first floor window jamb. The head of this diagonal wall survives at the ceiling of the porch.

The interior floor in the porch is vinyl asbestos tile over linoleum over the original wood deck; portions of the flooring are missing, exposing the wood. The adjacent building exterior walls are painted brick, while the perimeter walls are painted wood beadboard cladding and wood framing posts supporting the window units. Below the window sill is continuous radiator piping within a wood and wire mesh enclosure. The windows are paired six-light painted wood casements. The ceiling is painted beadboard. A partition wall of similar wood beadboard and casement windows divides the east part of the porch from the north part. An original exterior door at the east wall of the porch has been removed and replaced by a temporary plywood door.

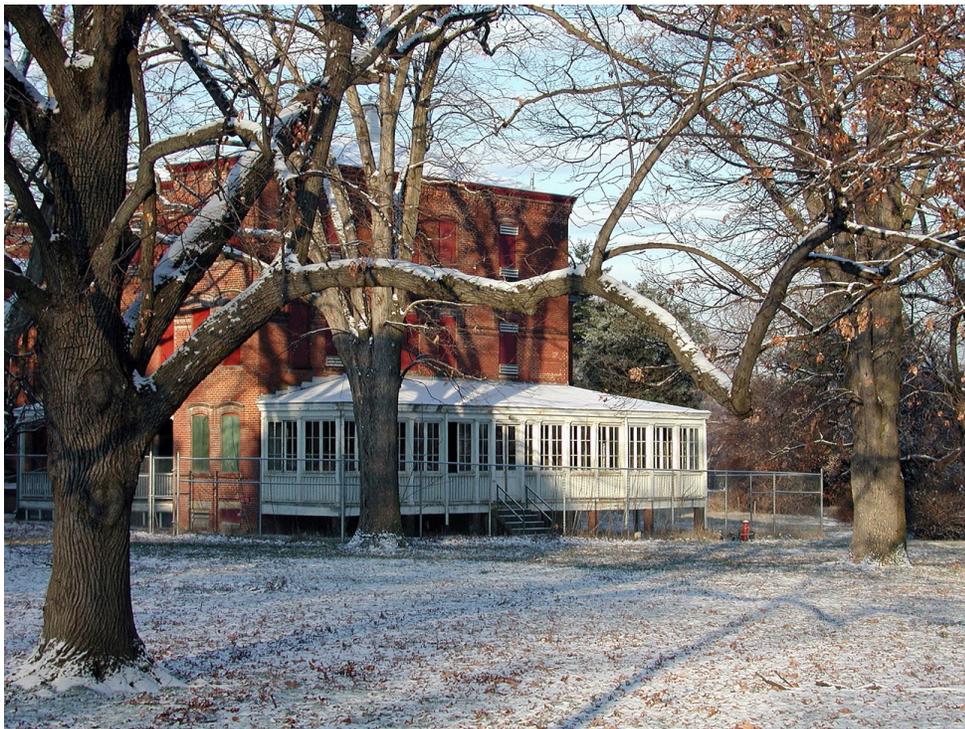
Figure 6. View of Willow from the southeast, 2003. Source: GSA archive, image DC1442SE0P006.
