ST. ELIZABETHS HOSPITAL, ALLISON A  
(Building No. 25)  
518-542 Redwood Drive, Southeast  
Washington  
District of Columbia

### ST. ELIZABETHS HOSPITAL, ALLISON A (BUILDING 25)

ADDENDUM TO  
HABS No. DC-349-AN

**Location:** 518–542 Redwood Drive, Southeast, Washington, District of Columbia, on the West Campus of St. Elizabeths Hospital (2700 Martin Luther King Jr. Avenue, Southeast)

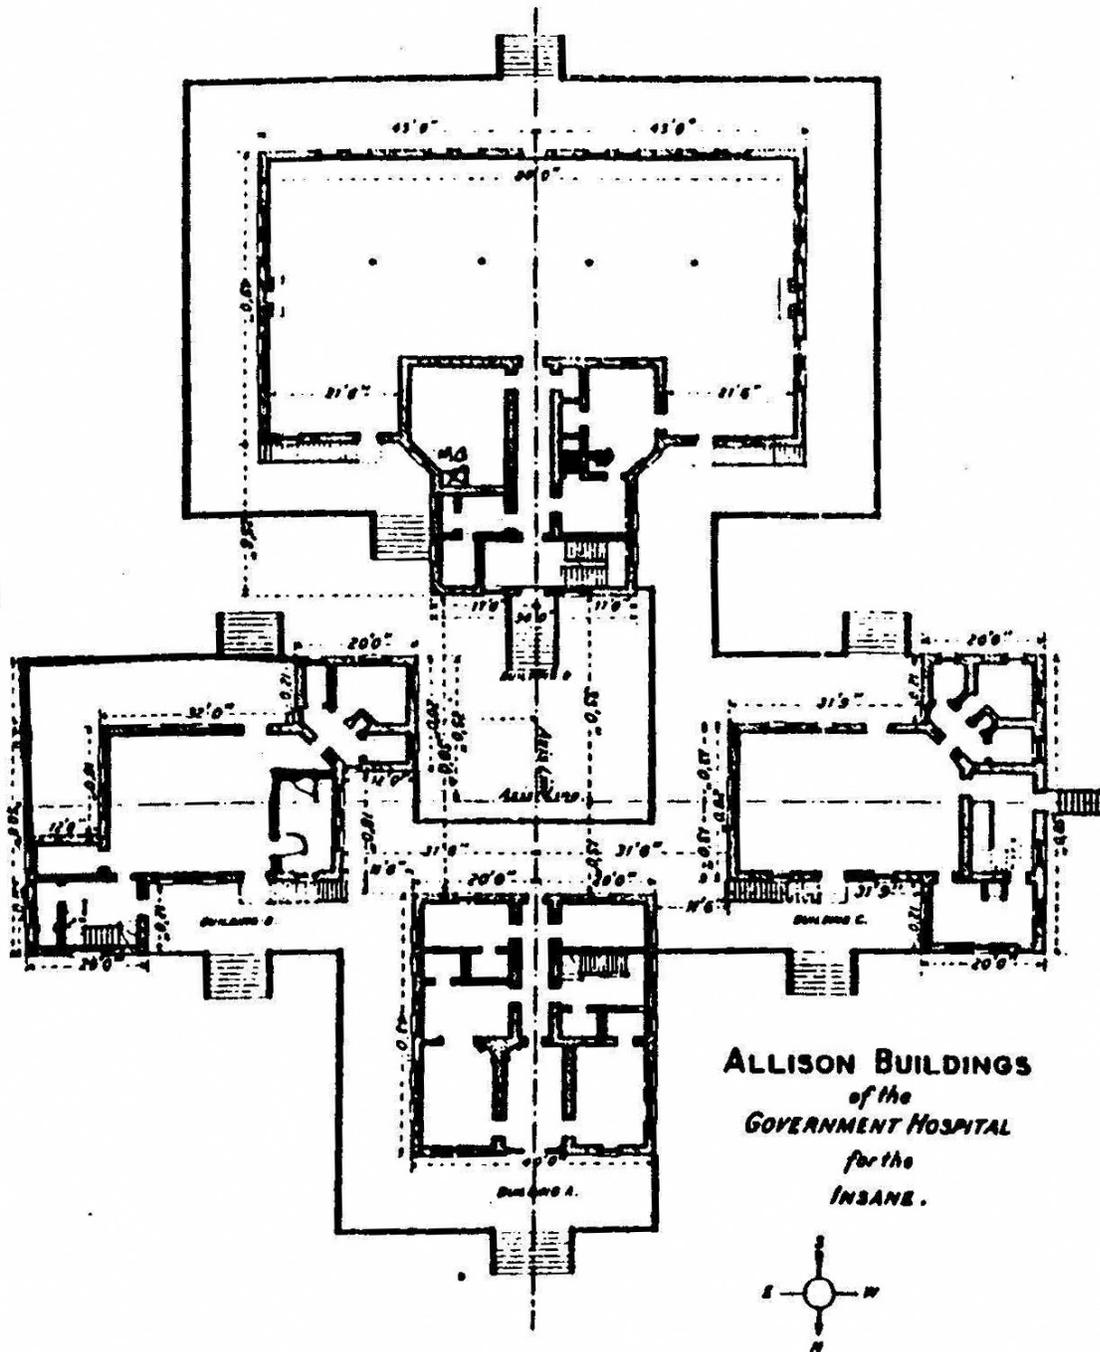
Figure 1. Plan of the proposed Allison group as published in the 1895 Annual Report. The buildings were constructed in 1899 generally following this plan. Source: 1898 Annual Report.

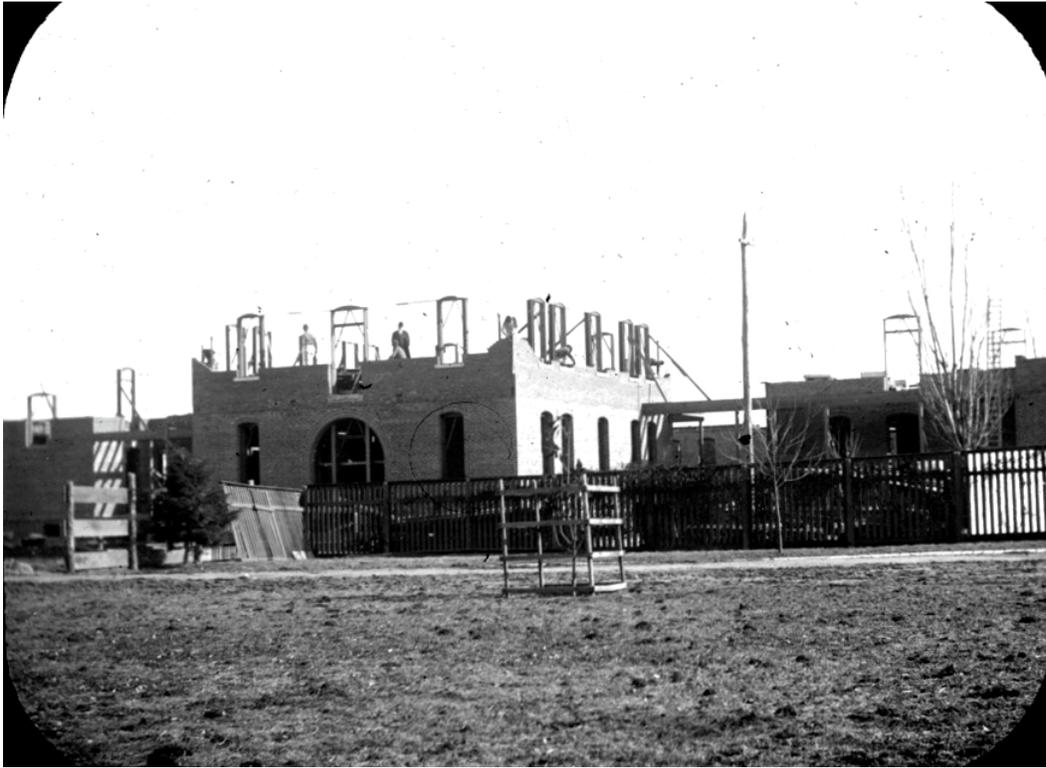
*Figure 2. View of the Allison group under construction, late 1890s. Source: GSA archive, image DC1472SE0P196.*

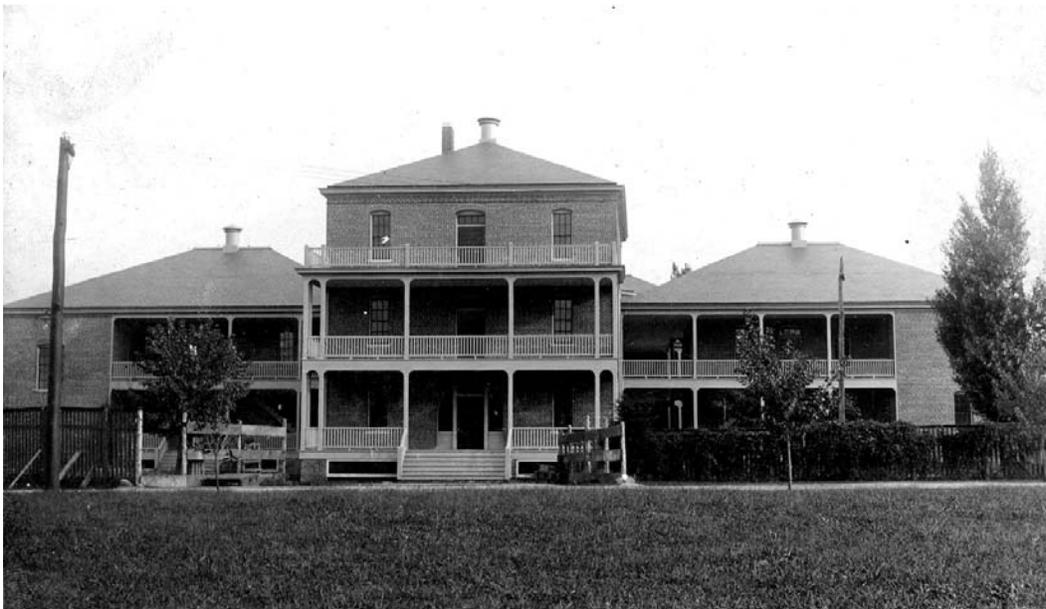
*Figure 3. View of the Allison group from the north, nearing completion, September 20, 1898. Source: GSA archive, image DC1450SE0P002.*

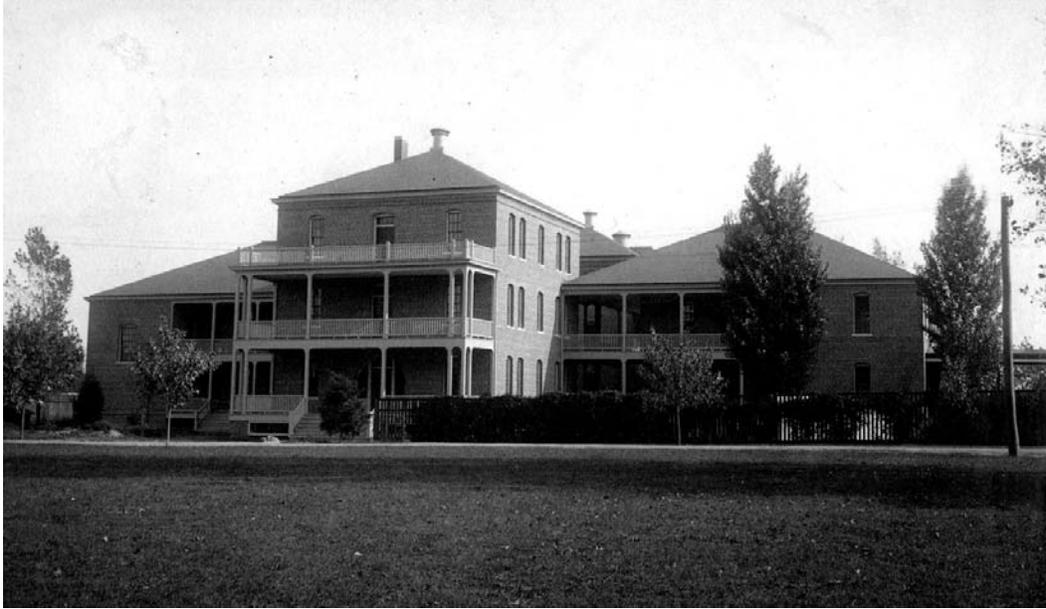
*Figure 4. View of the Allison group from the northwest shortly after its completion in 1899. Source: GSA archive, image DC1450SE0P003.*

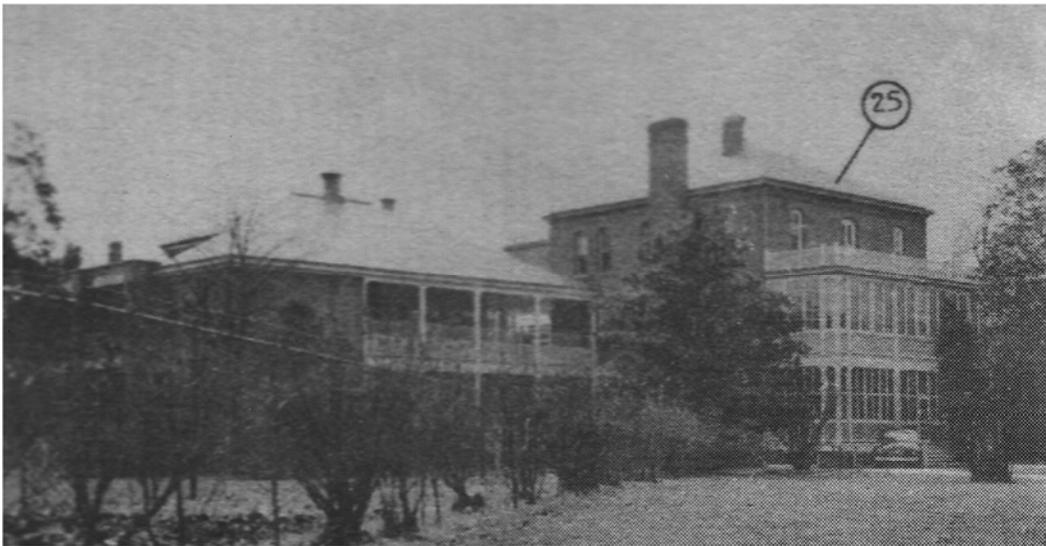
*Figure 5. View of Allison A and Allison C from the northeast, 1945. Note the enclosure of the two-level north porch with wood-framed glazing and the addition of a second chimney along the east elevation. Source: GSA archive, image DC1450SE0P025.*

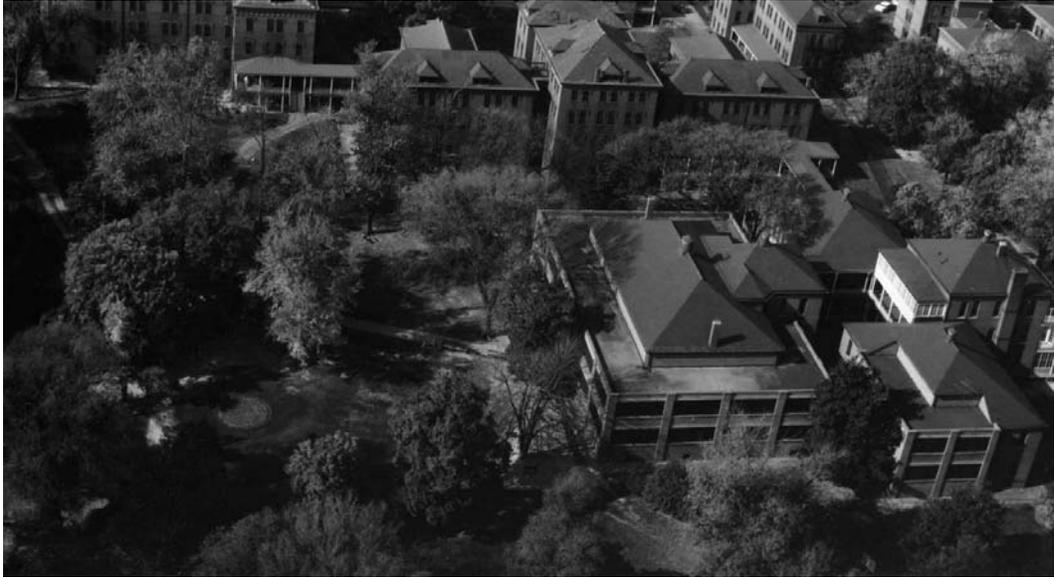
Figure 6. Aerial view of the Allison group from the east, 1963. This view clearly shows the enclosed third floor south porch of Allison A, as well as the north porch with non-original glazed enclosure of the first and second floors. Source: GSA archive, image DC1472SE0P009.

Also between 1963 and 1968, the wood-framed glazed enclosures of the first and second floor of the north porch and the third floor of the south porch were altered. The porches were completely enclosed through the installation of synthetic siding and new, smaller windows. At the third floor porch, most portions of the previous enclosure wall and window framing were retained and used to support the new siding, whereas at the north porch, the earlier enclosure and original porch posts were apparently removed and replaced with new wall framing. The wood-framed stair on the north facade was removed and replaced with a brick staircase with concrete treads. A small wood-framed door hood was installed above the north entrance.

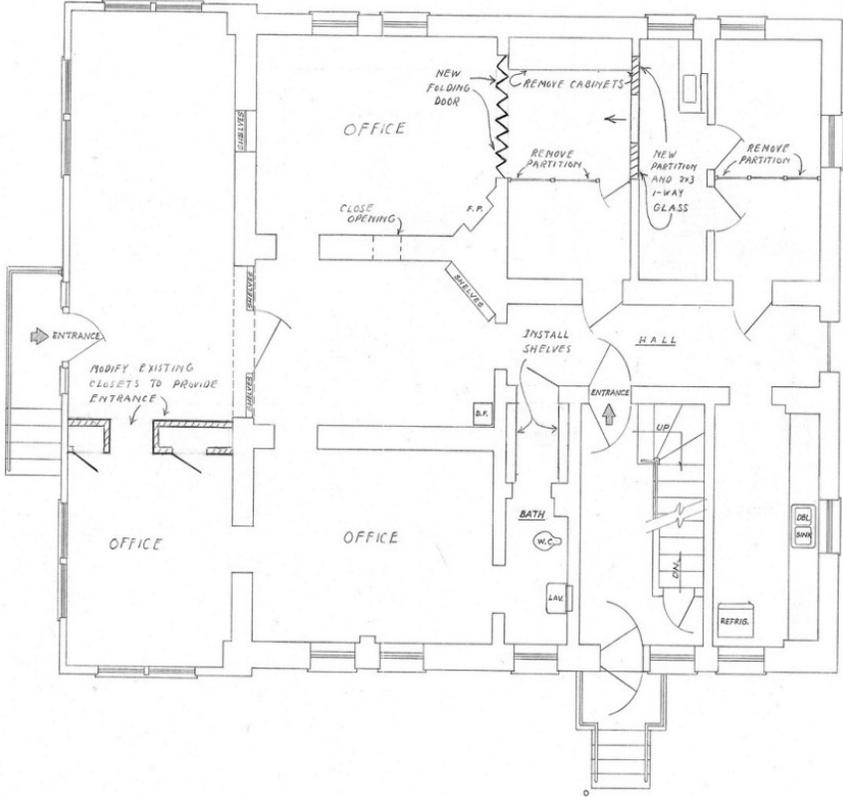
Figure 7. Excerpt from drawing dated 1967 for the renovation of the first floor for office use by the Mental Health Program for the Deaf. North is to the left in this image. Source: GSA archive, image DC1450SE003.

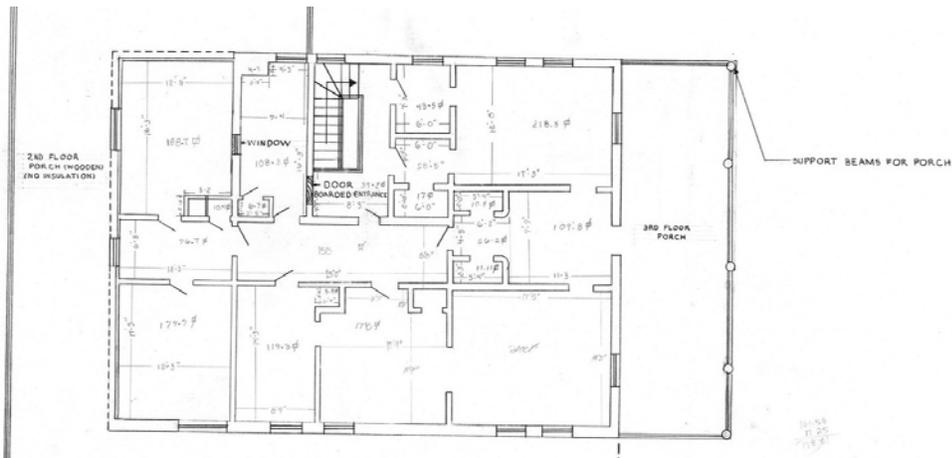
Figure 8. Excerpt from an undated drawing for the renovation of the third floor, circa 1960s–1980s. This drawing postdates various alterations, including changes to the enclosure of the south porch, the addition of a roof to the third floor north porch, and the removal of some third-floor partitions. The only change to the third floor subsequent to this drawing was the addition of an exit staircase from the third floor south porch and the closing up of some doorways that open into the stairwell. North is to the right in this image. Source: GSA archive, image DC1450SE002.

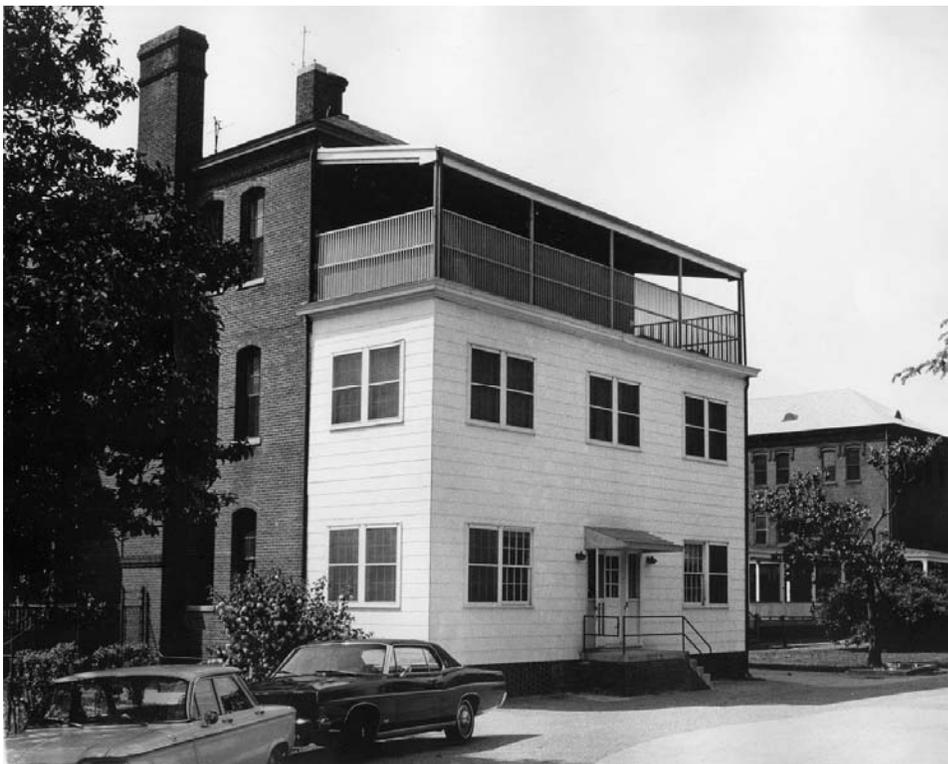
Figure 9. View of Allison A from the northeast, circa 1970s, showing the new enclosure of the north porch on the first two floors and the addition of a roof over the third floor porch. Source: GSA archive, image DC1450SE0P001.

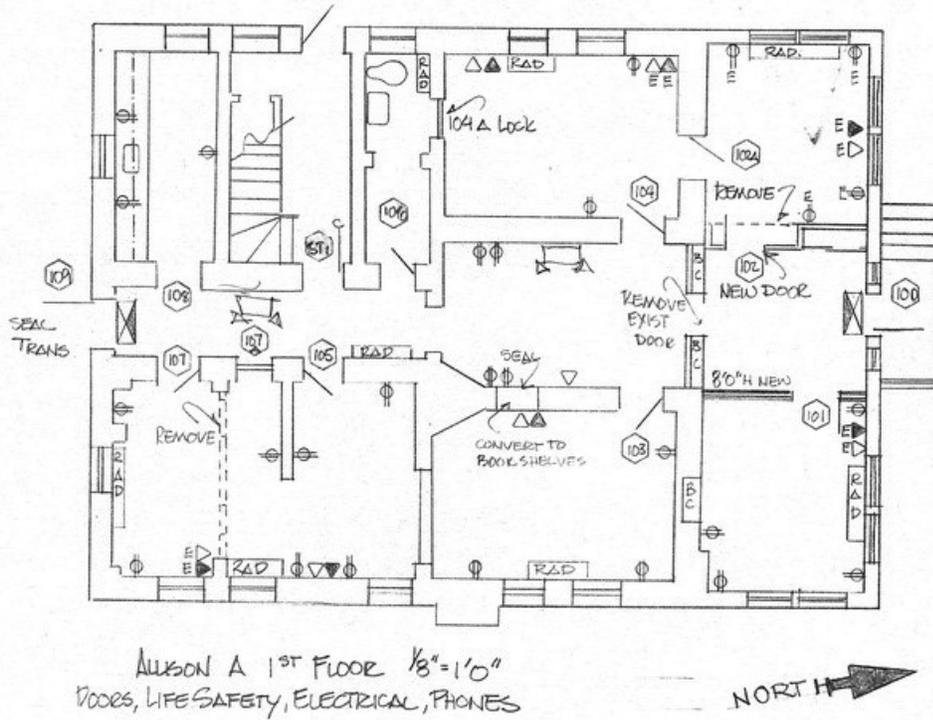
Figure 10. Excerpt from an undated drawing for further remodeling of the first floor offices, possibly circa 1982, when the Mental Health Program for the Deaf left the building and Community Mental Health Center took over the space. North is to the right. Source: GSA archive, image DC1450SE001.

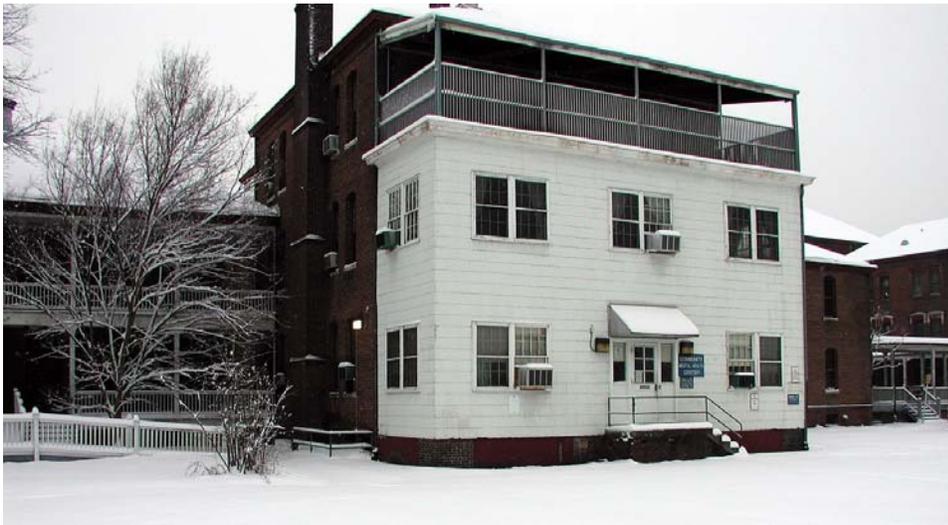
Figure 11. View of Allison A from the northeast, circa 1990s. Window air conditioning units have been added, but the building exterior is otherwise essentially unchanged from the 1970s. Source: GSA archive, image DC1450SE0P023.

The heating system was retrofitted with direct hot water radiation utilizing cast iron radiators. No air conditioning system was present. As seen in archival photographs, the building was formerly cooled via window air conditioning units.

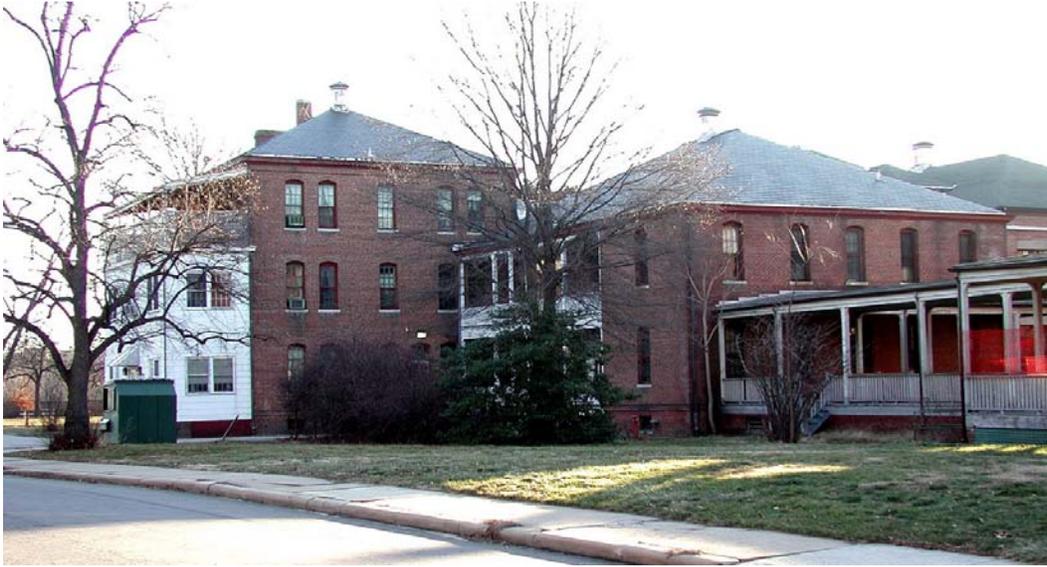
*Figure 12. View of the Allison group from the northwest, circa 2003. Source: GSA archive, image DC1450SE0P022.*
