U.S. NAVAL BASE, PEARL HARBOR, NAVAL HOUSING AREA MAKALAPA,  
SENIOR OFFICERS' QUARTERS TYPE A HABS No. HI-355-A  
(U.S. Naval Base, Pearl Harbor, Naval Housing Area Makalapa, Facility No. 77)  
37 Makalapa Drive  
Pearl Harbor  
Honolulu County  
Hawaii

U.S. NAVAL BASE, PEARL HARBOR, NAVAL HOUSING AREA MAKALAPA,  
SENIOR OFFICERS' QUARTERS TYPE A  
(U.S. Naval Base, Pearl Harbor, Naval Housing Area Makalapa, Facility No. 77)

HABS No. HI-355-A

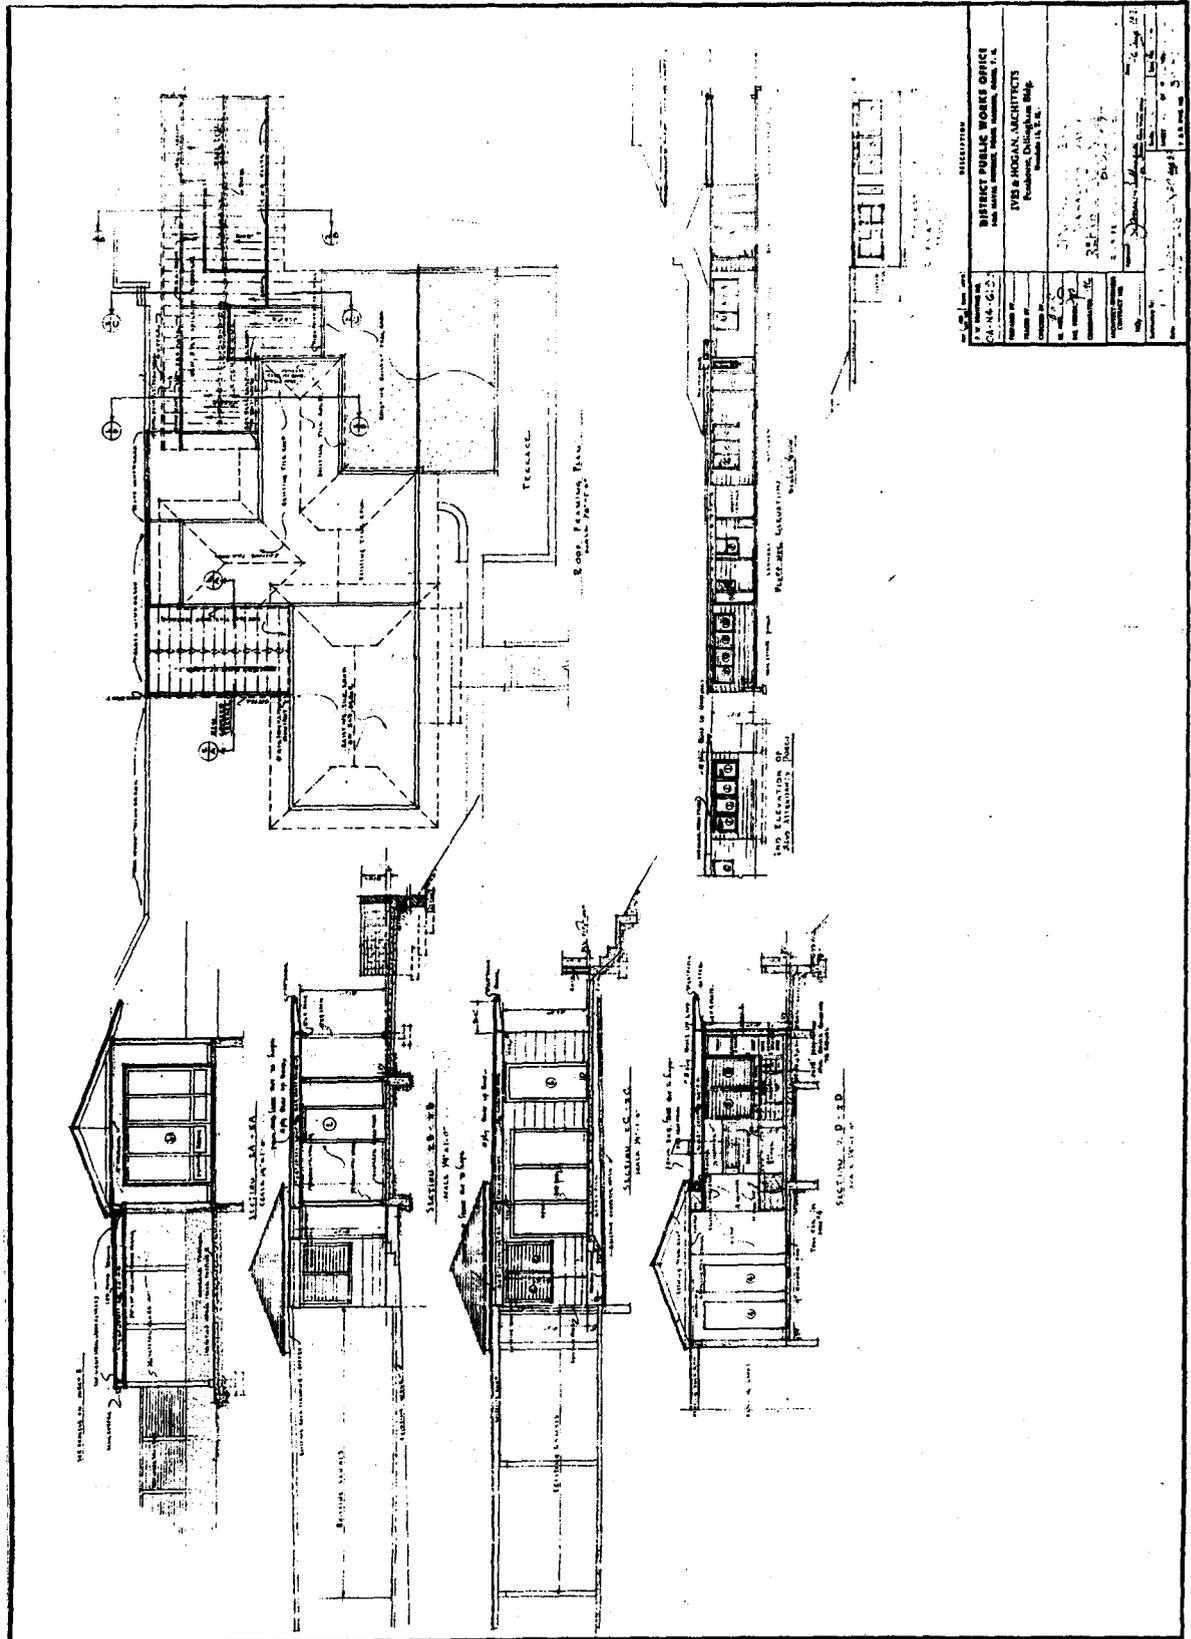
1952 Rehabilitation Drawing  
 Dwg. No. 583690. Roof Plan and Sections through new additions, 8/20/52

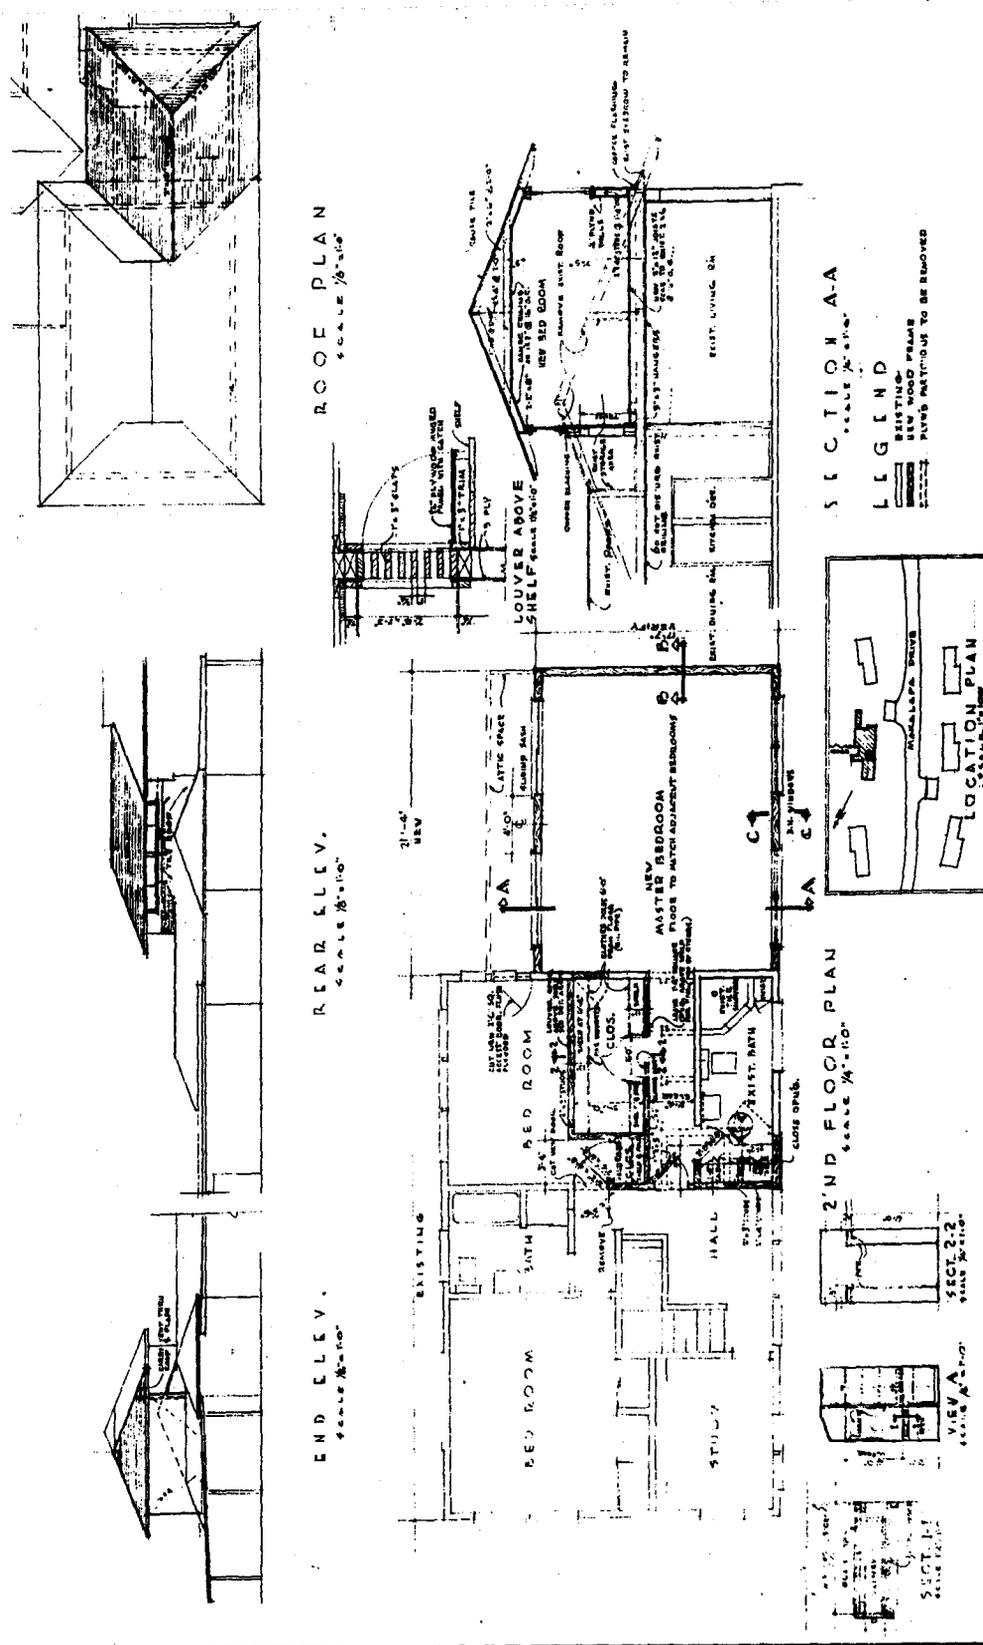
1953 Rehabilitation Drawing  
 Dwg. No. 622665. Addition of Master Bedroom — Plan, Elevations and Section, 8/28/53

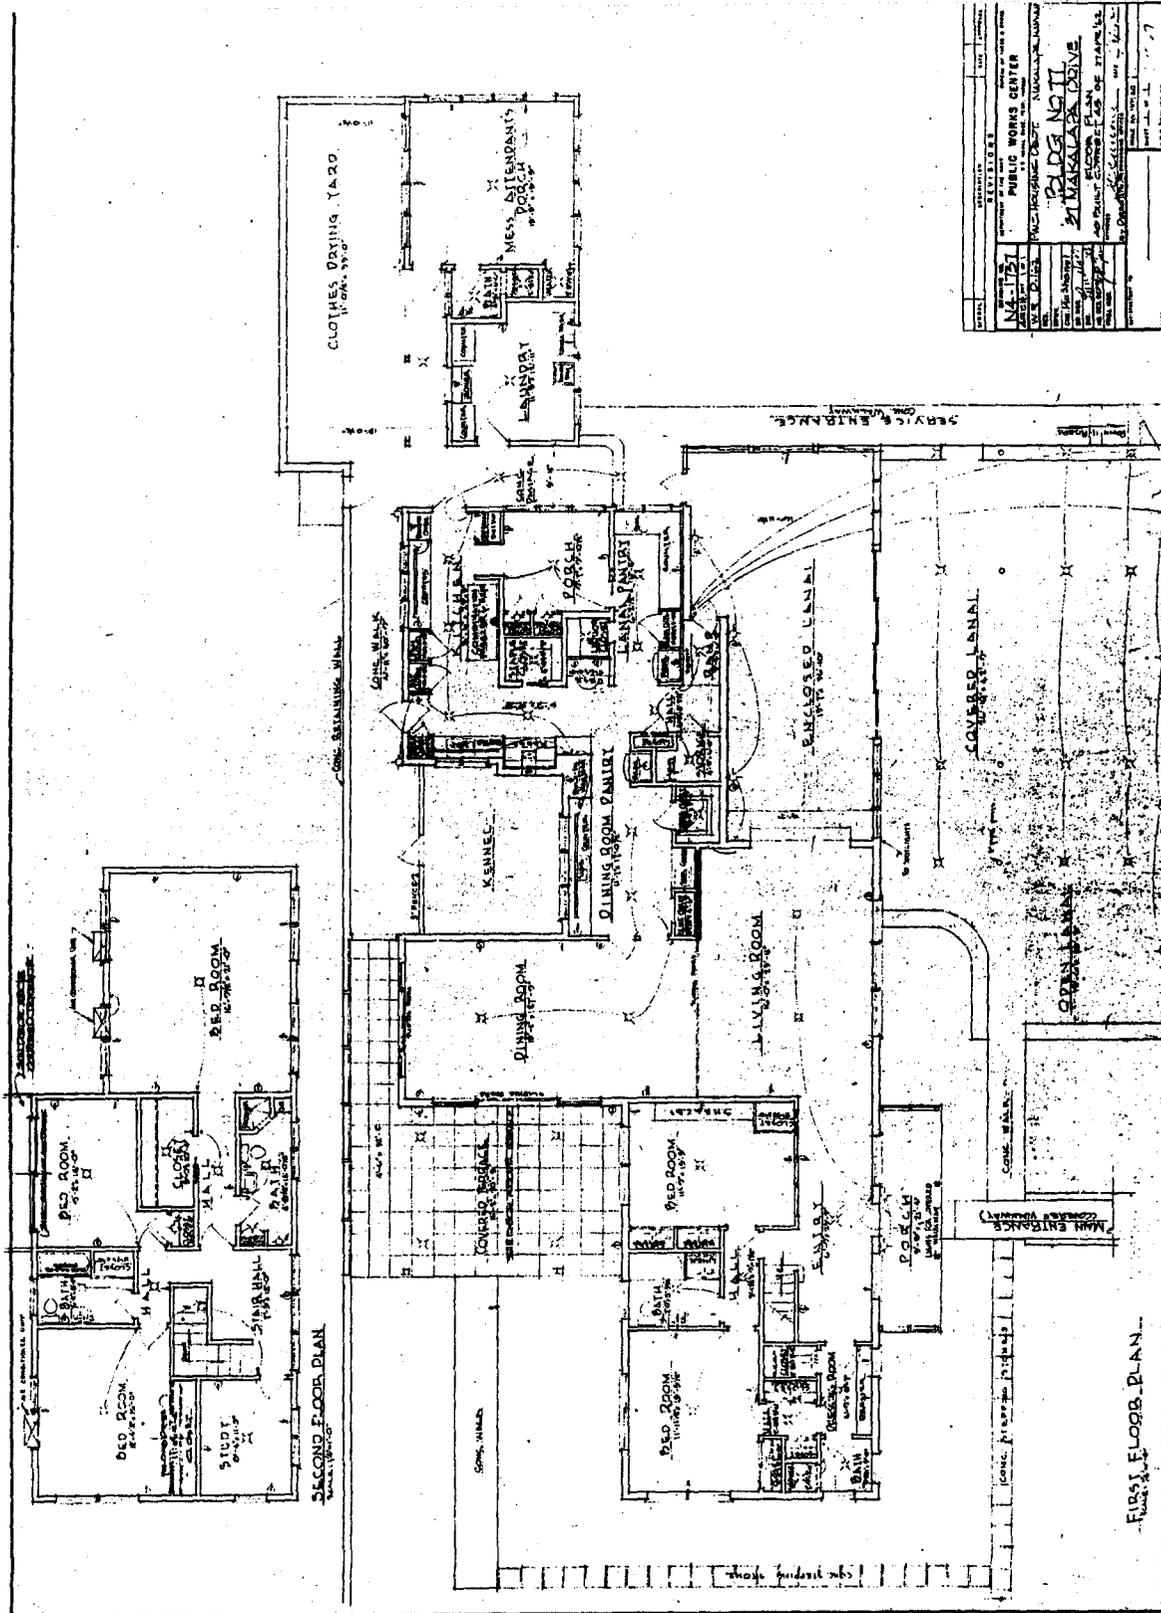
1962 First- and Second-Floor Plans, As-Built Drawing  
 Dwg. No. 9767. Floor Plans, Correct as of 27 Apr. 62, 5/08/62

and dining room, and another swinging door is between the pantry and the living room extension. The positions of these swinging doors have been recently changed and are not reflected in the floor plan accompanying this report. Bedroom closets typically retain the original pairs of flush wood sliding doors. The master bedroom has a pocket door at the walk-in closet. On the second-floor, original closet doors have been replaced with bi-folding doors. There is one closet with a single hinged door in bedroom #1 on the first-floor. A closet space is also located underneath the stair in the dressing room. Bathroom 2 and 3 have stacked, built-in closets; these originally had sliding wood doors, but now have bi-folding louvered doors.

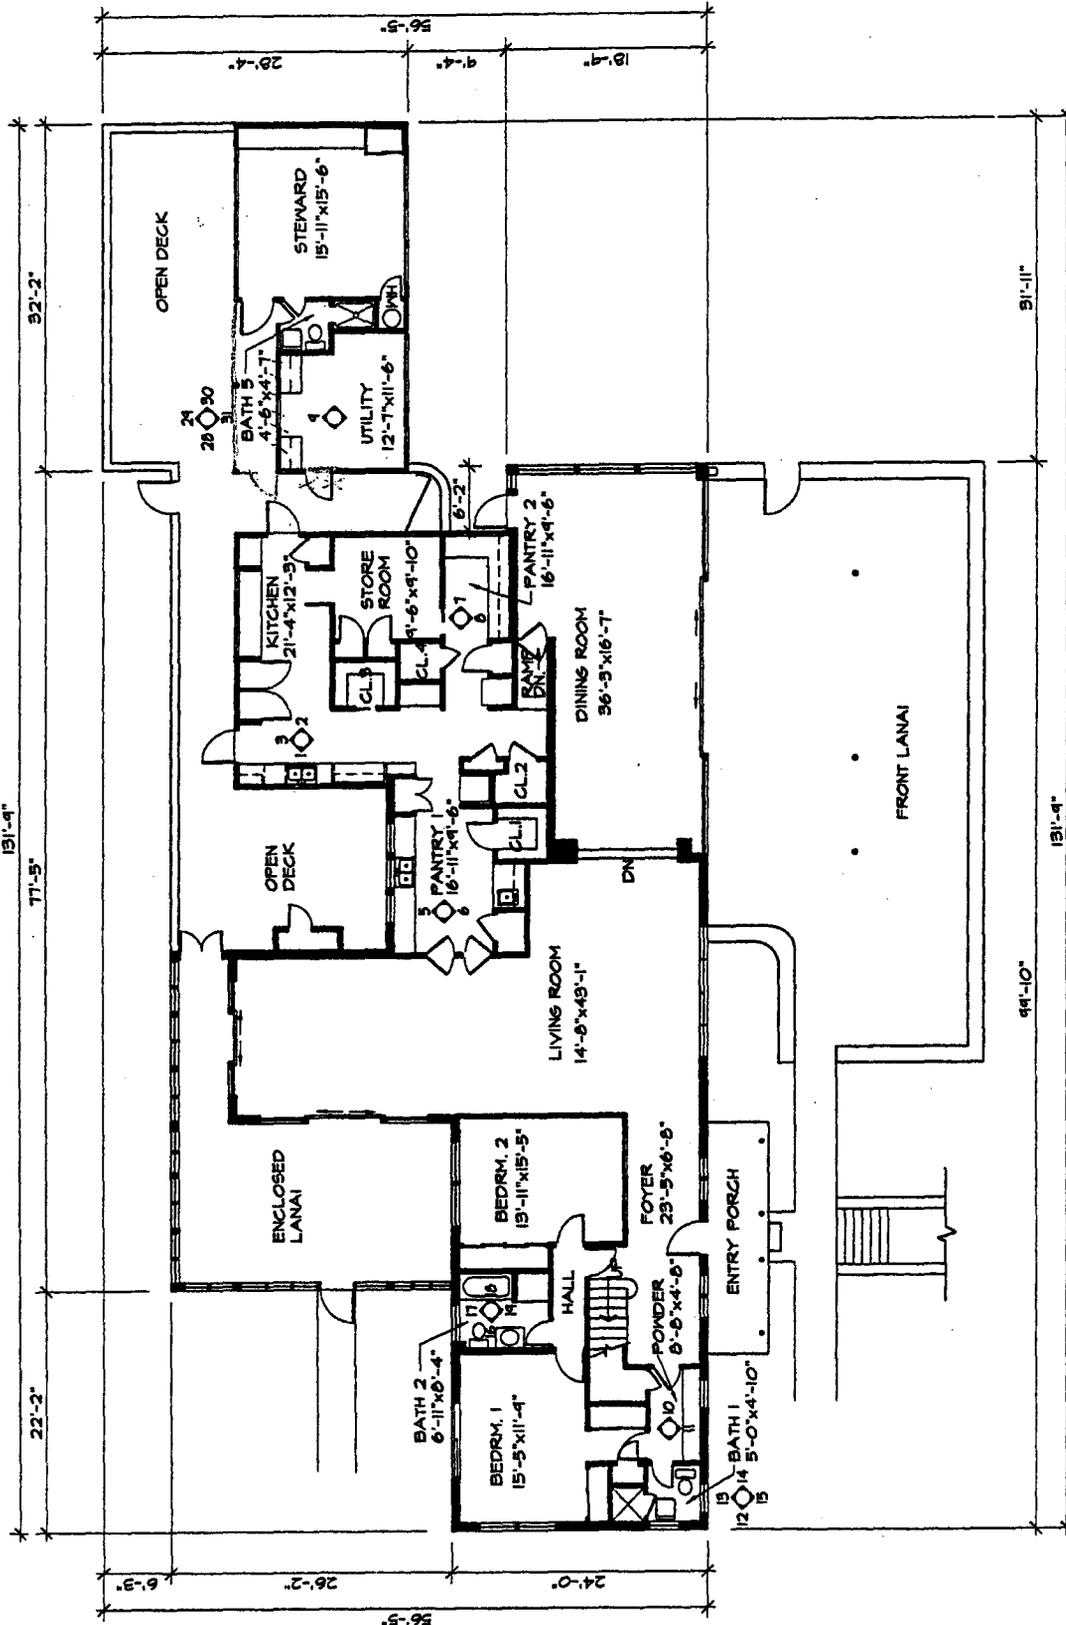
FIRST FLOOR PLAN

First-Floor Plan, Recent Drawing  
 Naval Facilities Engineering Command. p. 2-12.

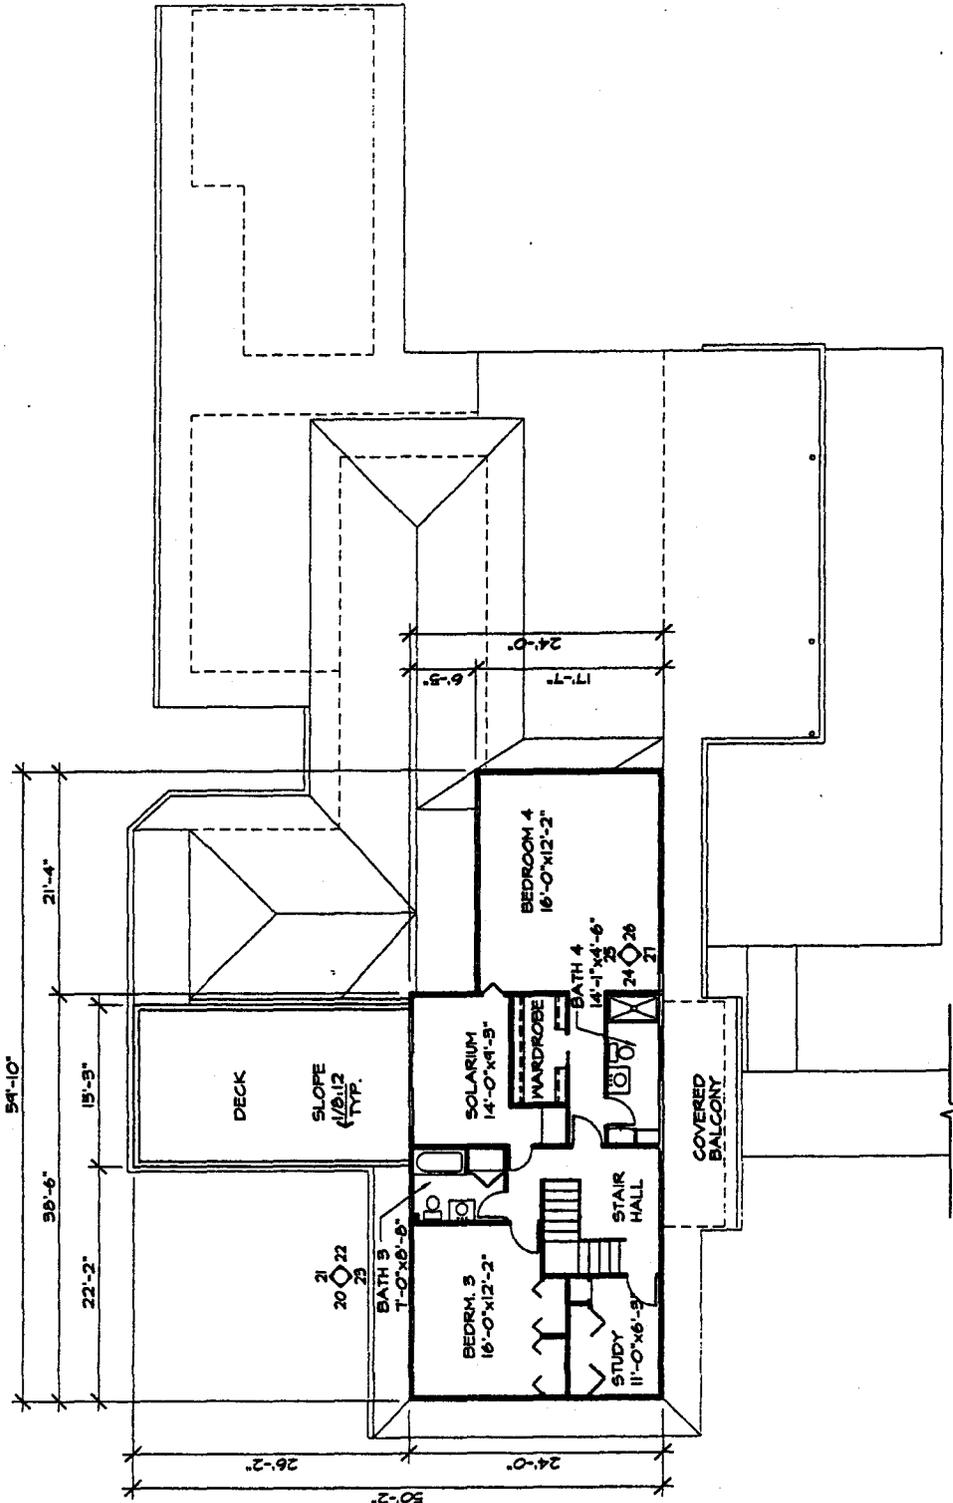
**SECOND FLOOR PLAN**

Second-Floor Plan, Recent Drawing  
 Naval Facilities Engineering Command. p. 2-13.

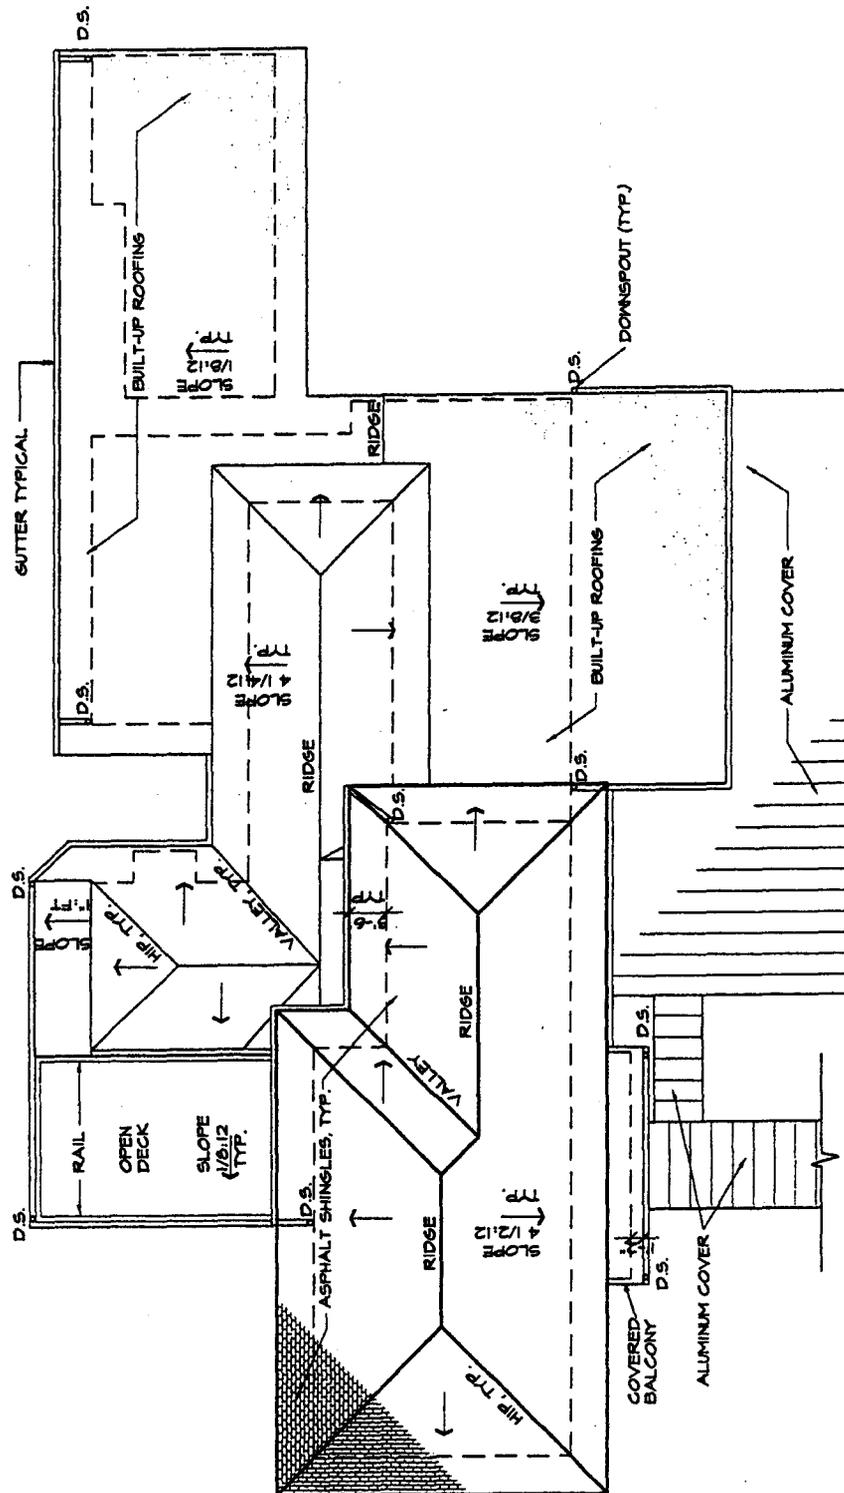
**ROOF PLAN**

Roof Plan, Recent Drawing  
 Naval Facilities Engineering Command. p. 2-15.

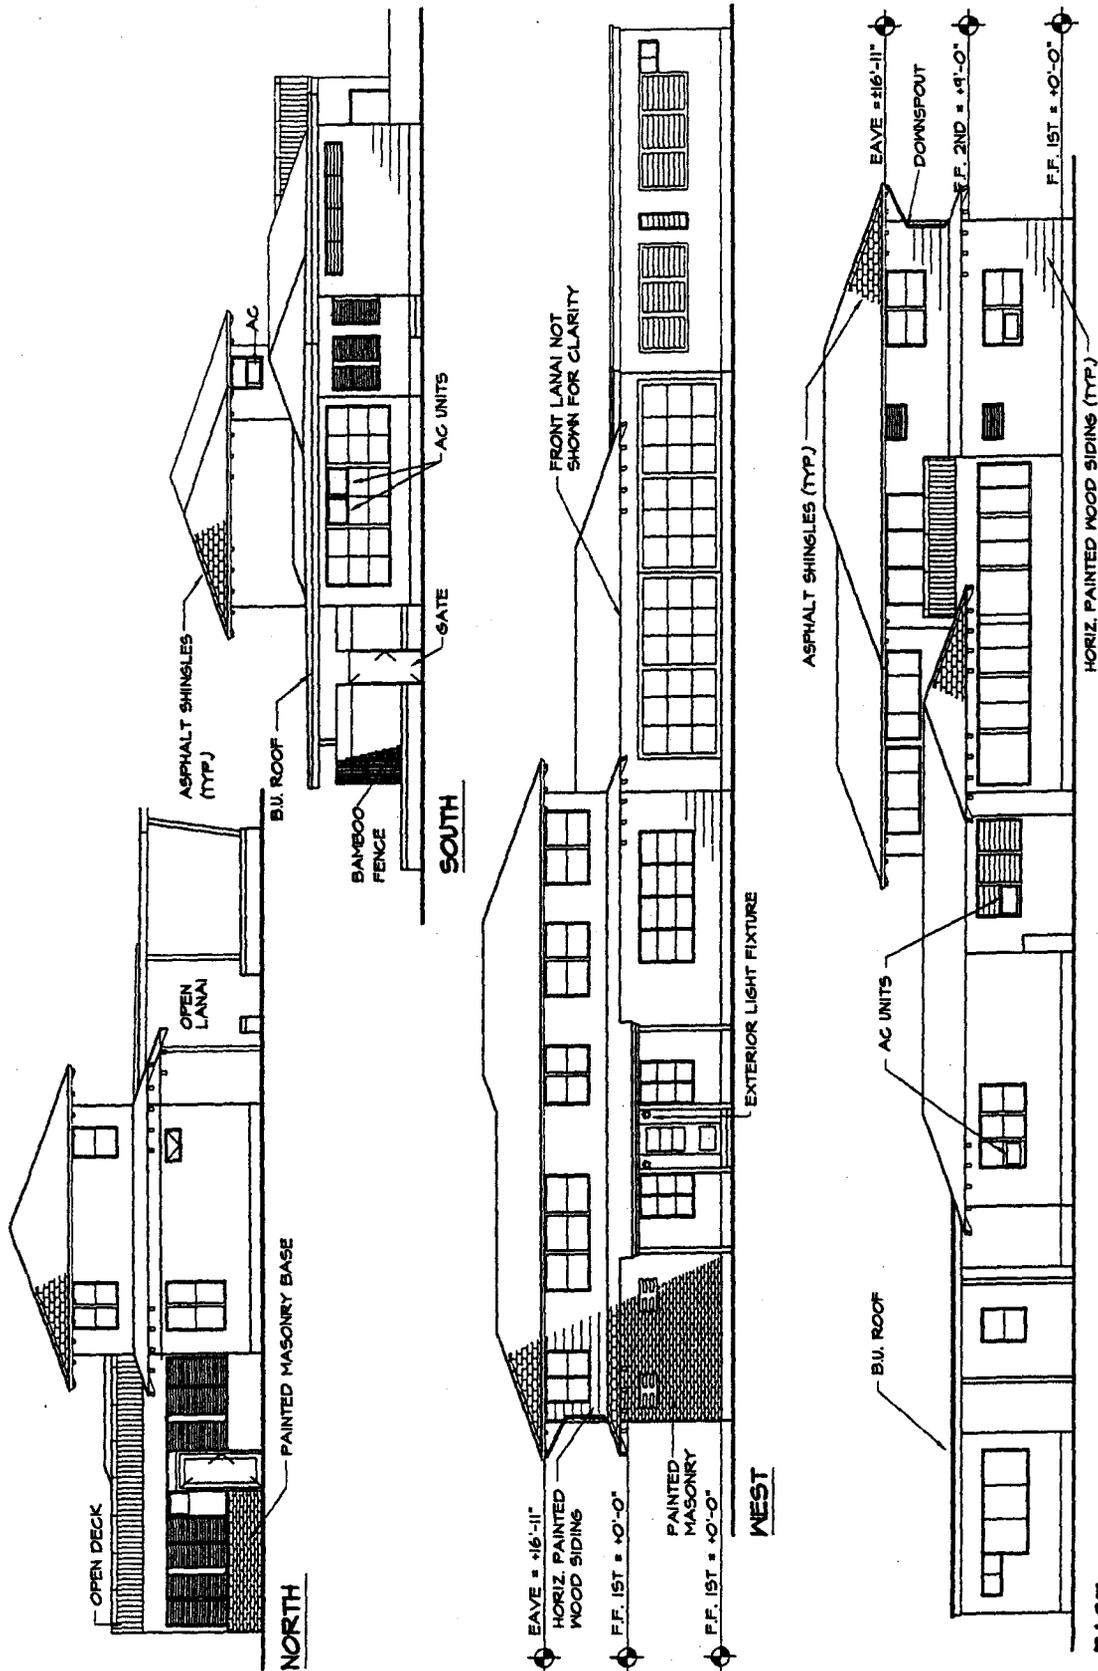
Exterior Elevations, Recent Drawing  
 Naval Facilities Engineering Command. p. 2-16.
