U.S. NAVAL BASE, PEARL HARBOR, NAVAL HOUSING AREA HOSPITAL POINT,
CHAPEL AND DUPLEX QUARTERS HABS No. HI-356-H
(U.S. Naval Base, Pearl Harbor, Naval Housing Area Hospital Point, Facility No. 829)
9 First Street
Pearl Harbor
Honolulu County
Hawaii

U.S. NAVAL BASE, PEARL HARBOR, NAVAL HOUSING AREA HOSPITAL POINT, CHAPEL AND DUPLEX QUARTERS

HABS No. HI-356-H

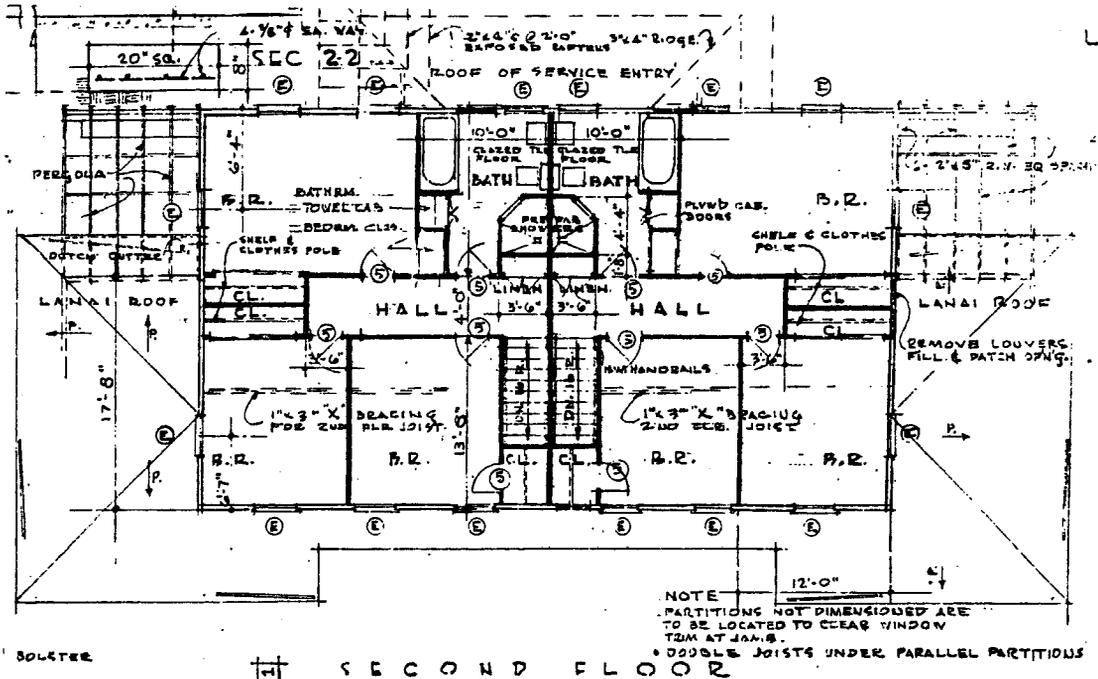
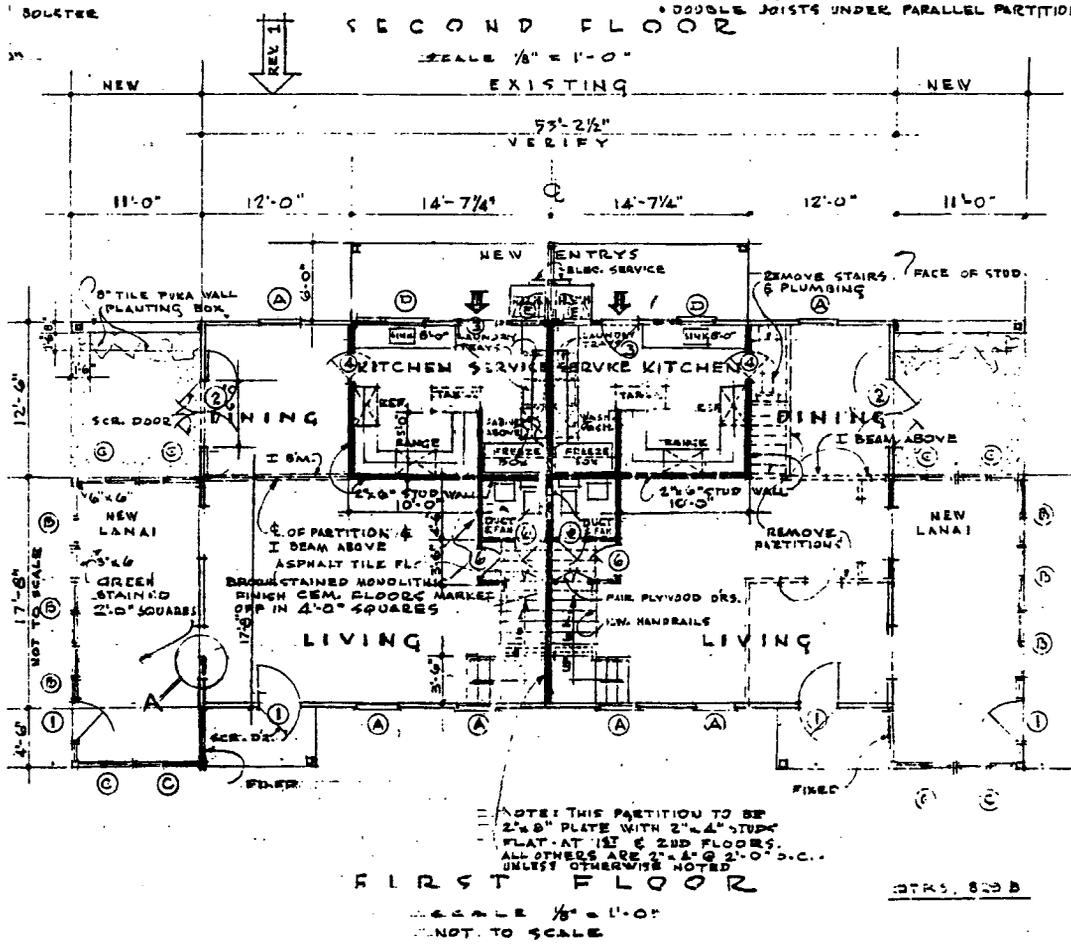
Renovation Drawings to Fit New Location and Use, First and Second Floor Plans
 DWG. #L-N04-211 Renovation and Relocation Architectural 8/29/1947

6. Alterations and Additions: According to the 1947 renovation and relocation plan, when the structure's function was changed from a chapel to a duplex residence, a large part of the present second floor was added, many new walls on the first floor were added, and the original stairs were removed. The whole building was raised about two feet, adding to the ceiling height of the first floor. The first-floor windows were replaced with larger ones and more windows were added. The square louvered openings on the upper level were replaced with new paired casement sash, and window openings were added on the ends of the building. A new party wall was added down the center of the building, perpendicular to the roof ridge, halving the building. However, since its renovation and relocation in 1947, only minor changes have been made. The washer and drier machines are now located on the rear lanai and the laundry areas next to the kitchens have been remodeled.

Sources: Original Architectural Drawings: Original drawings and any drawings completed up to the present for building renovations by the U.S. Navy are located at the U.S. Navy, Pacific Division Naval Facilities Engineering Command, Plan File Room, Pearl Harbor Hawaii. The drawings found for Facility 829 are listed below. Copies of the original floor plans and elevations, from the 1947 conversion to a duplex, are included in this report.
