U.S. NAVAL BASE, PEARL HARBOR, PAINT SHOP & RIGGING
LOFT
(U.S. Naval Base, Pearl Harbor, Naval Shipyard, Facility No. 11)
Sixth Street between Avenues E & G
Pearl Harbor
Honolulu County
Hawaii

U.S. NAVAL BASE, PEARL HARBOR, PAINT SHOP & RIGGING LOFT (U.S. Naval Base, Pearl Harbor, Naval Shipyard) (Facility No.11)

HABS No. HI-488

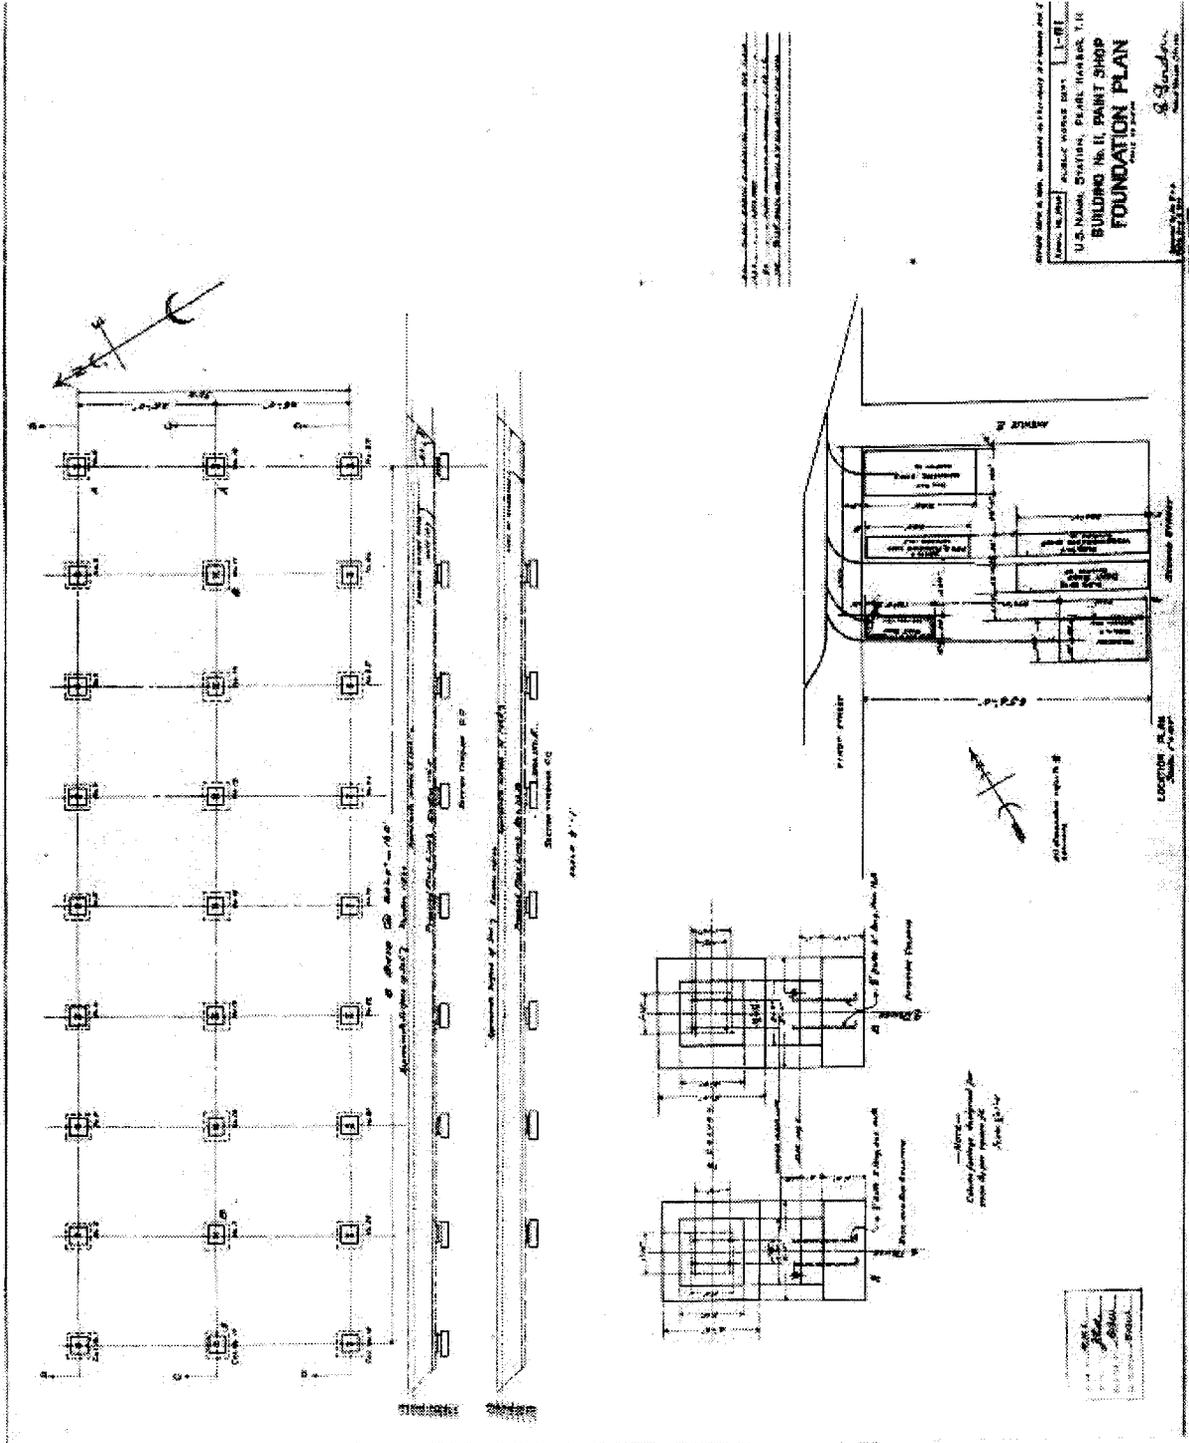
Original Construction Drawings, Foundation Plan
 (Drawing No. I-61, dated 4/16/1914) (reduced, not to scale)

The foundation system is a concrete pile/slab foundation. The ground was excavated and leveled approximately 5' below original grade (115.0'), digging 4'-0" below the approximate surface of rock, to an elevation of 110.0'. (The Mean Low Water (M.L.W) elevation is designated as 100.0' thus the original grade was about 15' above the water level.) The floor line is at an elevation of 110.5'. The concrete footings are set three feet below the floor line. Concrete two-tiered footings measuring 4'-6" square and 5'-0" square are spaced 20'-0" on center. The height of the footings is 2'-0" total, with the bottom portion 1'-6" high and the top portion 6" high. The column footings are designed for 5000 lbs. per square foot. Steel columns are bolted with 4, 7/8" bolts 2'-0" long using hexagonal nuts. The central column steel bearing plate size measures 2'-0" x 1'-10" in plan from outside to outside and 1'-3" x 1'-5³/₄" from center of bolt to center of bolt. The steel columns sit in the direct center of the footing. The entire floor area of the first floor is concrete slab.

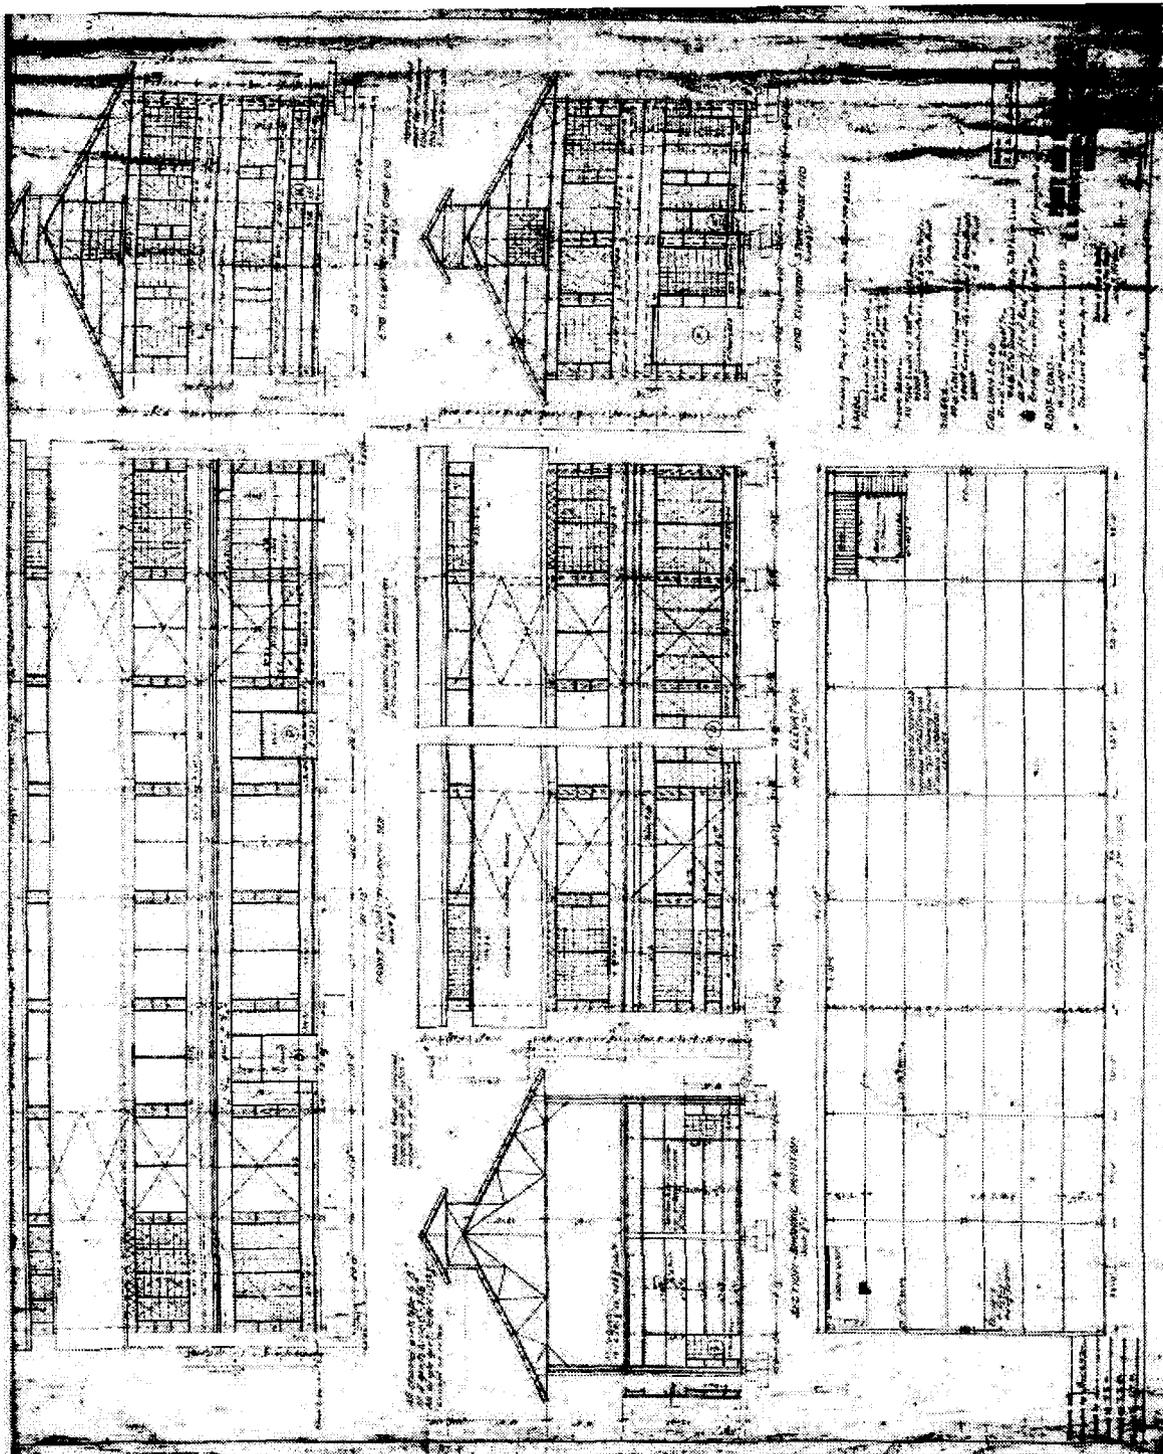
Original Construction Drawings, Floor Plans and Elevations,
(Drawing No. 62268, dated 1/5/1914) (reduced, not to scale)

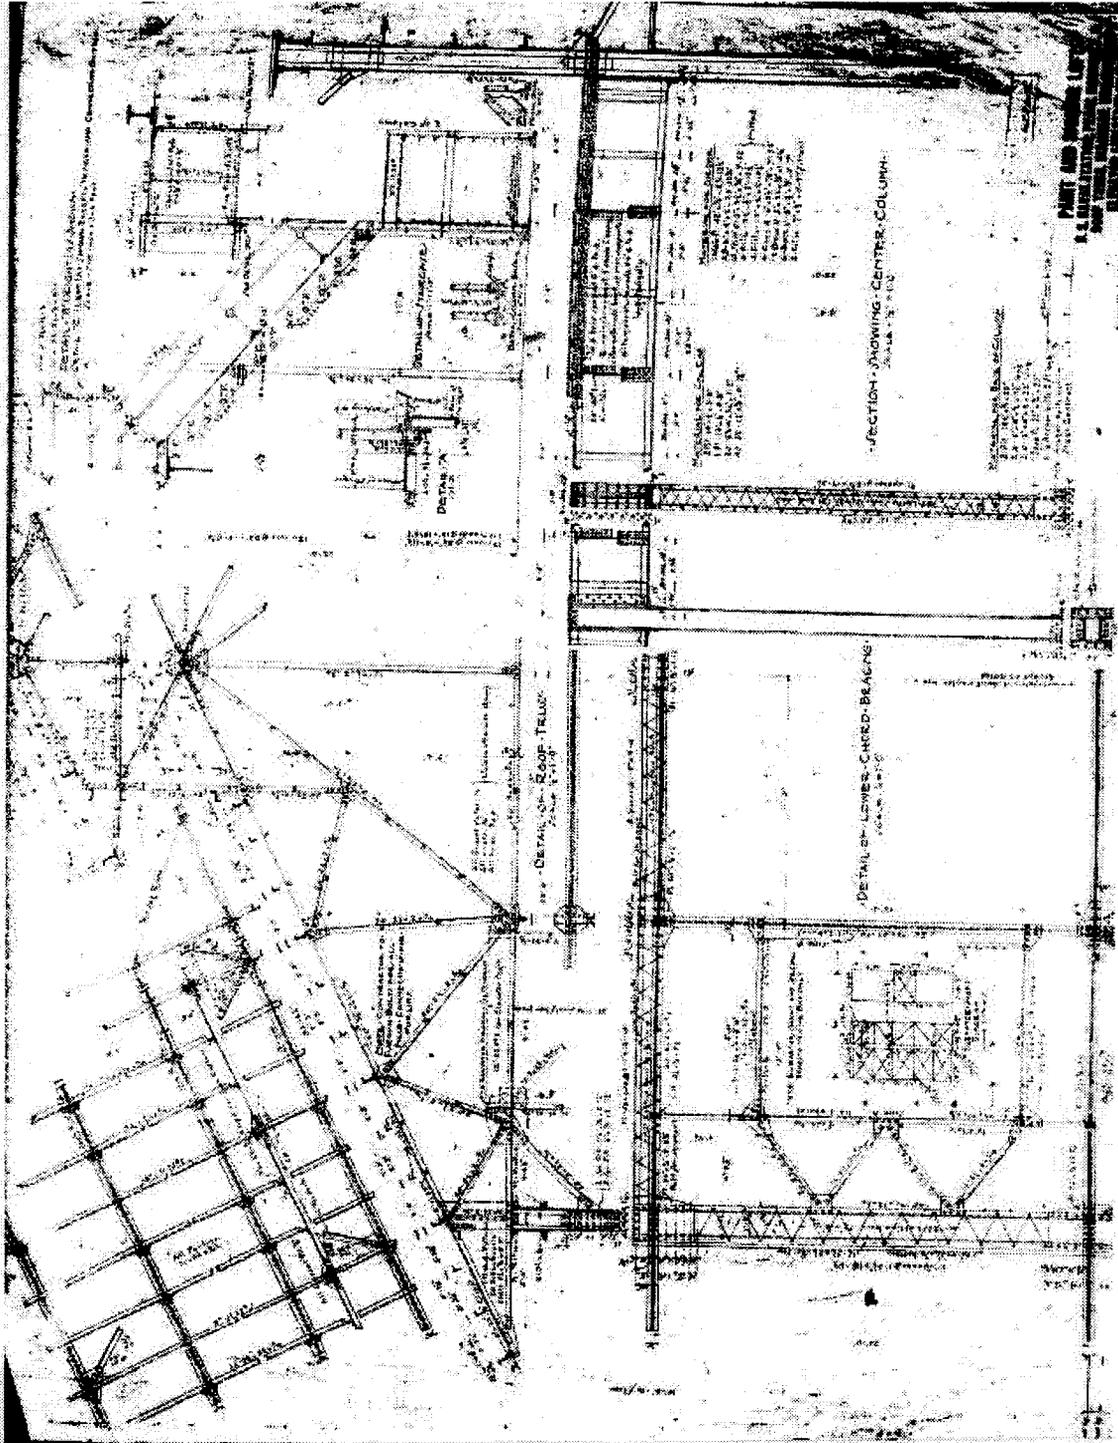
Original Construction Drawings, Cross-section of Structure, including roof truss detail
(Drawing No. 62269, dated 1/5/1914) (reduced, not to scale)

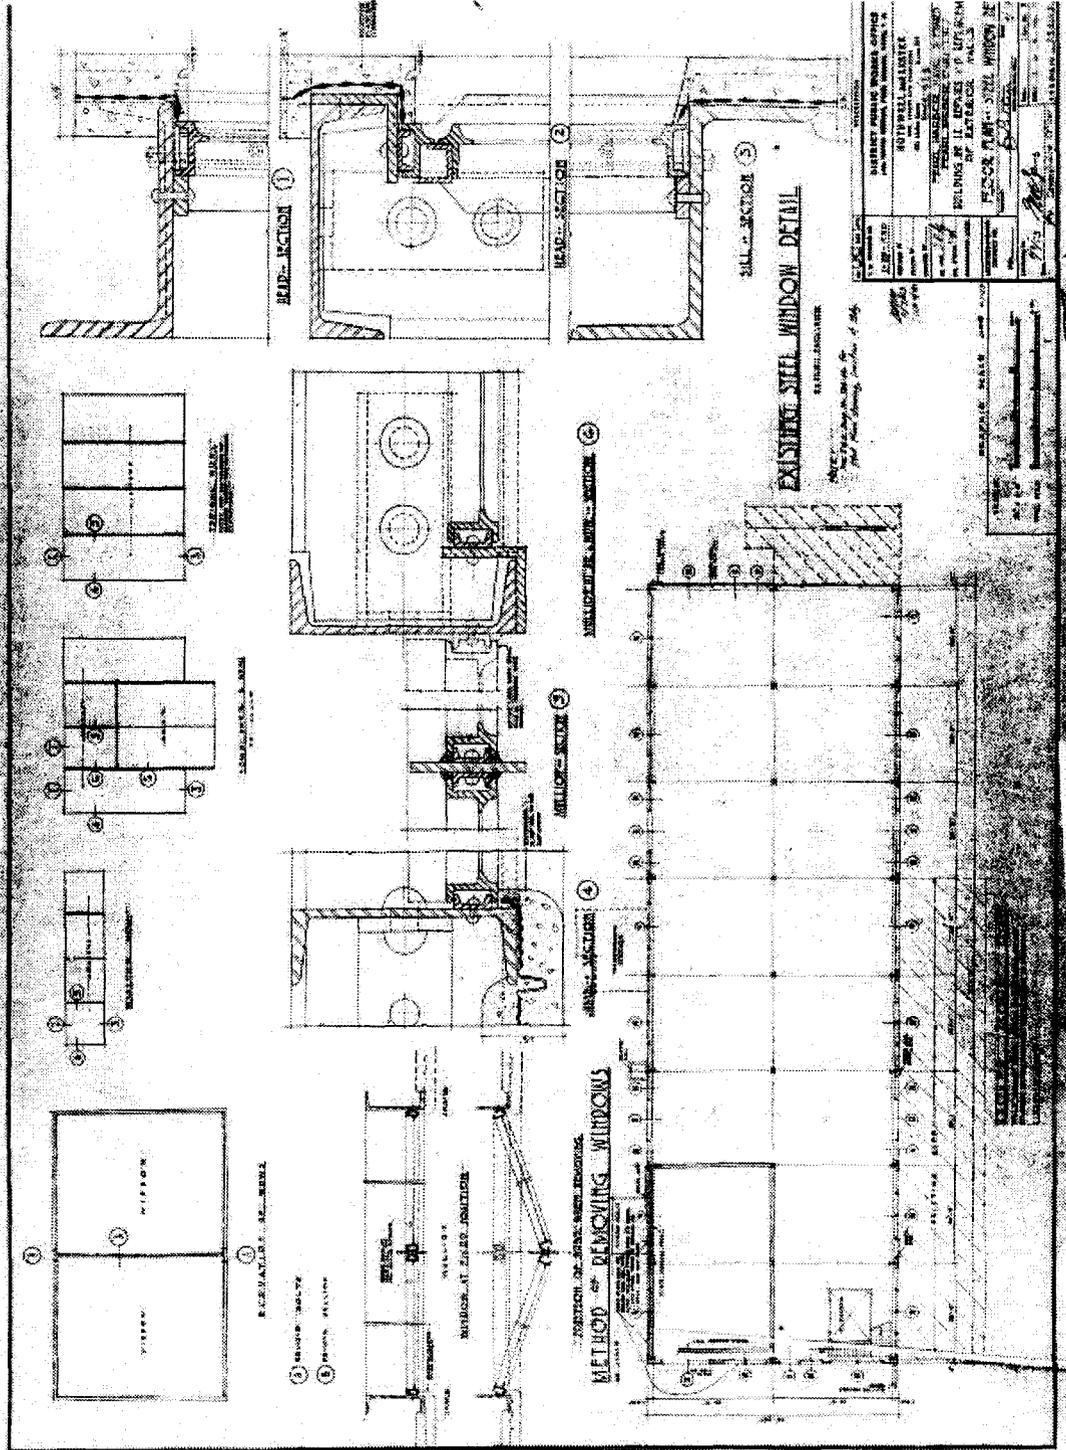
1953 Building repairs and replacement of exterior walls, Floor plan and details
 (Drawing No. 584142, dated 4/7/1953) (reduced, not to scale)

1953- Major repairs and alterations to Facility 11. Use changed to house administration spaces on at least part of the building. Repairs and replacement of exterior walls, including new corrugated asbestos siding and the replacement of some windows. New windows were specified to fit within the existing openings and new multi-light steel windows replaced older (rusting?) windows. Drawings show intermediate floor (now called the First Floor) as being elevated from 7'-6" to 11'-2" from finished floor, spanning the whole floor area. When this change was made is unknown. The 1'-6" gap between the horizontal roofing truss member and the underside of the roofing material was originally left open for ventilation. However, this gap was covered by new corrugated asbestos in this repair work.

The architecture firm that did the 1953 repair and replacement of exterior walls and interior modifications was Rothwell and Lester, Architects and Engineers. This was a local firm that was located in Honolulu, at 821 Alakea Street.

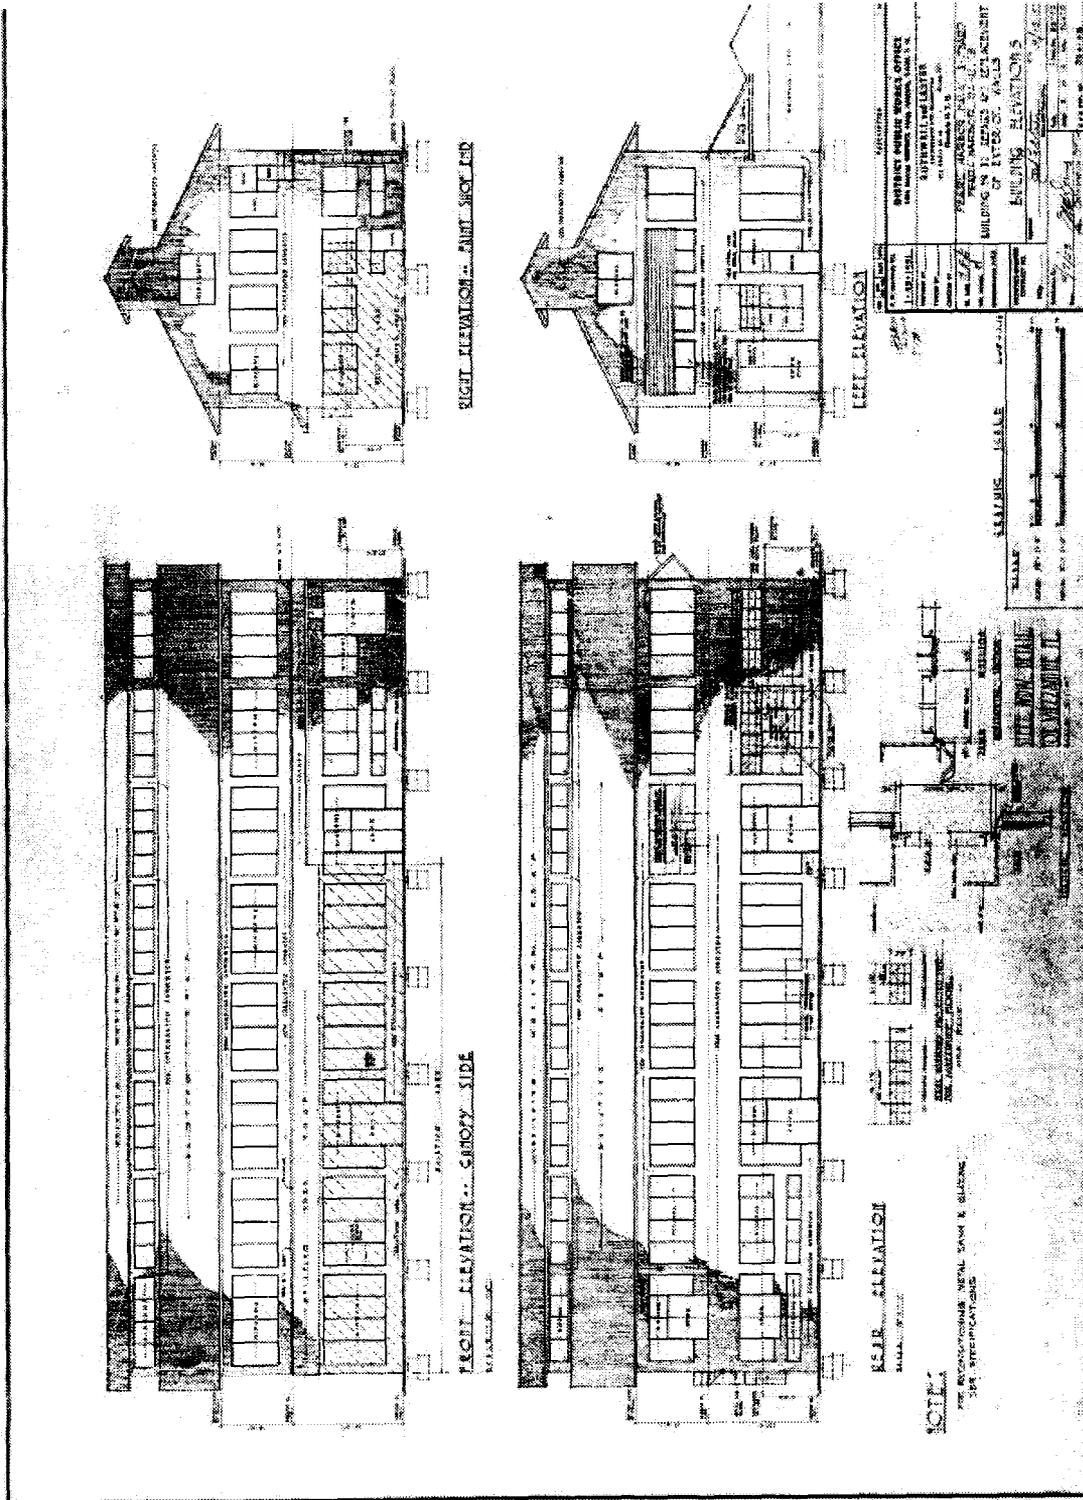
**1953 Building elevations of repairs and replacement of exterior walls
 (Drawing No. 584143, dated 4/7/1953) (reduced, not to scale)**

Its use had changed by 1951 when it was no longer being called the Paint Shop and Rigging Loft on the repair construction drawings, although the end elevation drawing was still called the 'Paint Shop End Elevation'. It was referred to only as Building 11. In photos taken in 1984, the sign on Facility 11A, a small one-story wooden structure

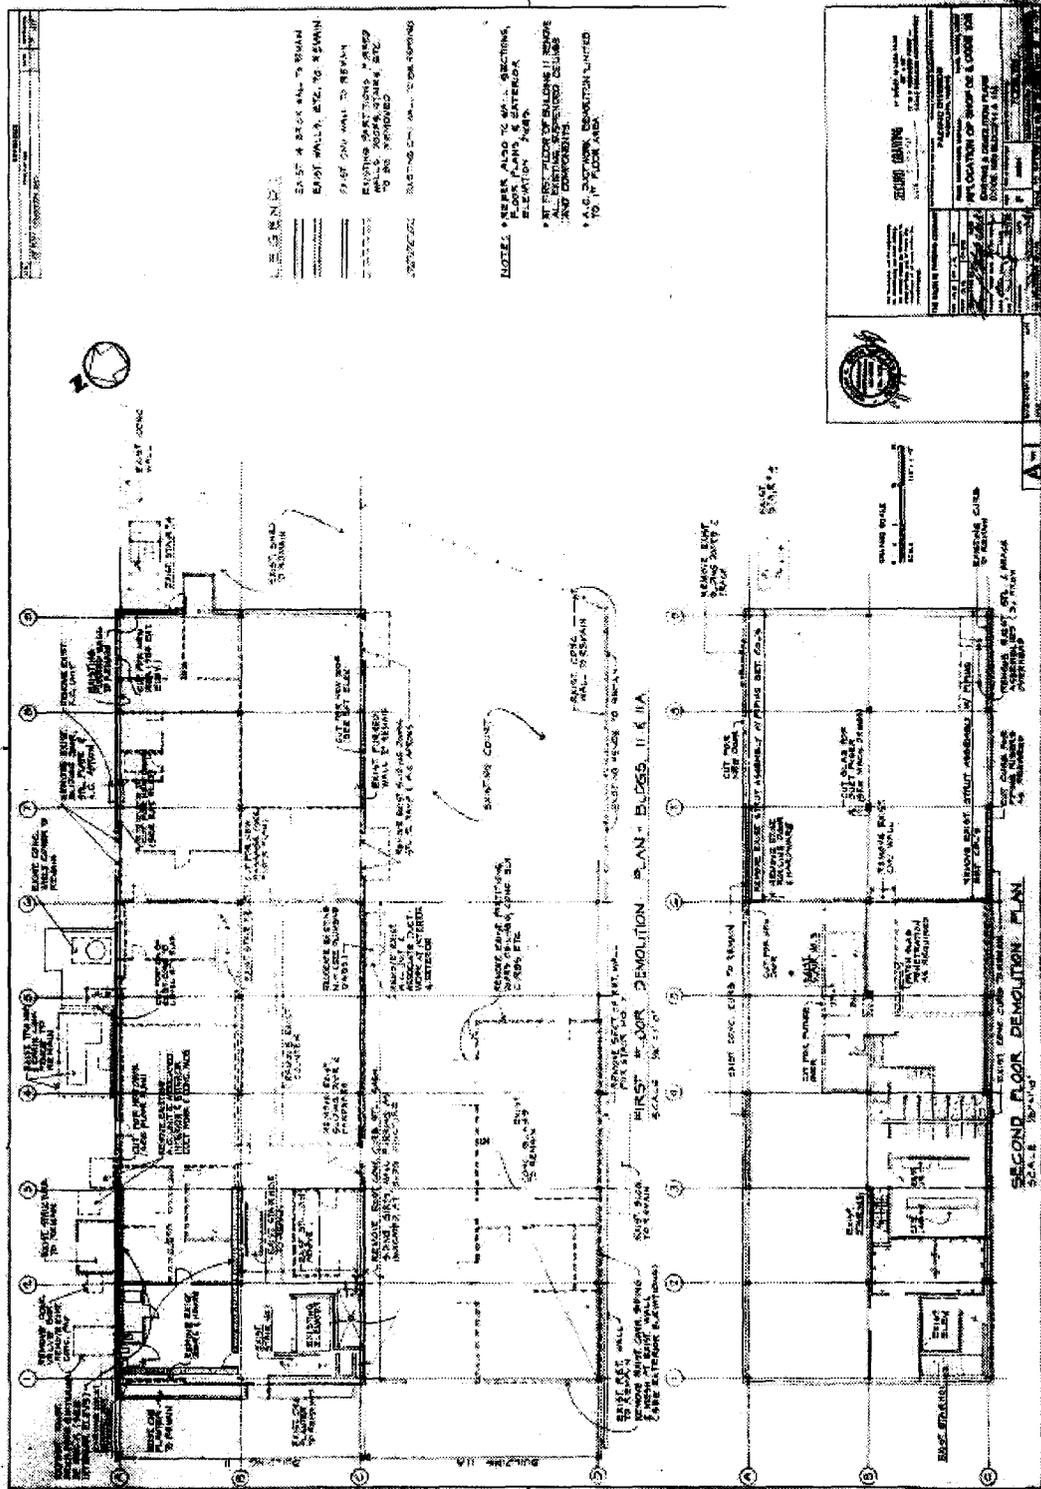
1984 Renovation/Demolition of Facility 11 and 11A - Demolition plans
 (Drawing No. 7058721, dated 7/24/1984) (reduced, not to scale)

1984- Major renovations/ demolitions done to Facilities 11 and 11A. Most interior walls on the first floor were removed and the entire interior redesigned with new walls. Some alterations done to second floor. Third floor was not in the contract. All walls on the first and second floors furred with corrugated metal siding on the exterior so that windows cannot be seen from the exterior. The steel multi-light central window directly under the clerestory roof was replaced with

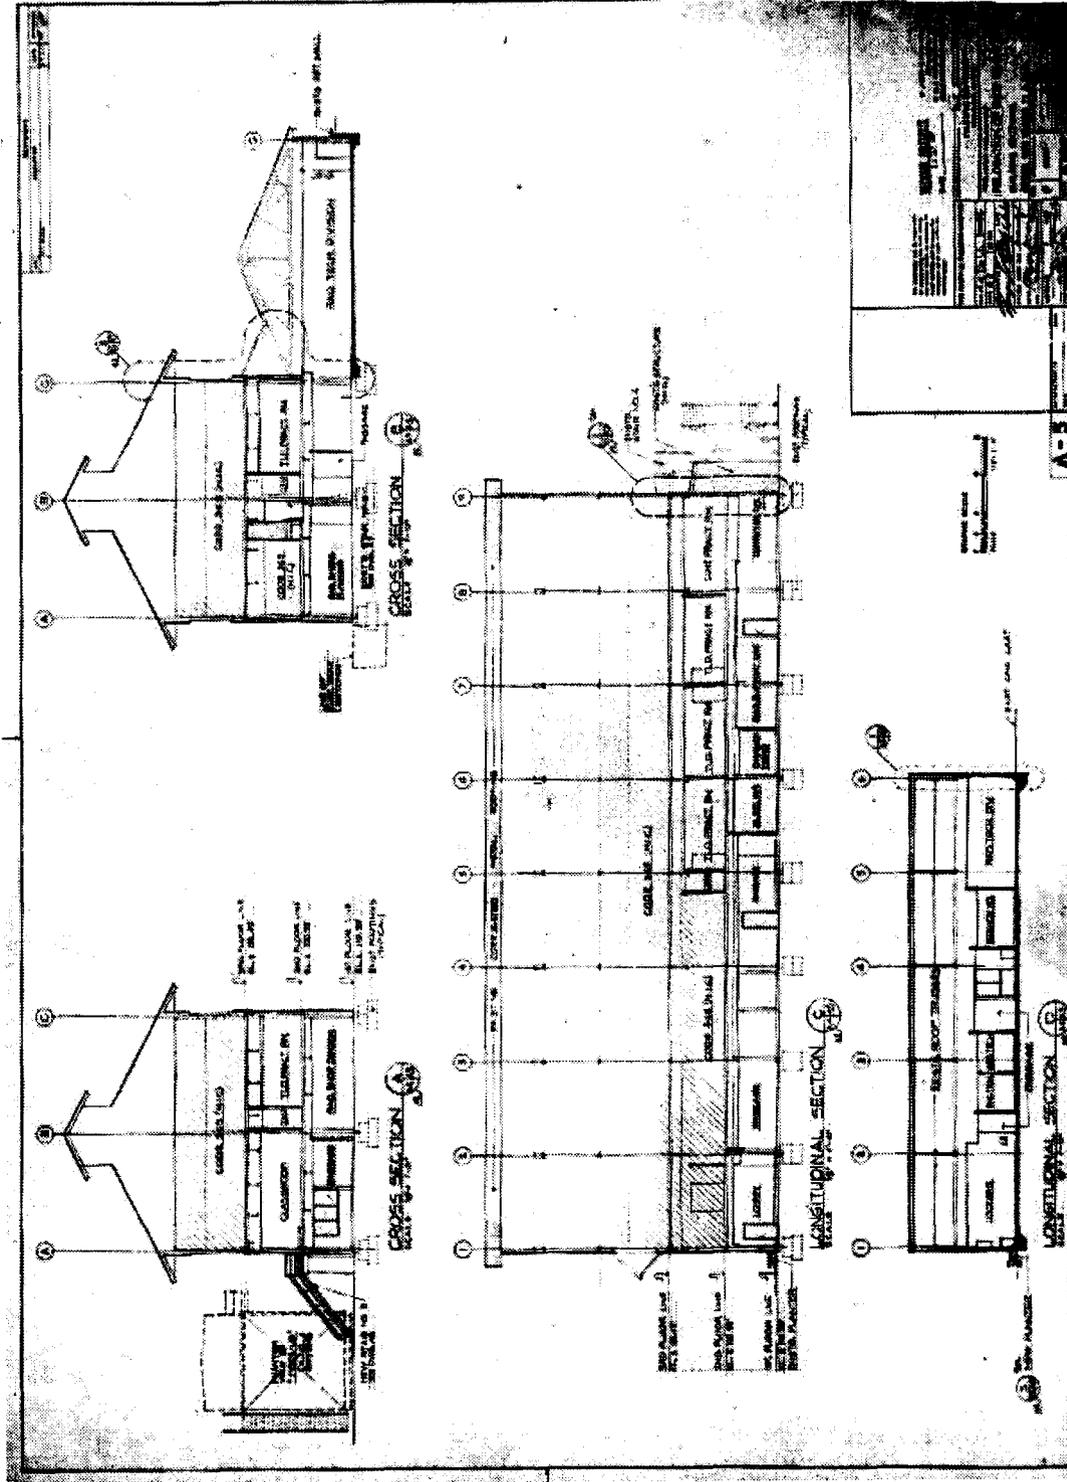
1984 Renovation/demolition of Facility 11 and 11A - Building sections
 (Drawing No. 7058725, dated 7/24/1984) (reduced, not to scale)

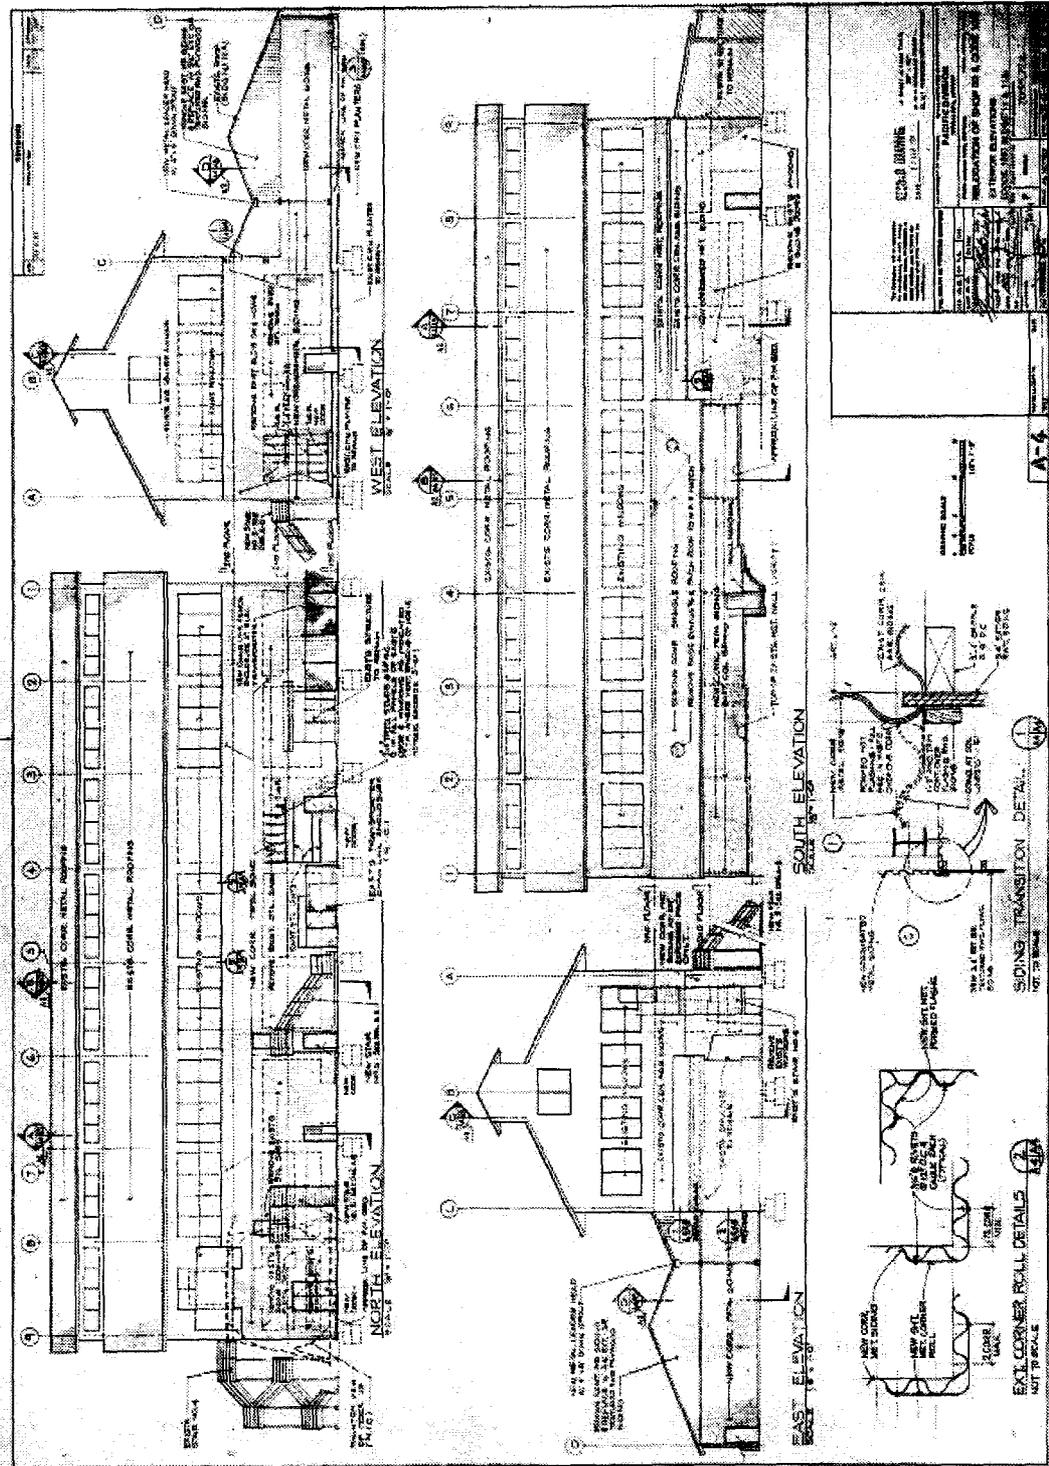
1984 Renovation/demolition of Facility 11 and 11A - Building elevations
 (Drawing No. 7058724, dated 7/24/1984) (reduced, not to scale)
