NATIONAL HOME FOR DISABLED VOLUNTEER SOLDIERS,
MARION BRANCH, BUILDING NO. 24
(Ward Building)
1700 East 38th Street
Marion
Grant
Indiana

ADDENDUM TO
NATIONAL HOME FOR DISABLED VOLUNTEER SOLDIERS – MARION BRANCH,
BUILDING No. 24
(Hospital Annex No. 1)
(Barracks No. 8)

HABS No. IN-306-AA

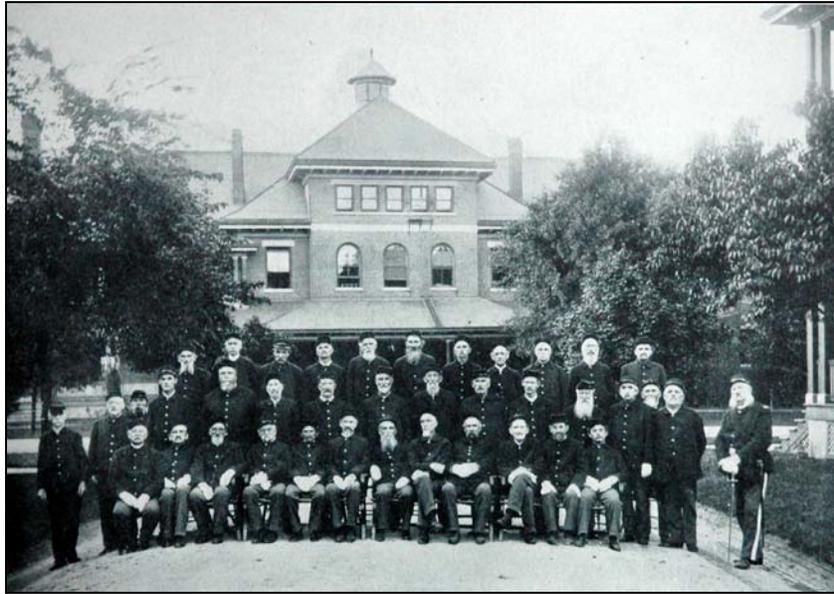
Figure 1: Company No. 8 in front of Barracks No. 8, c. 1908
Source: *National Military Home Indiana*, c. 1908, Marion VAMC files

porches, and dormers (Figure 1). The current interior layout may be a c. 1921 conversion from open wards/barracks to many small rooms.

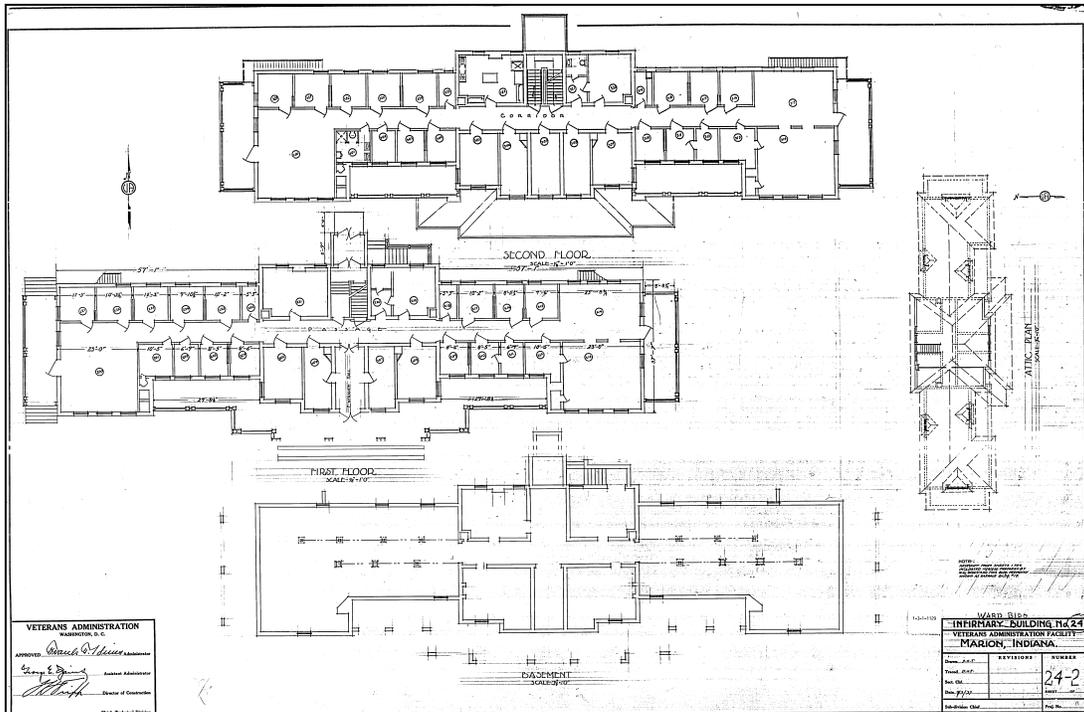
Figure 2: Building No. 24 Floor Plans, 1937
Source: PLIARS database, VACO

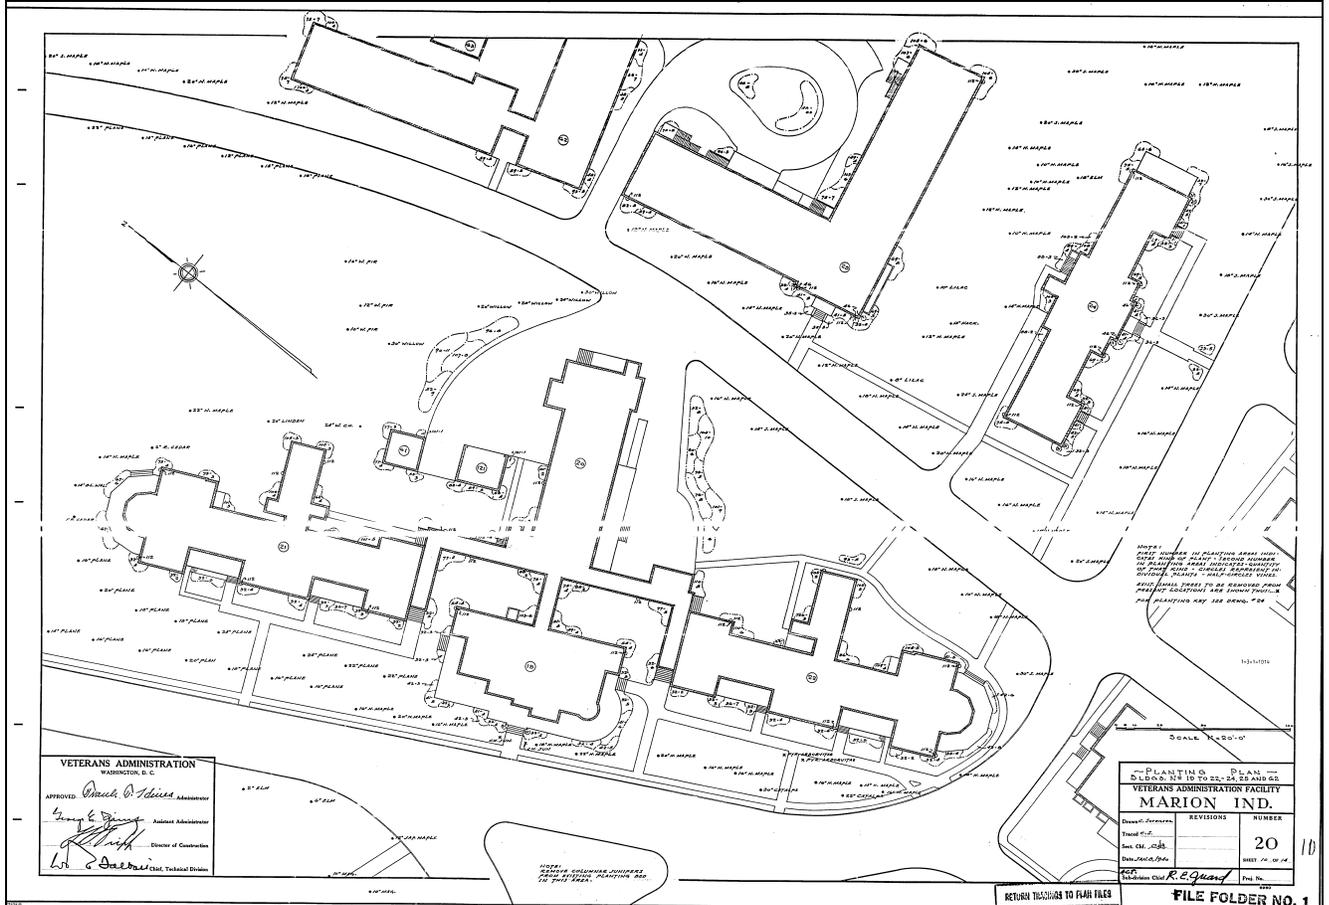
Figure 3: Site Plan of Marion Branch Hospital, 1940
 Source: PLIARS database, VACO

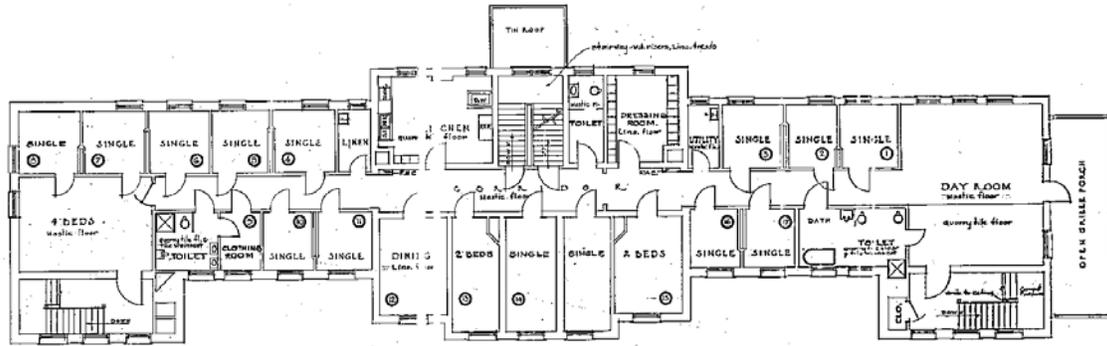
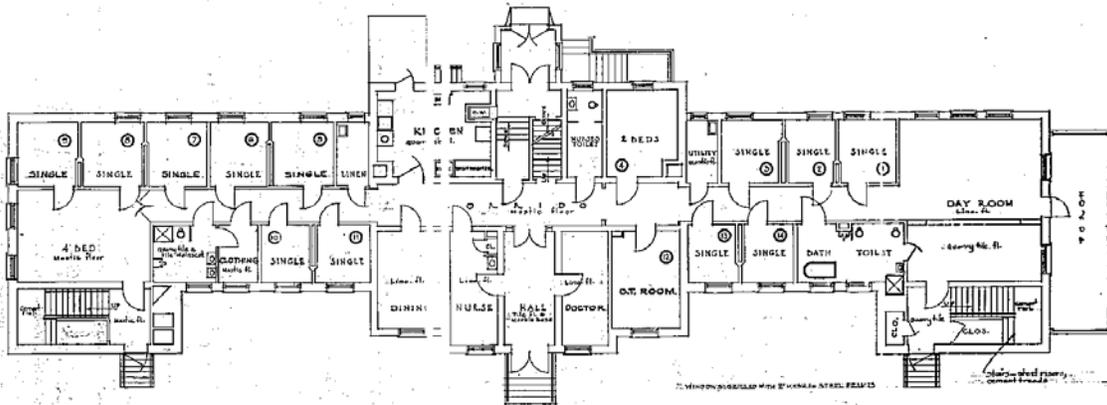
FLOOR PLAN
 SCALE 3/8" = 1'-0"
 CAPACITY THIS FLOOR, 22 BEDS.

FIRST FLOOR PLAN
 SCALE 3/8" = 1'-0"
 CAPACITY THIS FLOOR, 20 BEDS.

Figure 4: Building No. 24 First and Second Floor Plans, 1944, revised 1963
 Source: PLIARS database, VACO

1. Floor plans: Building No. 24 has a roughly rectangular footprint with a central entrance and a double-loaded transverse corridor running west to east (Figure 4). Larger day rooms (east) or four-bed wards (west) are located at each end of building while the halls are lined with small patient rooms, offices, and bathrooms. The center section of the basement has concrete floors and roughly finished rooms with arched openings. The ends of the basement are partially unfinished with dirt floors and lower ceilings. It is likely that when originally built as a barracks the floor plan included small rooms in the center pavilion and large open dormitories in the wings.
