NATIONAL HOME FOR DISABLED VOLUNTEER SOLDIERS,
MARION BRANCH, BUILDING NO. 60
(Medical Treatment Building)
(Administration Offices & Educational Therapy)
1700 East 38th Street
Marion
Grant
Indiana

ADDENDUM TO:
NATIONAL HOME FOR DISABLED VOLUNTEER SOLDIERS,
MARION BRANCH, BUILDING NO. 60
(Medical Treatment Building)
(Administration Offices & Educational Therapy)
(Barracks No. 7)
1700 East 38th Street
Marion
Grant County
Indiana

ADDENDUM TO NATIONAL HOME FOR DISABLED VOLUNTEER SOLDIERS – MARION BRANCH, BUILDING No. 60 (Administration Building)

HABS No. IN-306-AI

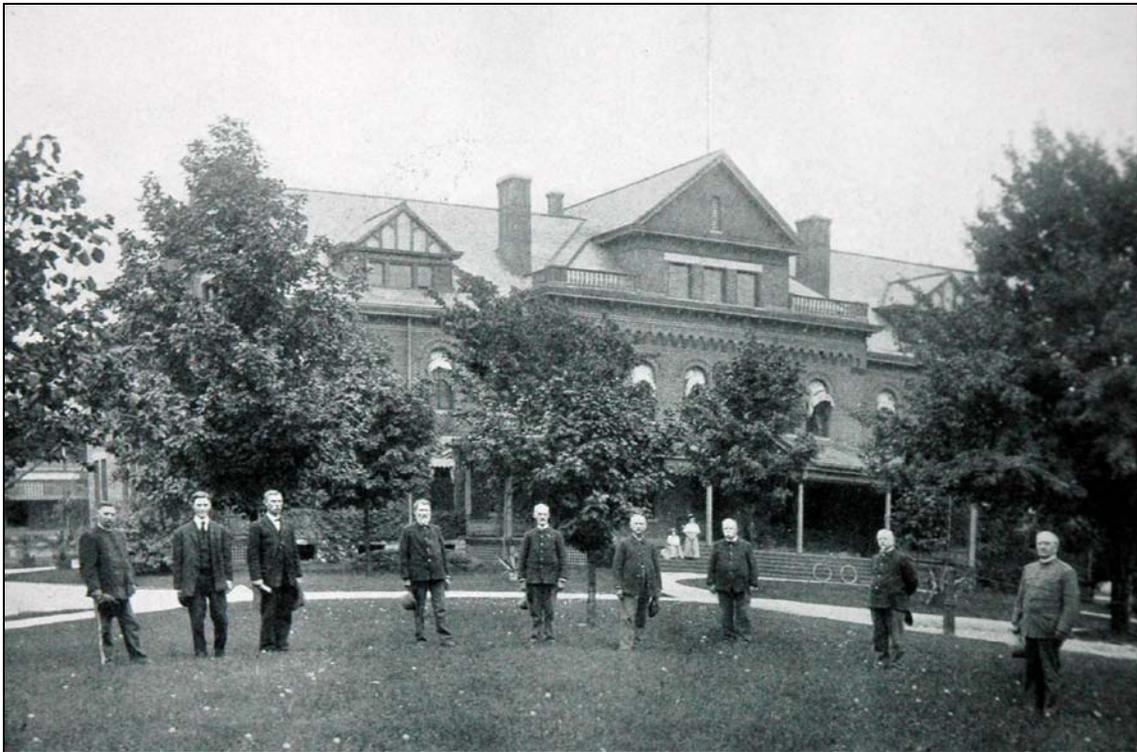
Figure 1: “Headquarters and Employes [sic.] Thereof,” c. 1908
Note chimneys and dormers with half-timber decoration.
Source: *National Military Home Indiana*, c. 1908, Marion VAMC files

1. Date of erection: c. 1891
2. Architect: attributed to Peters and Burns, Dayton, Ohio
3. Original and subsequent owners, occupants, uses: Building No. 60 was built as an administration building for the Marion Branch, National Home for Disabled Volunteer Soldiers (Figure 1). It was converted to hospital/barracks use in 1909, at a cost of \$4,444.² In 1921 the Marion Branch became a National Sanitarium dedicated to neuropsychiatric care and Building No. 60 was renovated and functioned as an administrative support structure for the hospital. In 1934 a dental clinic and X-ray facility were added to the building; during the 1930s Building No. 60 was designated the Clinical Laboratory. Floor plans from c. 1943 indicate that the basement housed file and film storage, educational therapy, dieticians, and chaplains' offices were located on the first floor, and the second floor included nursing education and central sterilizing supply (Figure 2). It is likely that an elevated connecting bridge to the main hospital was built at this time. The building was last used by Rehabilitation Medical Services and the Social Recreation Center (1980s) and now stands vacant, awaiting demolition.

B. **Early Views:** Early views of Building No. 60 include a c. 1900 postcard in the Marion Public Library collection. Building No. 60 is called “Head Quarters.” Another early view appears in the c. 1908 souvenir booklet, with Building No. 60 again called headquarters (See Figure 1).

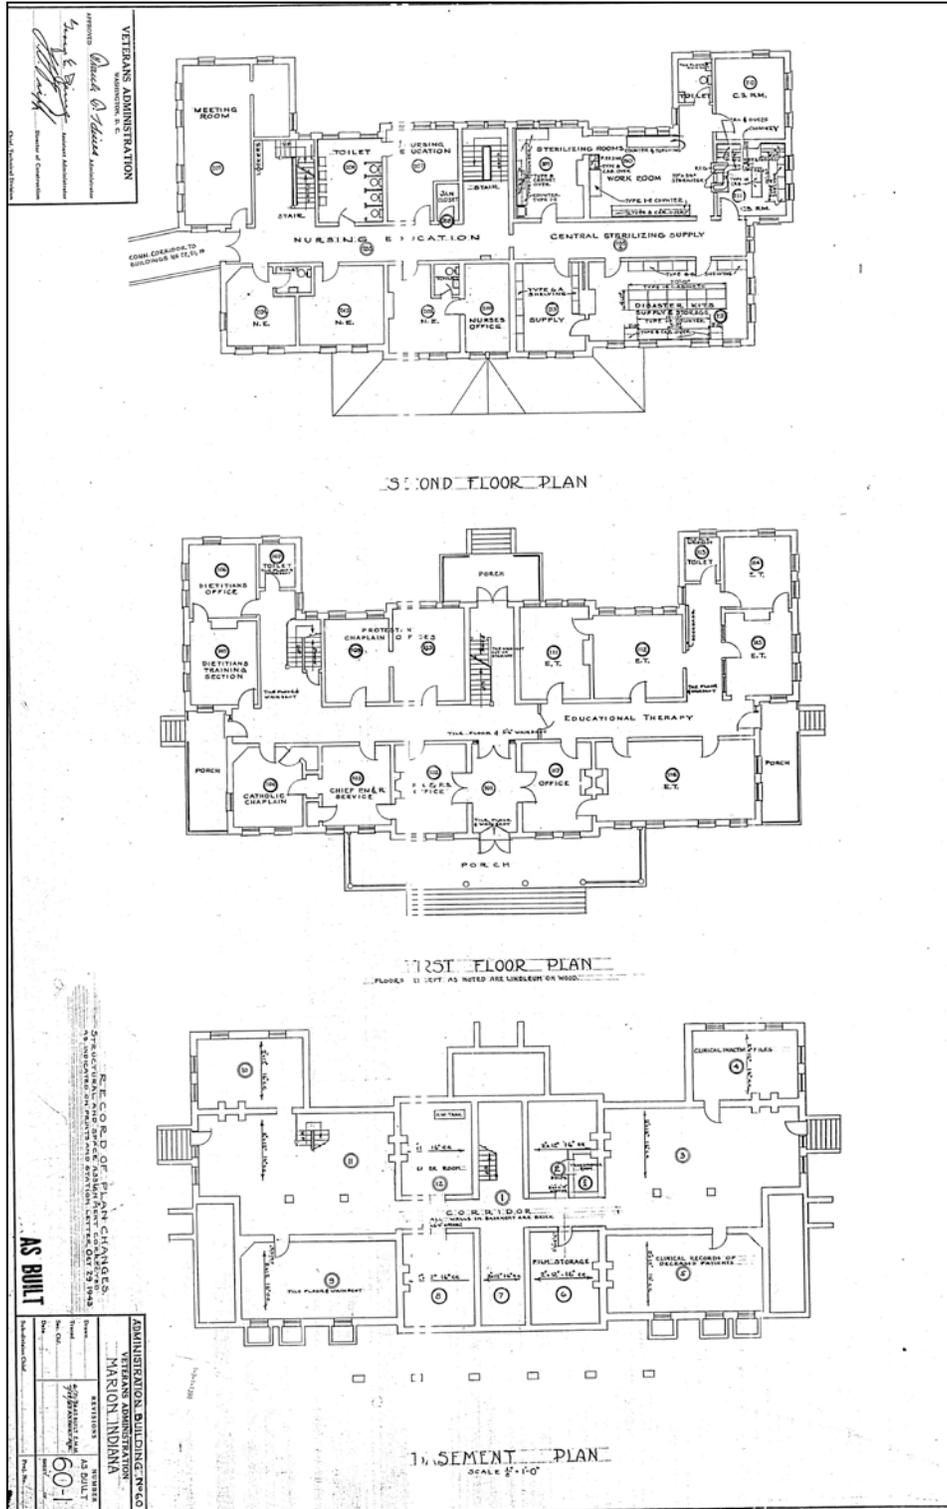
Figure 2: Building No. 60 Floor Plans, c. 1943
 Source: PLIARS database, VACO
