ALLEN PARK VETERANS ADMINISTRATION HOSPITAL, BUILDING NO. 8
(Allen Park Veterans Administration Hospital, Research Building
Allen Park Veterans Administration Hospital, Attendants' Quarters)
Southfield Expressway & Outer Drive
Allen Park
Wayne County
Michigan

HABS No. MI-427-D

HISTORIC AMERICAN BUILDINGS SURVEY

ALLEN PARK VETERANS ADMINISTRATION HOSPITAL BUILDING 8 (Attendants' Quarters/Research Building)

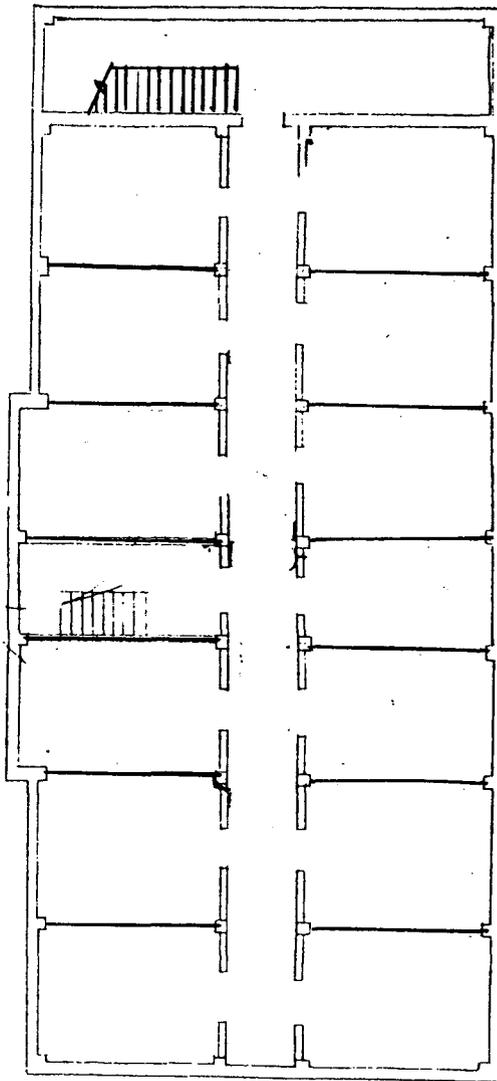
Reduced Copy of Current Plan, February 2002

N
BUILDING #8 - SECOND FLOOR PLAN
SCALE: 1/16" = 1'-0"
