Joyce Estate, Main Cabin (Main Lodge)  
Chippewa National Forest Road 2144, ←  
3 miles north of County Road 335  
Grand Rapids vicinity  
Itasca County  
Minnesota

HABS No. MN-146-A

JOYCE ESTATE,  
MAIN CABIN (Main Lodge)

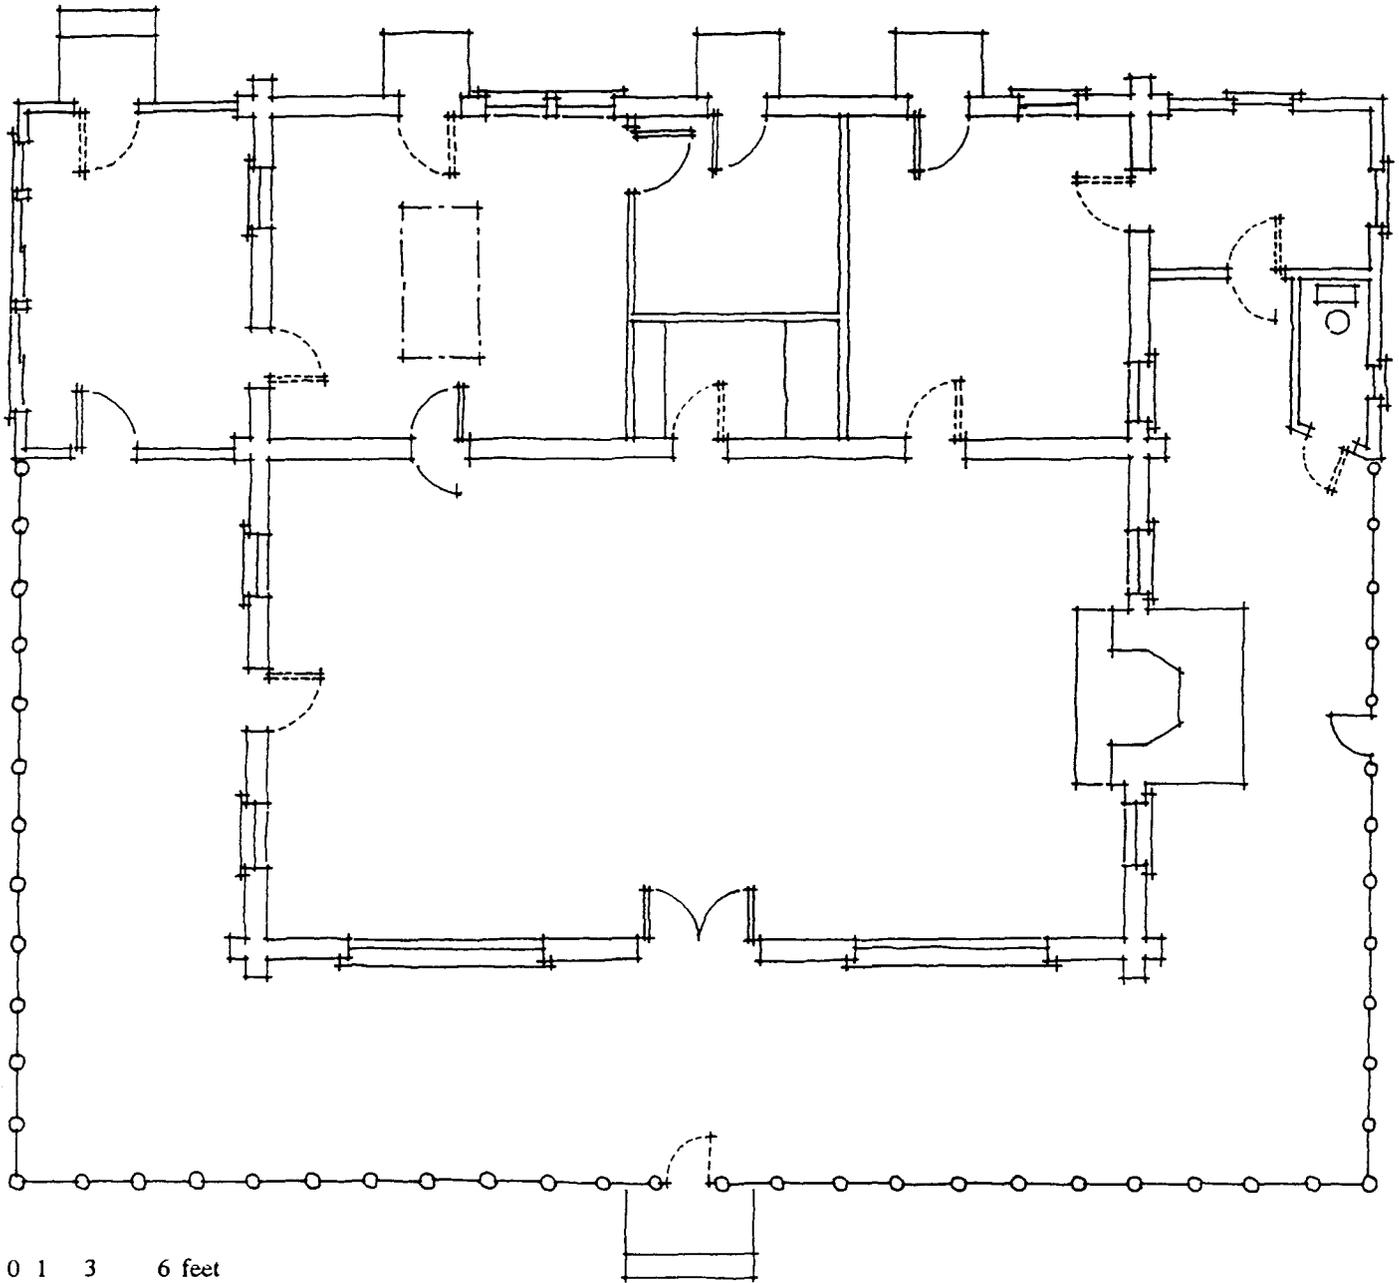
0 1 3 6 feet

0 1 2 meters

1. **Overall Dimensions** The central log structure measures approximately 37'2" by 35'0". A once-screened porch, about 9'8" wide, wraps around the building's north, east, and south sides, giving the building overall dimensions of approximately 56'6" by 44'8".
2. **Foundations** Concrete and stone.
3. **Walls** The main section consists of saddle-notched peeled logs. Shingles cover enclosed rooms on the northwest and southwest corners of the porch. Shingles also sheath the gable ends and the lower part of the porch.
