Joyce Estate, Farmhouse (Caretaker's Cabin)
Chippewa National Forest Road 2144,
3 miles north of County Road 335
Grand Rapids vicinity
Itasca County
Minnesota

PHOTOGRAPHS
HISTORICAL AND DESCRIPTIVE DATA

JOYCE ESTATE, FARMHOUSE (Caretaker's Cabin)

HABS No. MN-146-EE

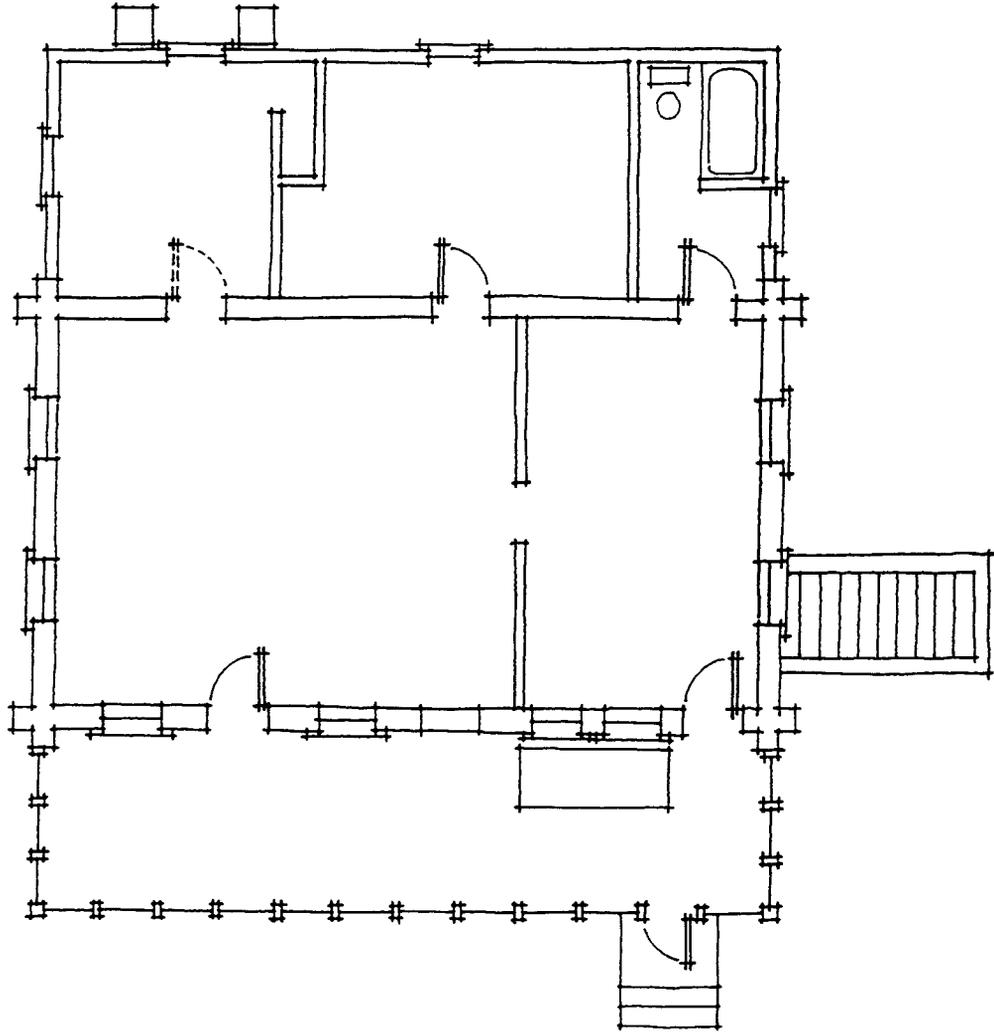
0 1 3 6 feet

1. **Architectural Character** The building's rectangular plan consists of three sections: a central gable-roofed log building; a shed-roofed, wood-frame front porch, which extends across the entire front (east) side; and a shed-roofed, wood-frame, shingled section to the rear. Most walls are painted brown; trim is painted white. It is the only cabin on the estate to have a basement.
2. **Condition of Fabric** Poor (foundation failure beneath east wall).

1. **Overall Dimensions** Main log section, 31'0" by 17'6"; wood-frame rear section, 31'0" by 10'4"; front porch, 31'0" by 7'10"; all measurements approximate.
2. **Foundations** Cast concrete, painted green, beneath log and rear sections; porch foundation obscured by shingled apron.
3. **Walls** The log section has saddle-notched peeled logs, with wood-frame, wood-shingled gable ends. The logs and shingles are painted brown, except for the logs on the front (east) wall, which have a natural varnish coating. Wood shingles, painted brown, cover the rear section. The wall beneath the porch screens consists of narrow beveled and beaded vertical wood siding, painted green; the porch foundation is hidden by wood shingles, painted brown.
4. **Structural System, Framing** Log and wood frame.
