FORT BRAGG, BOILER HOUSE
(Fort Bragg, Building No. 2-1150)
Northwest corner of Macomb Street & Sturgis Street
Fort Bragg
Cumberland County
North Carolina

FORT BRAGG, BOILER HOUSE

(Fort Bragg, Building No. 2-1150)

HABS No. NC-~~390~~
317-E

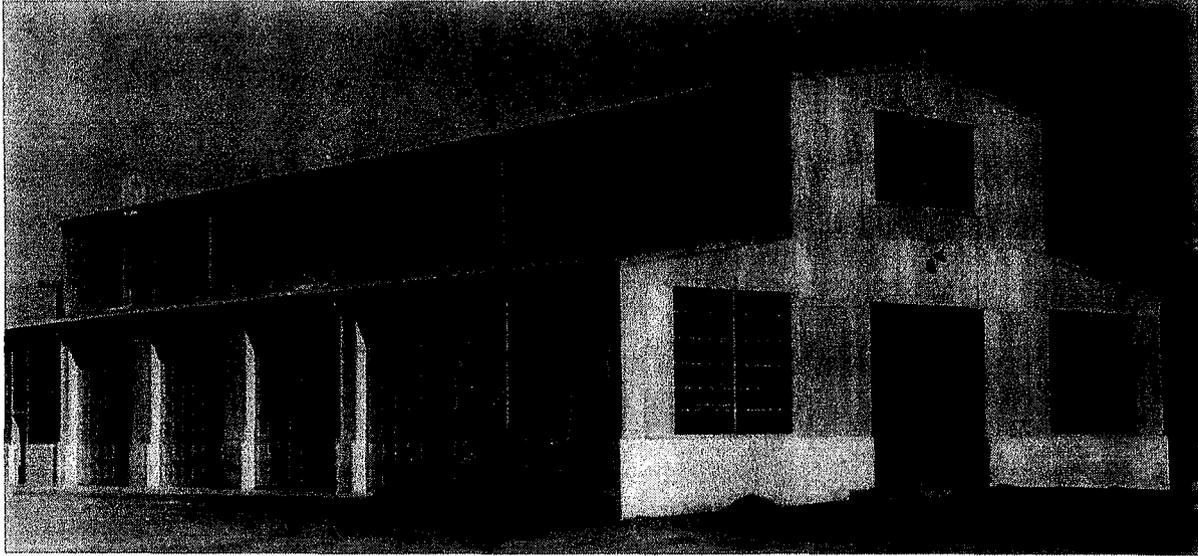
Figure 1: Building 2-1251 (courtesy of the National Archives).

During the inter-war years, industrial buildings continued to follow functional, industrial designs, a pattern established about World War I, in contrast to the revivalist tradition for industrial structures common in the nineteenth century. By the late 1930s, military architects designed and built buildings that deviated from the standard revivalist mode, such as streamlined, Art Deco-influenced buildings. An example of this at Fort Bragg is the Heavy Gun Shop (2-1549) located in the Quartermaster Support Area, a steel and brick building with International detailing, built in 1934. Further examples are the Ordnance/Motor Repair Shop (2-1251) and its Boiler House (2-1150), both constructed in 1941 (see Figure 1).

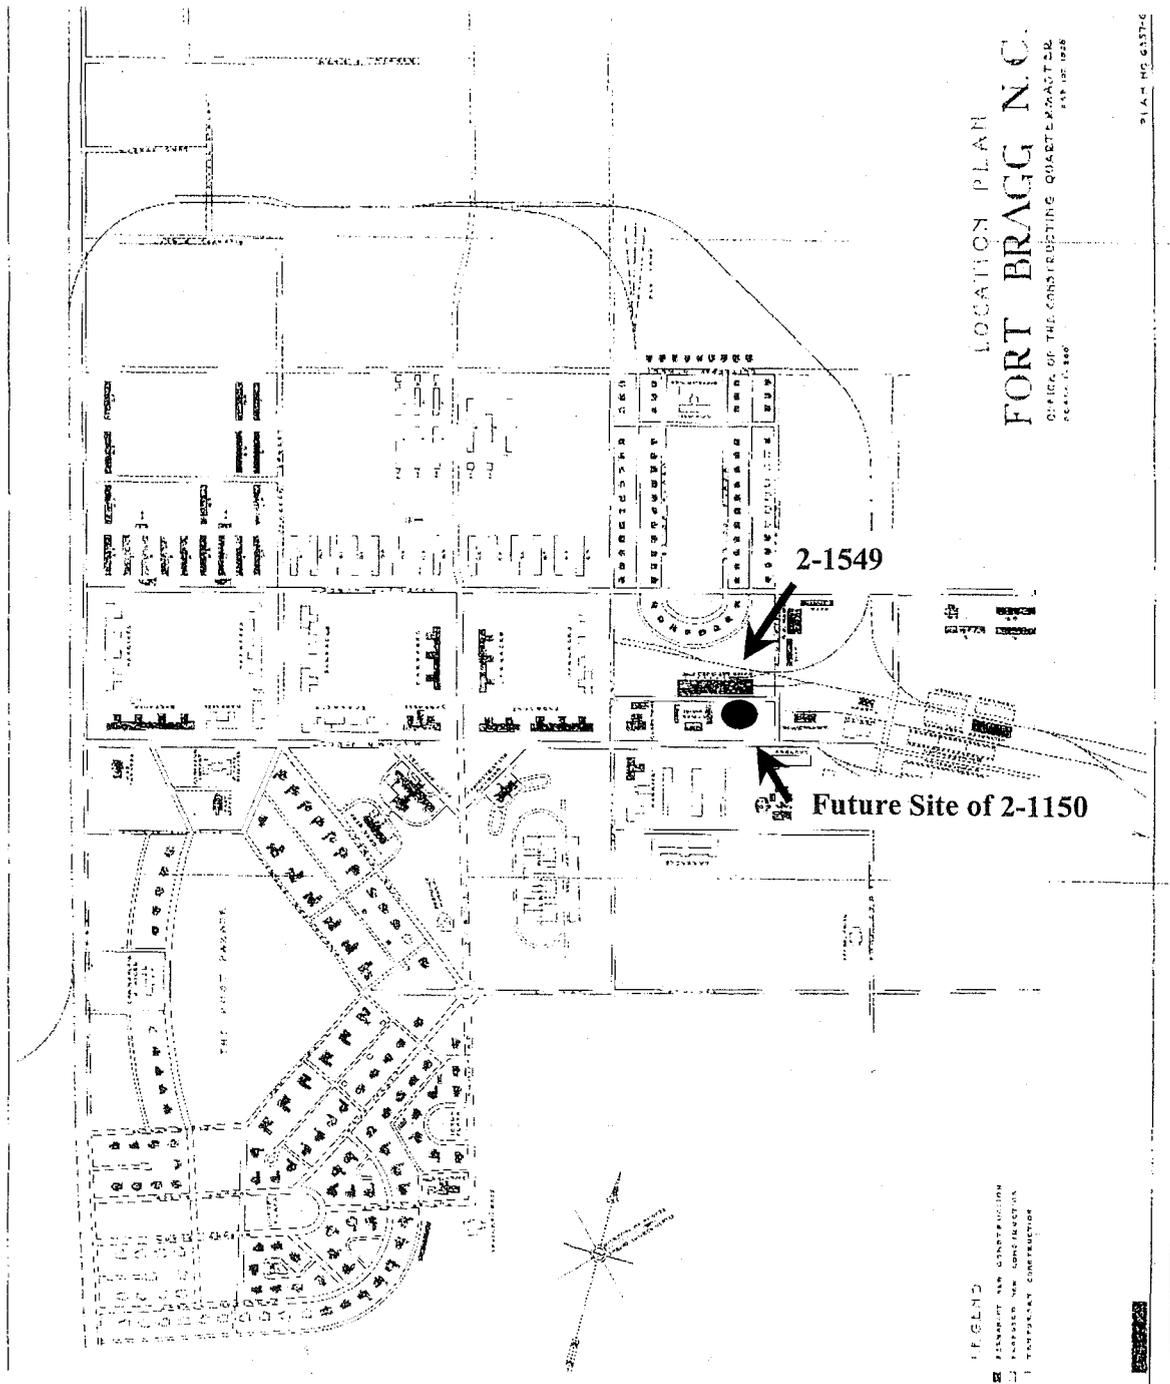
Figure 2: Fort Bragg February 1935 plan (courtesy PWBC, Fort Bragg).

From 1926 to 1939, the master plan was gradually completed with brick and stuccoed tile housing, civic, medical and office buildings (see Figure 2). Domestic buildings, including housing, the officers' club, and the chapel, are stuccoed Spanish Eclectic style, with barrel-shaped terra cotta tile roofs. The administrative buildings, hospital, and barracks are Georgian Revival style brick buildings with one exception: the Telephone Exchange (2-1114) is a simple Moderne style executed in stucco. Warehouses, repair buildings, and storage sheds are of standard industrial design and built of wood or steel frame with brick or metal cladding.

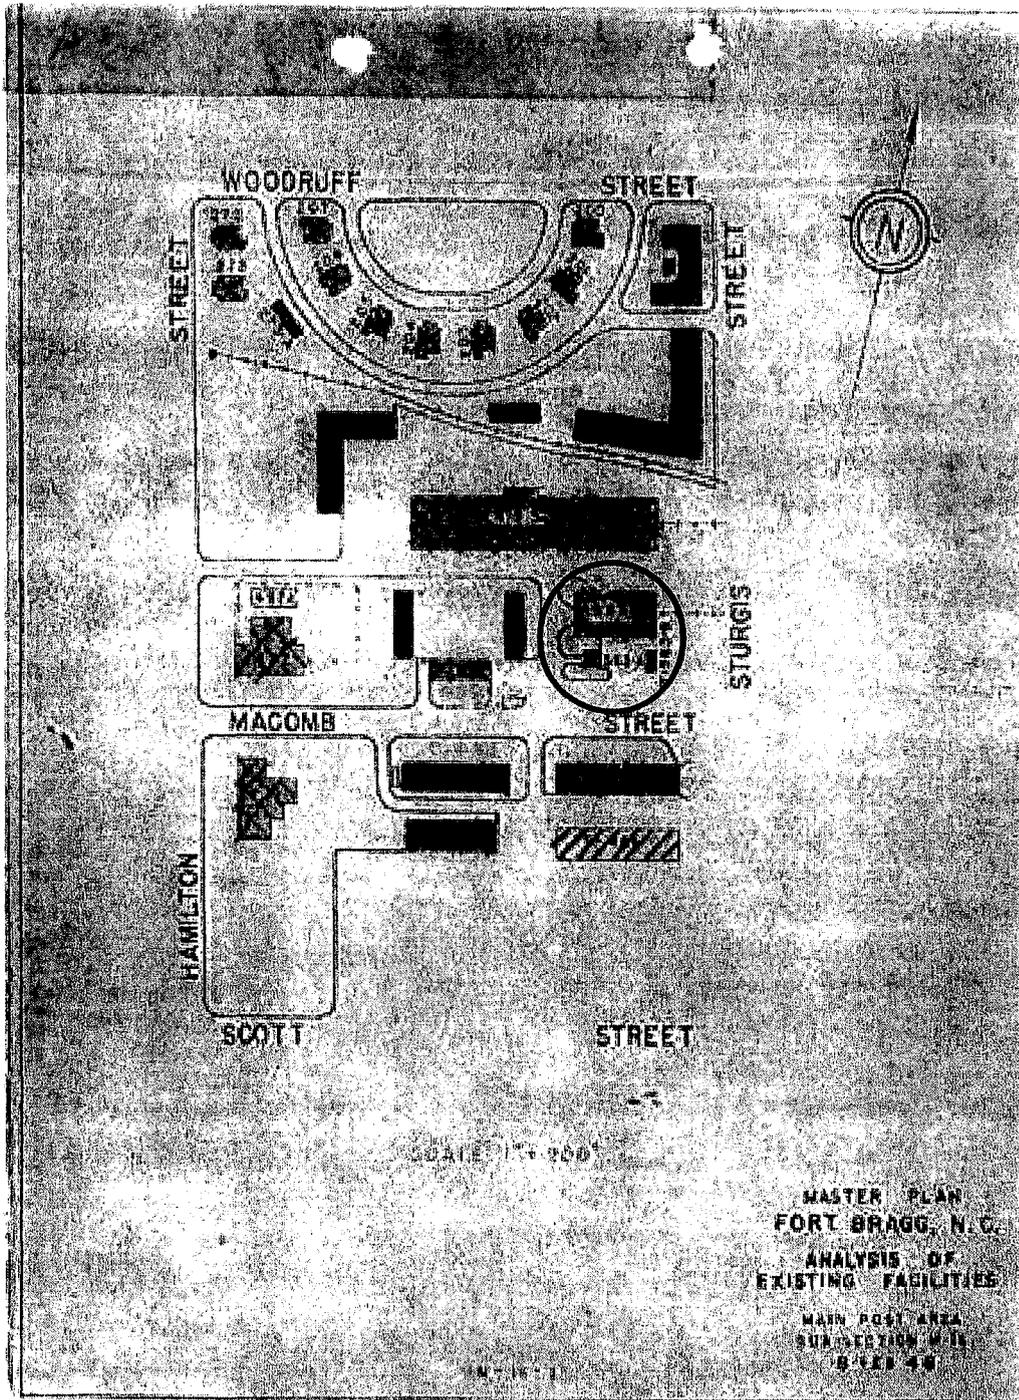
Figure 3: Portion of 1948 Master Plan with buildings in center right (courtesy PWBC, Fort Bragg).

At the east end of the Old Post Historic District, served by a network of rail spurs, stands the Quartermaster Support Area, containing the Quartermaster Office Building (2-1148), Quartermaster Maintenance Building (2-2055), Commissary (2-1256), Bakery (2-1361), Heavy Gun Shop (2-1549), and Ordnance Warehouse (8-3710), all constructed of brick in functional Georgian Revival, Moderne style, or utilitarian industrial design. Included in this area is the Boiler House (2-1150), constructed for the Ordnance/Motor Repair Shop (2-1251) out of steel framing and sided by corrugated galvanized iron, with a brick coal room to the side. The 1948 master plan shows the Boiler House (2-1150) in its context (see Figure 3).

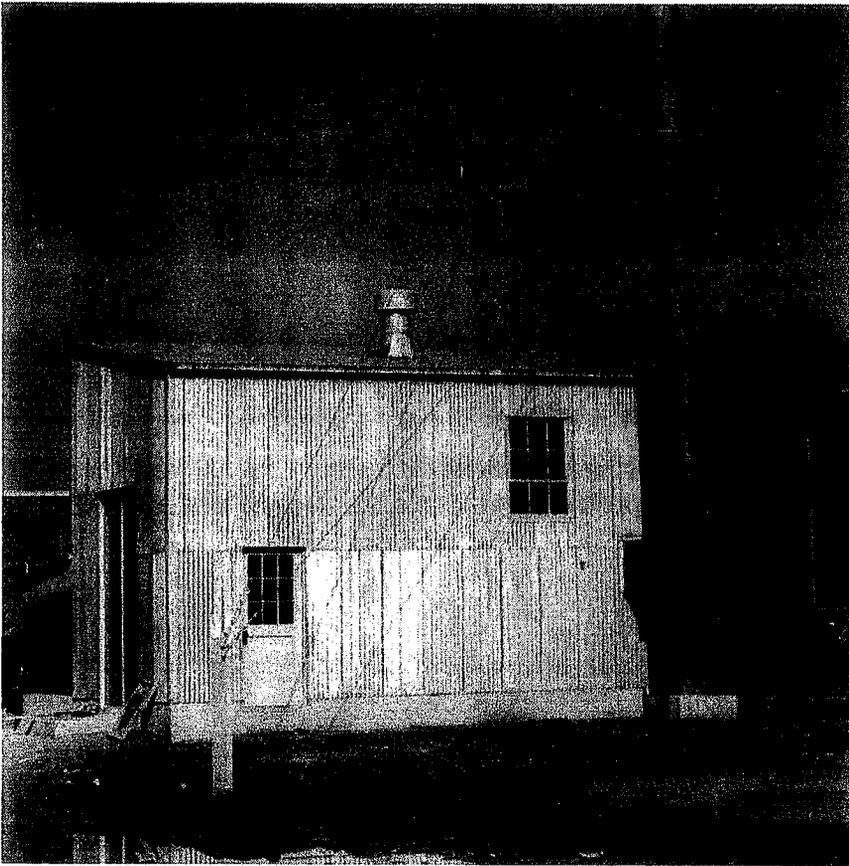
Figure 4: Building 2-1150 (courtesy of the National Archives).

The Boiler House (2-1150) follows the adage of "form follow function," with its service area constructed out of brick and the boiler room constructed out of steel covered by corrugated galvanized iron siding (see Figure 4). The boiler's chimney was a simple galvanized metal tube sitting upon a concrete pad. Guy wires supported the height of the chimney with one set placed in the parking area, another connected to the roof of the Boiler House, and the third connected to the Ordnance Repair Shop. This original chimney was replaced August 9, 1955 with a brick chimney 47' high at a cost of \$2,634.67 (see Figure 5).

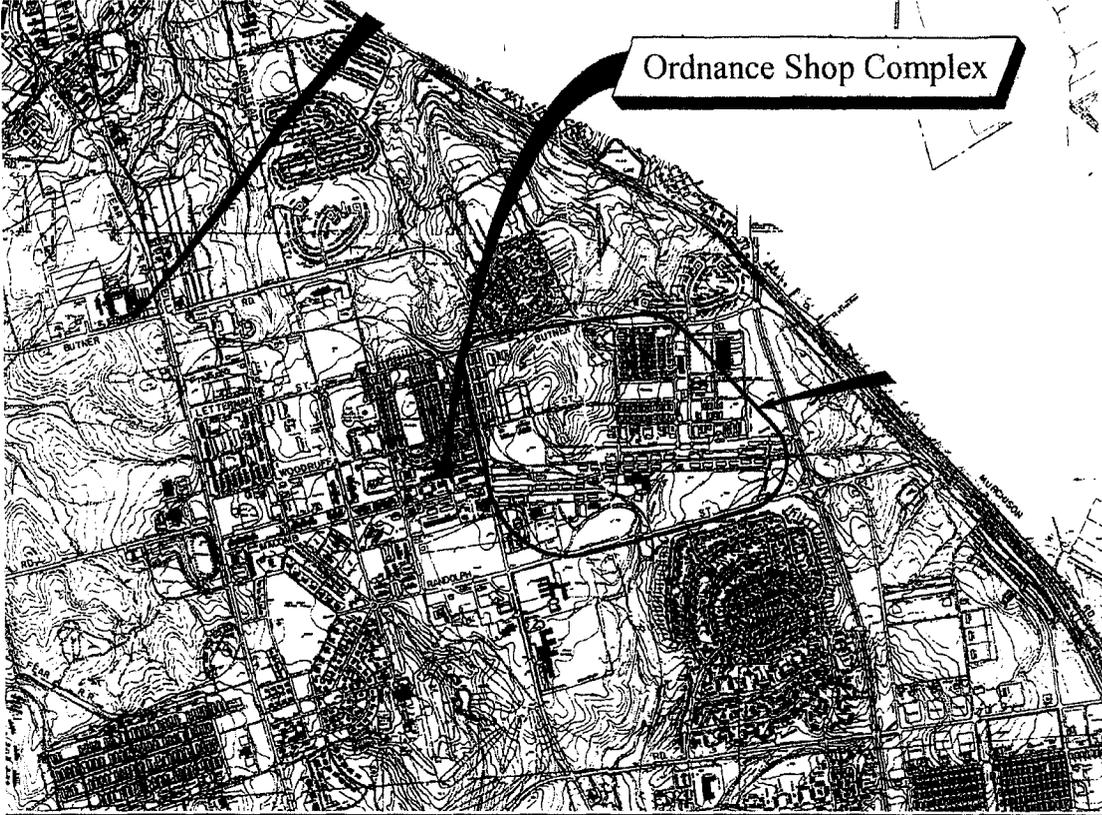
Figure 6: Location of Ordnance Repair area in the cantonment of Fort Bragg (courtesy PWBC, Fort Bragg).

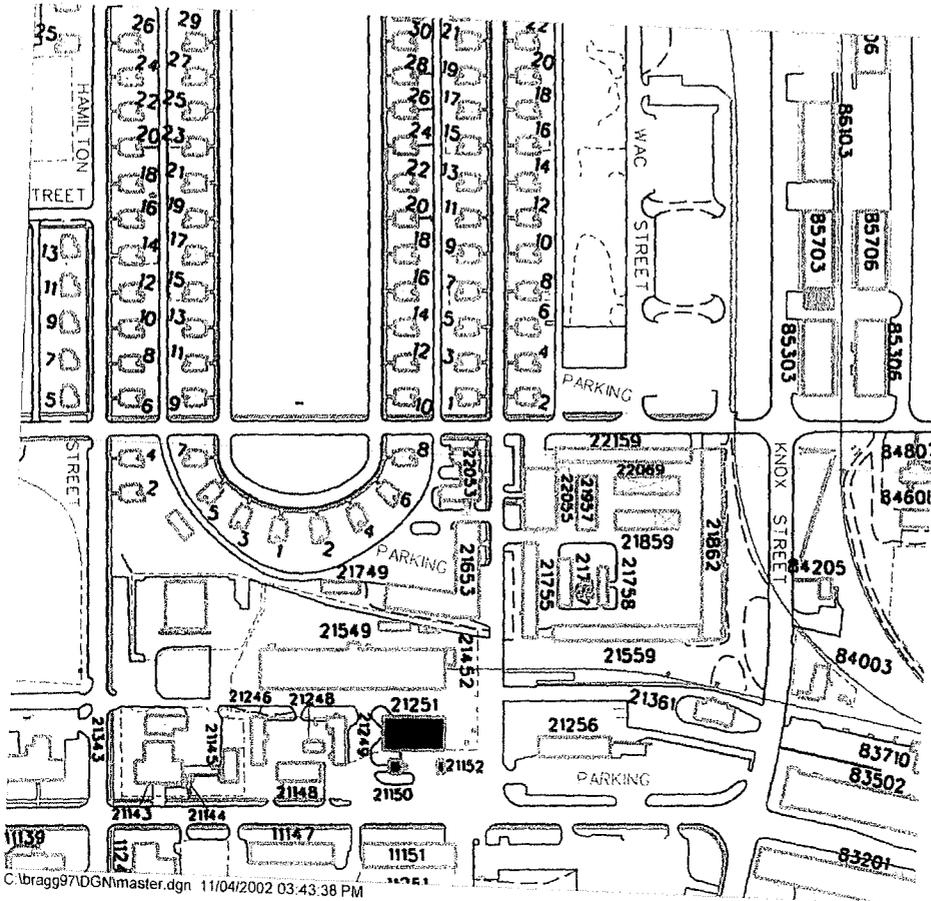
Figure 7: Portion of 2002 cantonment map with buildings marked in black (courtesy PWBC, Fort Bragg).

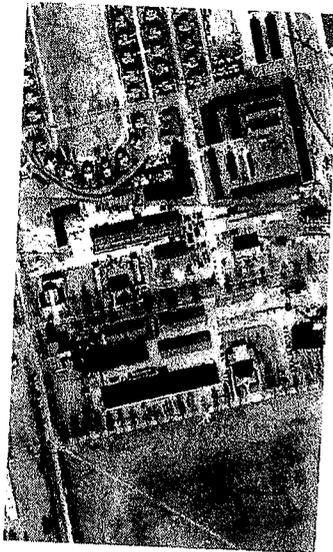
Figure 8: Comparison between the 1959 aerial and 2002 aerial with buildings in center of photographs (courtesy PWBC, Fort Bragg).
