OVERHILLS, POLO BARN
(Building No. 18)
Overhills Historic District
West of Nursery Road & North of Thurman Road
Fort Bragg
Harnett County
North Carolina

HABS
NC-407-K

OVERHILLS, POLO BARN

(Building No. 18)

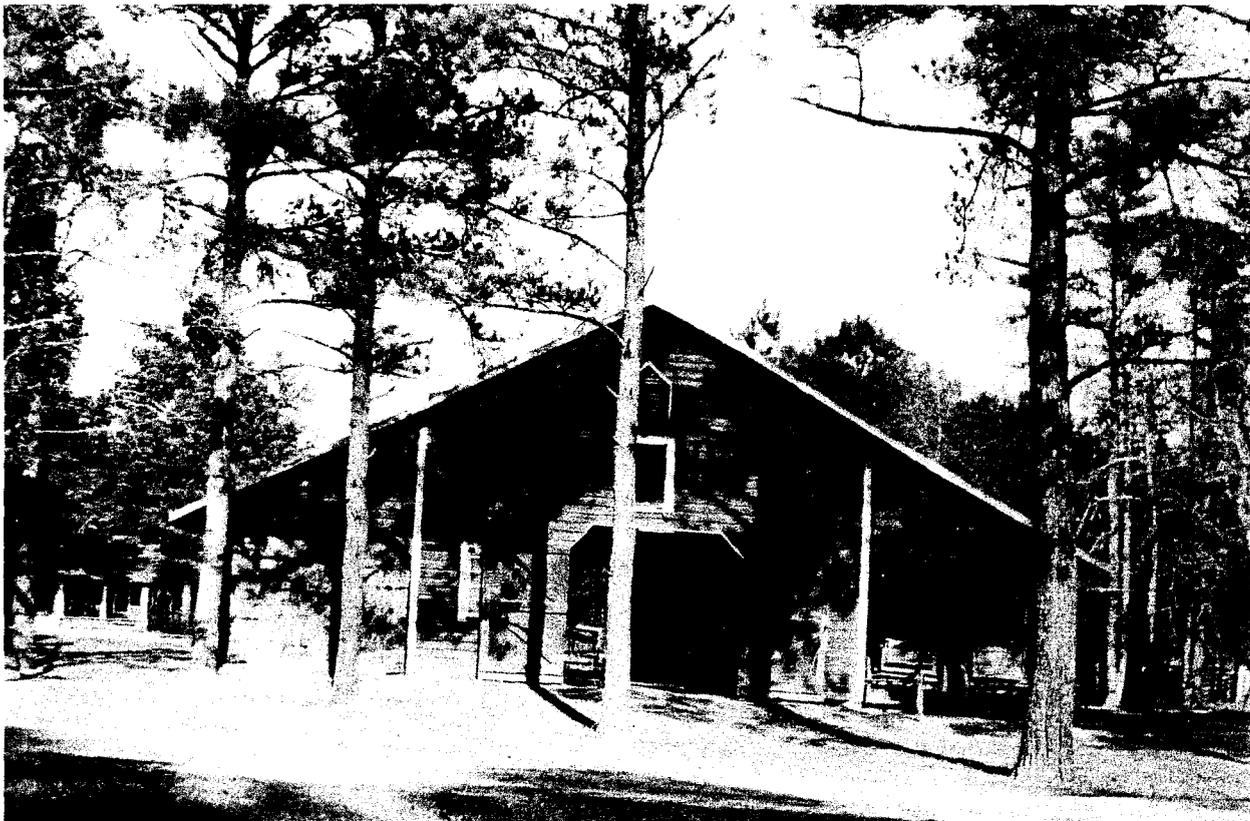
Figure 1: Overhills Hay Barn before renovation into Harriman's Polo Barn Ca. 1920 (courtesy NC SHPO).
