OVERHILLS, CROATAN  
(Building No. 54)  
Overhills Historic District  
West of Thurman Road & East of Overhills golf course  
Fort Bragg  
Harnett County  
North Carolina

# HISTORIC AMERICAN BUILDINGS SURVEY

## OVERHILLS, CROATAN

HABS No. NC-407-AD

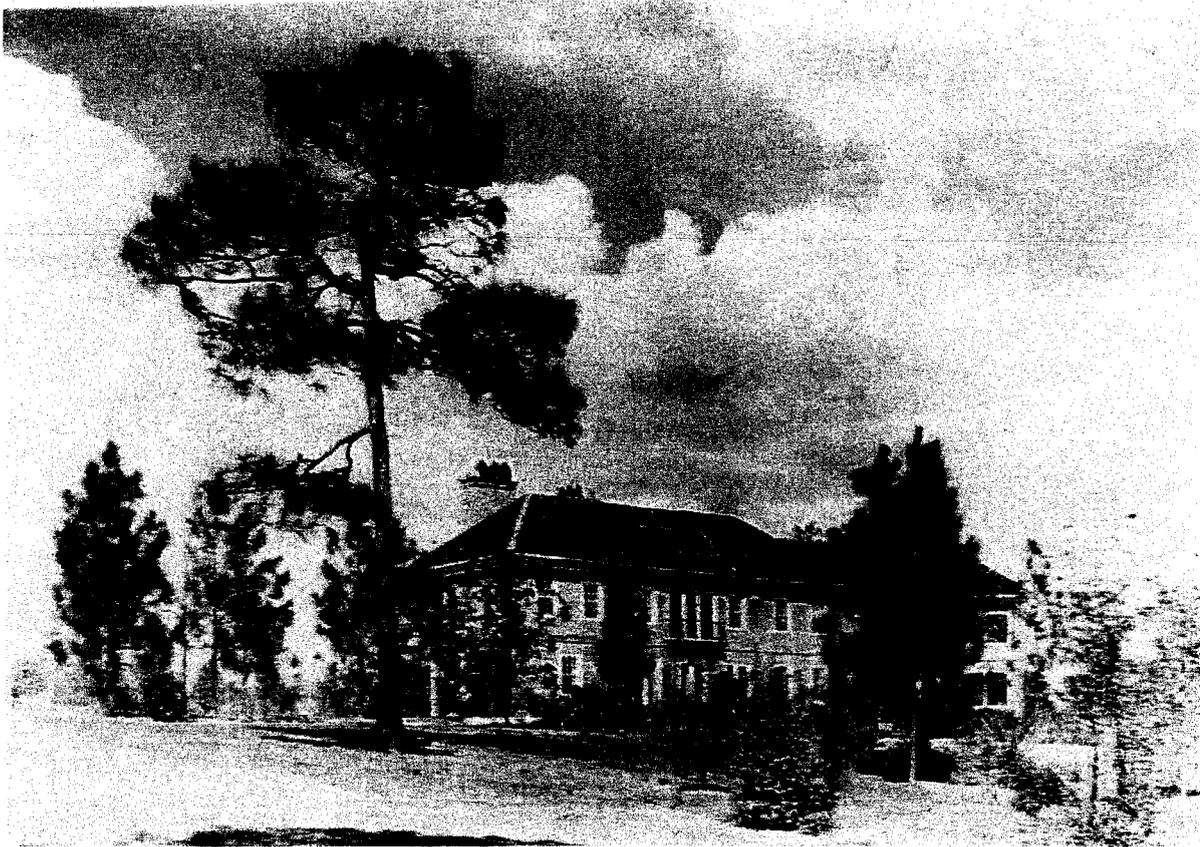
**Figure 1: Croatan view from south showing original sleeping porch on second floor and attic Ca. 1930 (courtesy Fort Bragg Cultural Resources).**
