Sanford Carpet Company, Building 46
(Bigelow-Sanford Carpet Company), Building 46)
South side of Prospect Street
West side of Church Street
Amsterdam
Montgomery County
New York

HABS No. NY-6299-B

HISTORIC AMERICAN BUILDINGS SURVEY
SANFORD CARPET COMPANY, BUILDING 46
(Bigelow-Sanford Carpet Company, Building 46)

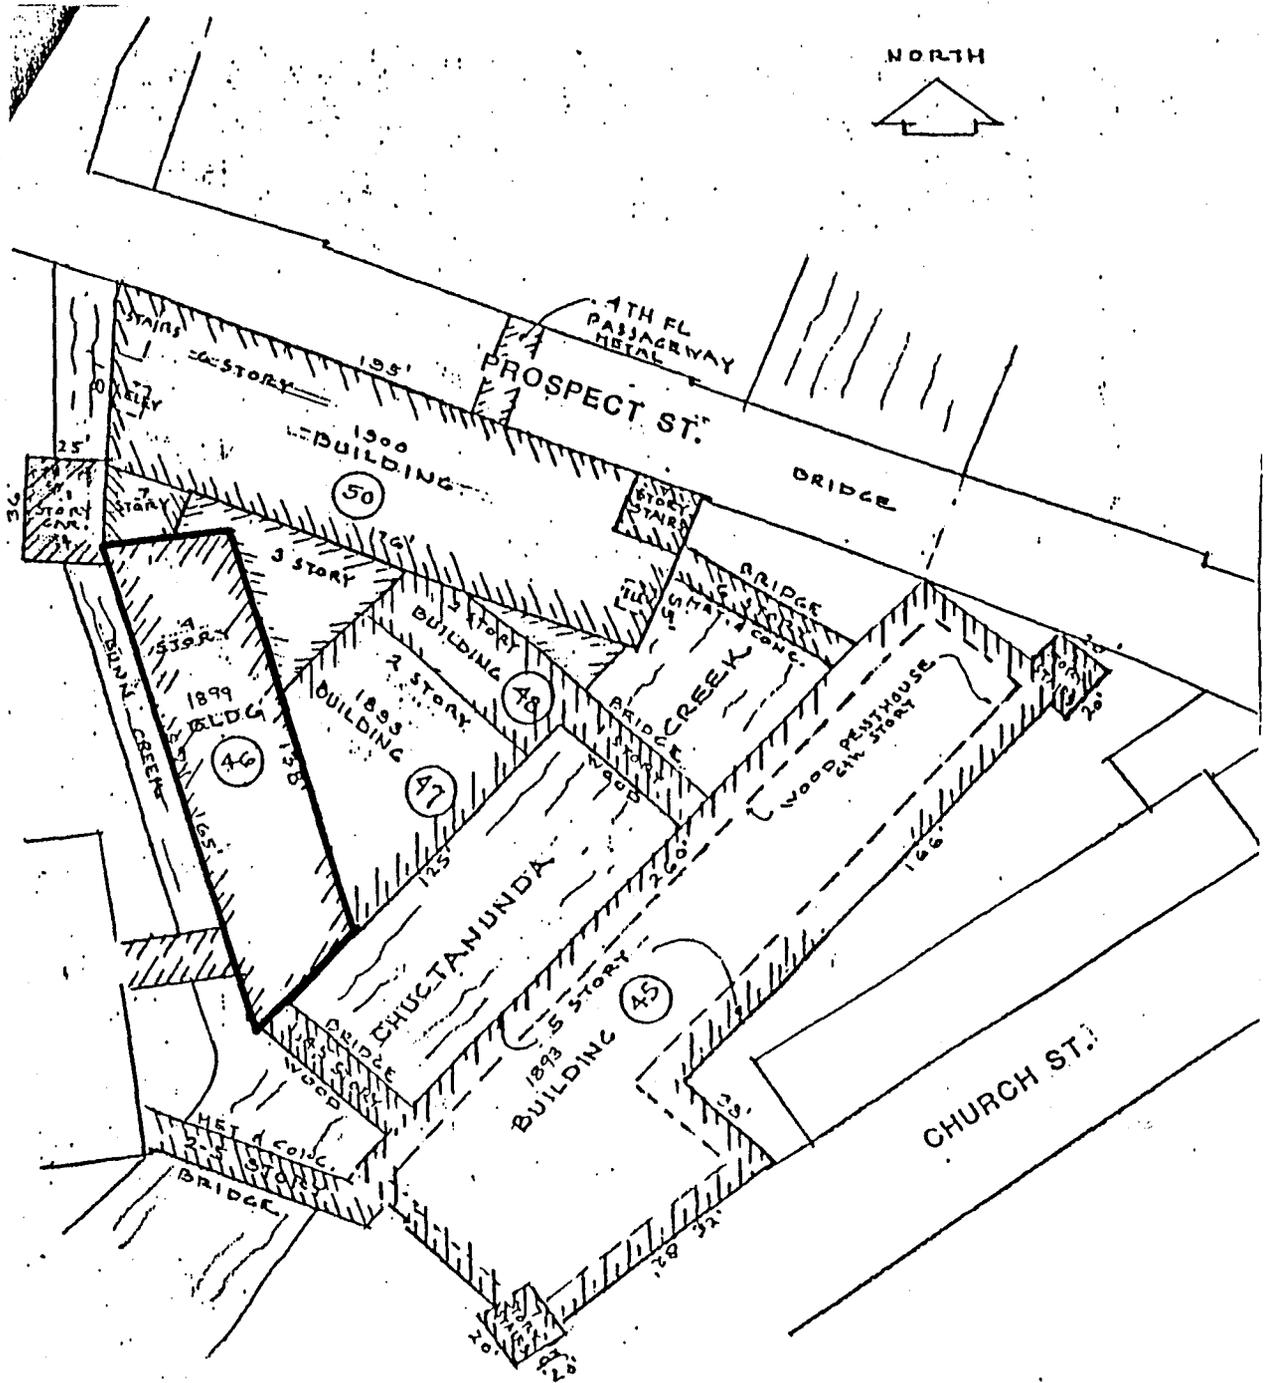
SITE PLAN
SCALE: 1" = 50'

"GROSSMAN PORTION"
BROOKSIDE AREA
SMALL CITIES PROJECT
AMSTERDAM URBAN RENEWAL AGENCY
AMSTERDAM, N.Y.
