NEW YORK STATE BARGE CANAL, LOCK CS1  
(Cayuga-Seneca Canal, Lock CS1)  
6817 River Road  
Cayuga  
Cayuga County  
New York

WRITTEN HISTORICAL AND DESCRIPTIVE DATA

### NEW YORK STATE BARGE CANAL, LOCK CS1 (Cayuga-Seneca Canal, Lock CS1)

#### HAER No. NY-521

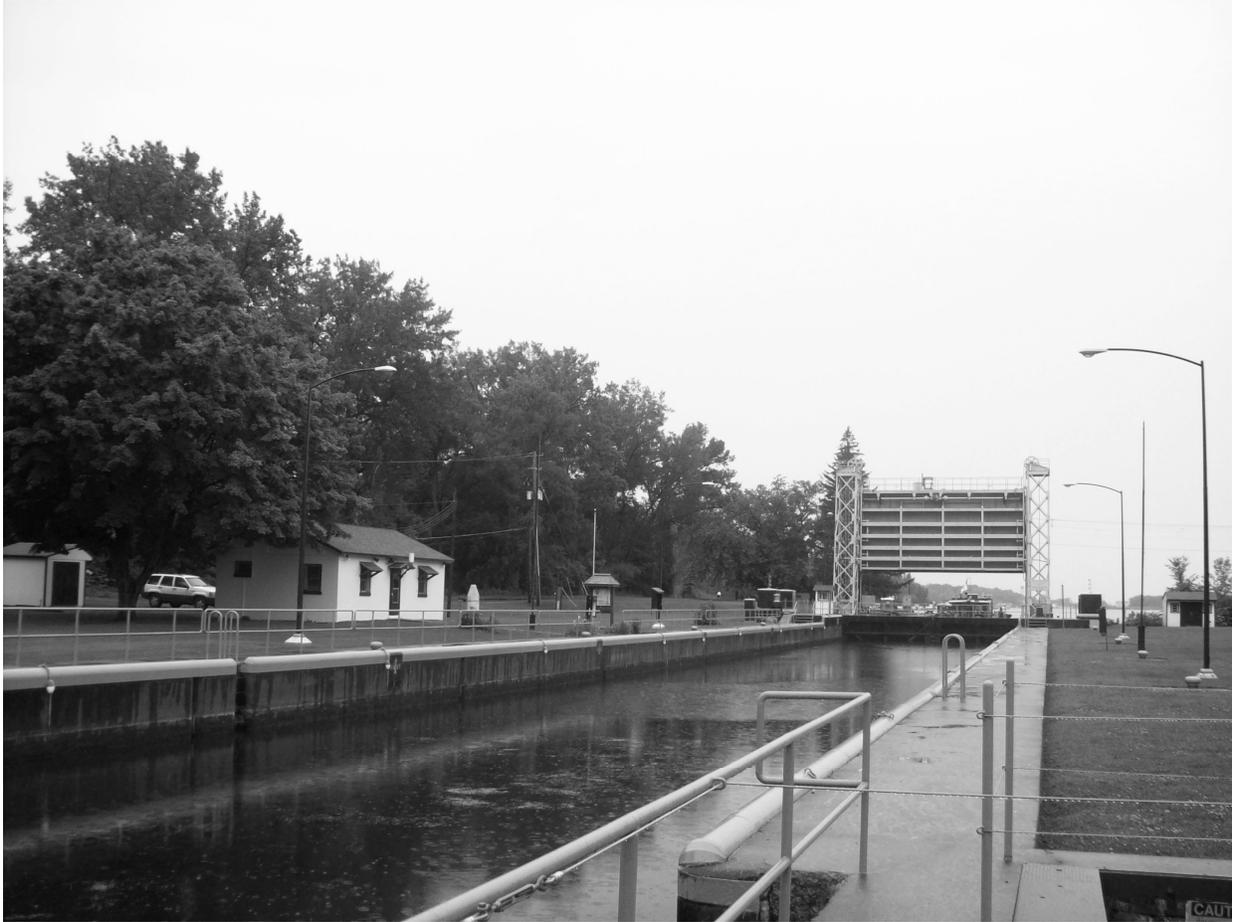
Image 1: Lock overview with lockhouse at left and guard gate at end of chamber. Field photograph taken by HAER recording team, summer 2009.

The lockhouse, centered on the east side of the lock chamber, is a single-story concrete block structure on a concrete foundation. It was built in 1966 on the opposite side of the chamber from

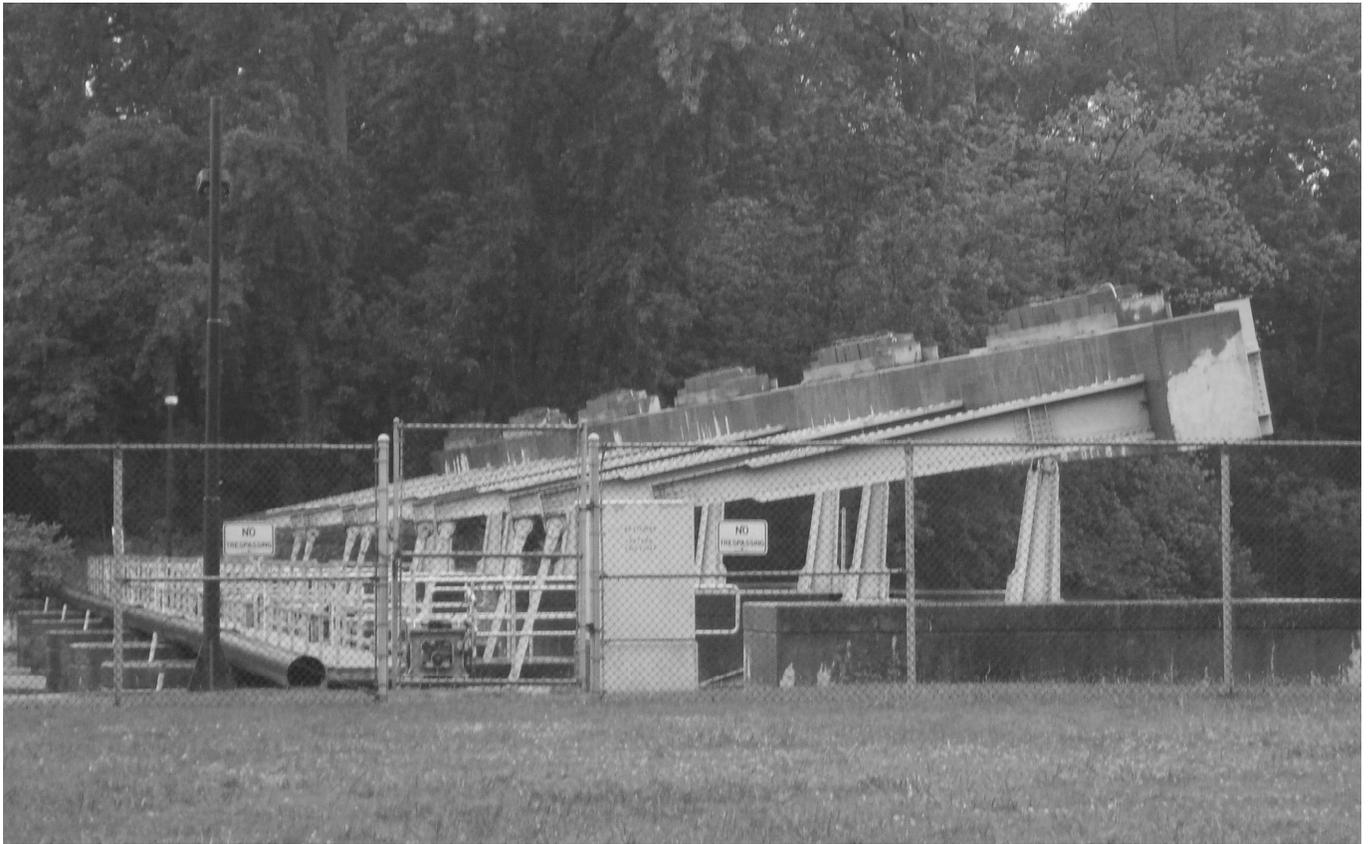
Image 2: Dam with Tainter gates. Field photograph taken by HAER recording team, summer 2009.

The movable dam is located west of the lock. The dam has six Tainter gates with a riveted steel superstructure located between concrete abutments and piers that exhibit signs of spalling and breaking. The gates operate with concrete counterweights. An open-grated catwalk extends the length of the structure. A modern electrical cabinet sits next to the dam. The dam is overall in fair condition, while the concrete abutments and piers are in poor condition.

The dam underwent repairs in 1941 because an “extensive leak” had been found under the concrete sills of Tainter gates 1 and 2. To fix the problem, a new concrete apron was poured extending about 3' deep and 15' beyond the existing sill. The dam was again rehabilitated in 1990 under Contract D252322.<sup>11</sup>
