NEW YORK STATE BARGE CANAL, LOCKS CS2 AND CS3  
(Cayuga-Seneca Canal, Locks CS2 and CS3)  
Seneca Street  
Seneca Falls  
Seneca County  
New York

HAER NY-522  
*HAER NY-522*

### NEW YORK STATE BARGE CANAL, LOCKS CS2 AND CS3 (Cayuga-Seneca Canal, Locks CS2 and CS3)

HAER No. NY-522

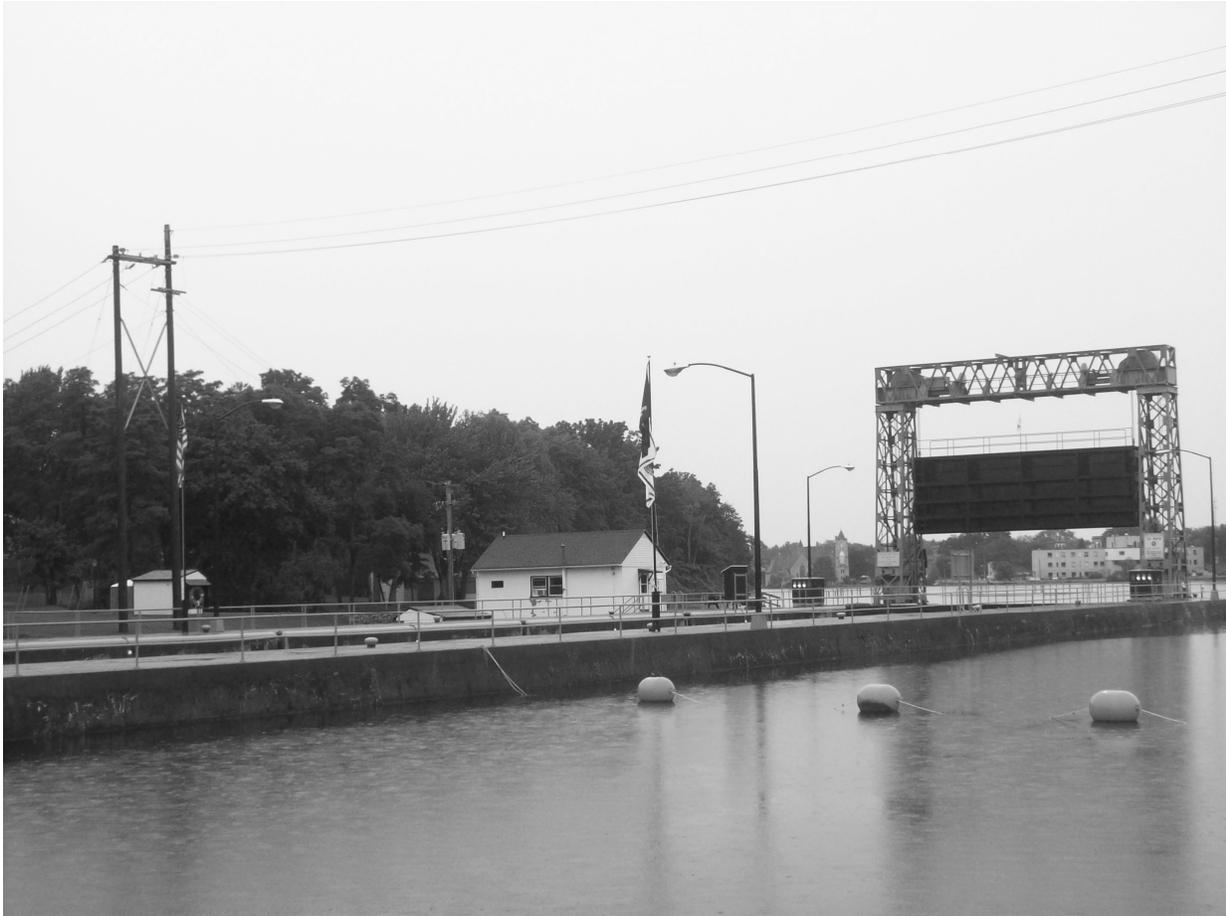
Image 1: Lockhouse and guard gate. Field photograph taken by HAER recording team, summer 2009.

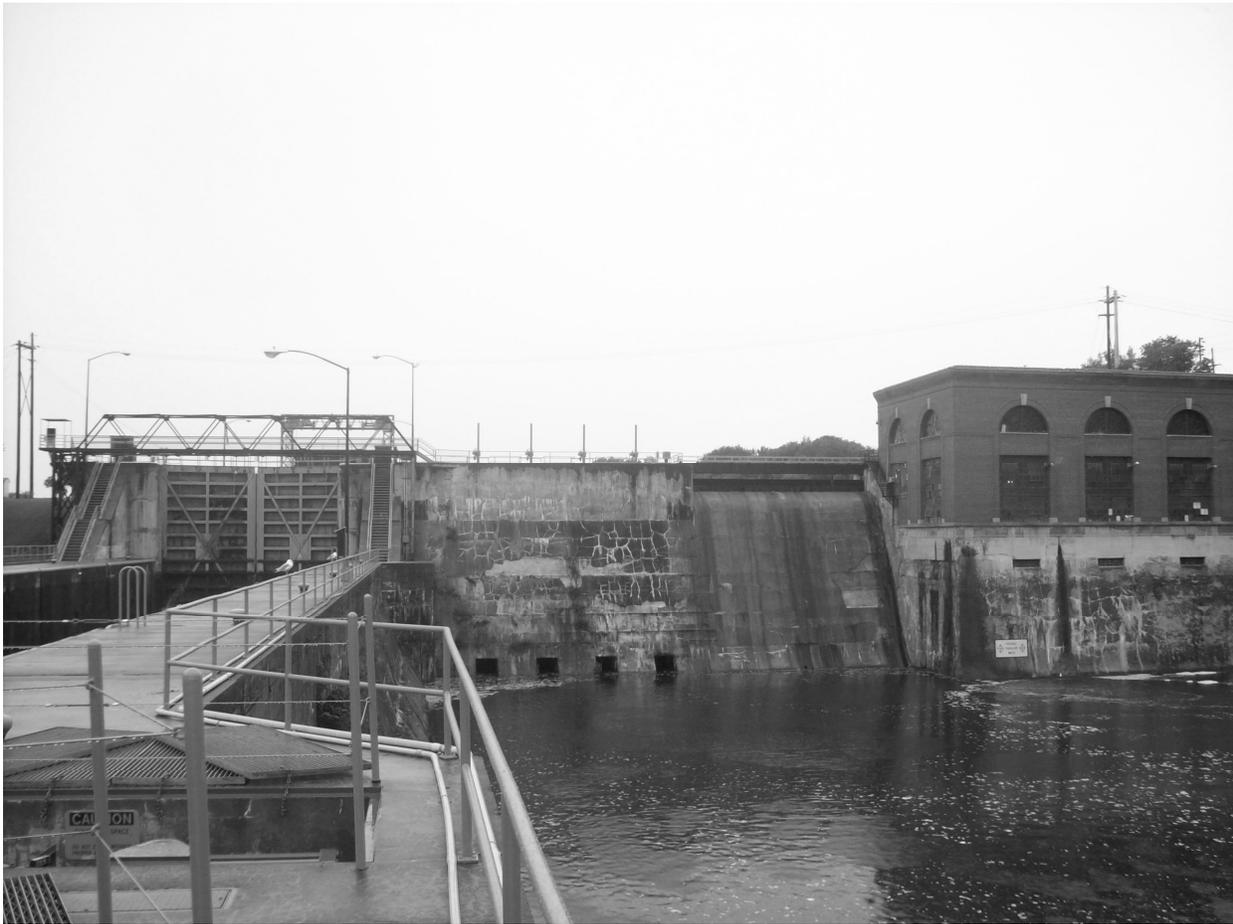
Image 2: View of dam with lock at left, and sluice gates, spillway, and hydroelectric power plant at right. Field photograph taken by HAER recording team, summer 2009.

Dam 2 extends across the Seneca River and consists of (from south to north) four sluice gates, a concrete spillway, and a privately-owned hydroelectric plant. The four sluice gates are located adjacent to the lock chambers on the former powerhouse site. The sluice gates have steel floor stands. The approximately 50' spillway is equipped with Obermayer gates, made up of hinged steel panels with inflatable rubber bladders. The spillway's concrete apron exhibits spalling and breaking, so the dam is in overall fair condition.
