HERSHBERGER FARM, OUTBUILDING
.4 mile east of Business Route 220,
.35 mile southeast of Cessna
Cessna Vicinity
Bedford County
Pennsylvania

HABS No. PA-5392-C

HERSHBERGER FARM, OUTBUILDING HABS No. PA-5392-C

Significance: Like the adjacent farmhouse, this brick-nogged frame outbuilding was built ca. 1820 by one of the German farmers who settled this region. Originally a dwelling, it offers potentially unique opportunities to document methods of construction and finishing details of a traditional house of this time and place.

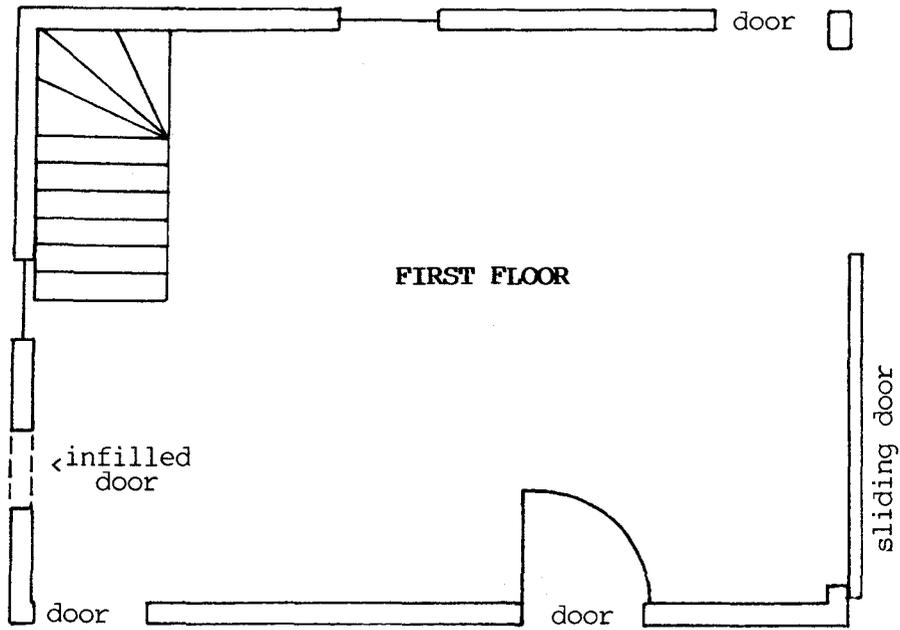
FLOOR PLAN

HERSHBERGER OUTBUILDING

1. Floor plans: The basement and first floor of the building are single rooms. The second floor is divided by a partition (parallel with the gable ends) into two rooms of almost equal size. See the attached sketch plans and Photographs #PA-5392-C-3 and #PA-5392-C-4.
2. Stairways: Winder stairs which turn 90° are located in the northeast corner of the building. They are enclosed with beaded tongue-and-groove pine paneling, some of which has been replaced with narrow tongue-and-groove wainscoting material. There are no cellar stairs; access is by two stone steps to an outside door.
3. Flooring: Debris covering the floors of this building makes observation difficult. They appear to be random-width pine, laid parallel to the roof ridge. The first floor is laid on log joists, 7-8" wide, hewn top and bottom (see Photograph #PA-5392-C-4). The second floor
