CEDAR PASS LODGE, CABIN 9  
Badlands National Park  
20681 South Dakota Highway 240  
Interior  
Jackson County  
South Dakota

HABS SD-25-H  
*HABS SD-25-H*

### CEDAR PASS LODGE, CABIN 9

HABS No. SD-25-H

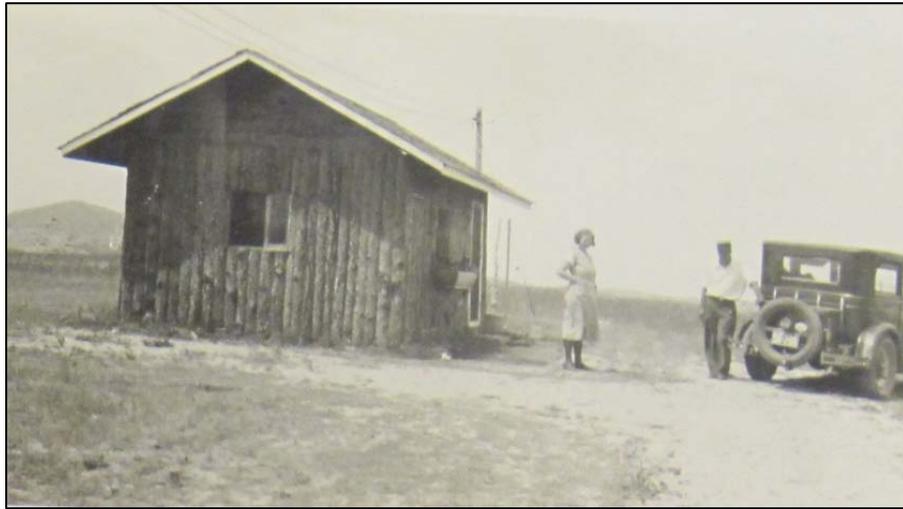
Figure 1: Cabin, Cedar Pass Camp, c. 1935.  
Source: Mary (nee Allburn) Aggergaard Scrapbook, BADL Archives.

3. Builder, contractor, suppliers: Unknown.
4. Original plans and construction: This small tourist cabin was probably built with a square footprint and side gable roof (Figure 1). This form is still clearly visible. Early wood sash slider windows are still extant.

B. Early Views: A cabin similar to Cabin 9 appears in a c. 1935 photograph, showing the wood timber sheathing and original windows (see Figure 1). Views from the 1960s show alteration of the exterior with stucco (Figures 2, 3, and 4).

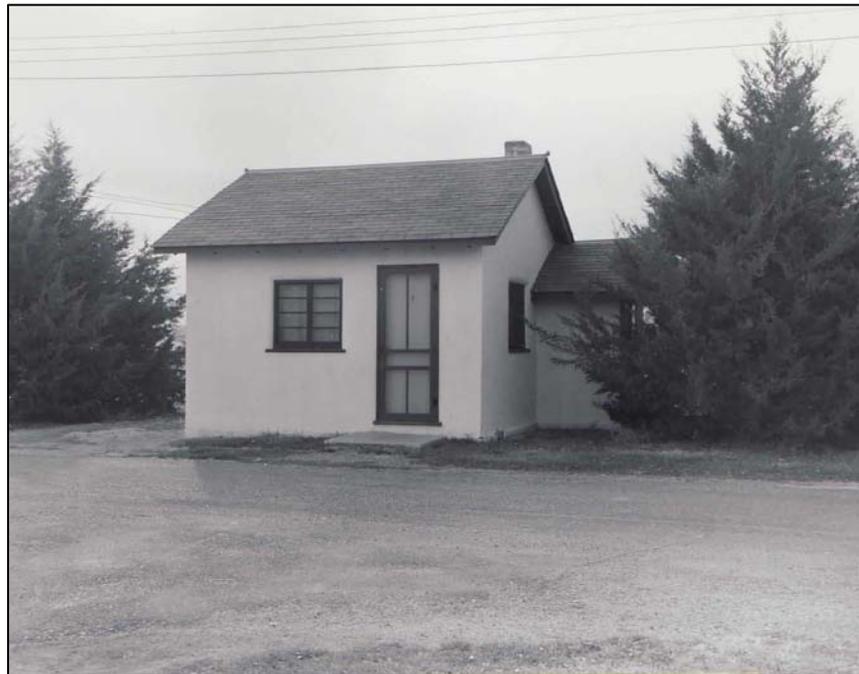
Figure 2: Cabin 9 (November 1965).  
Source: "Concessions Buildings, Badlands," (19 November 1965), Box 830, Entry P 11, RG 79, NARA II.

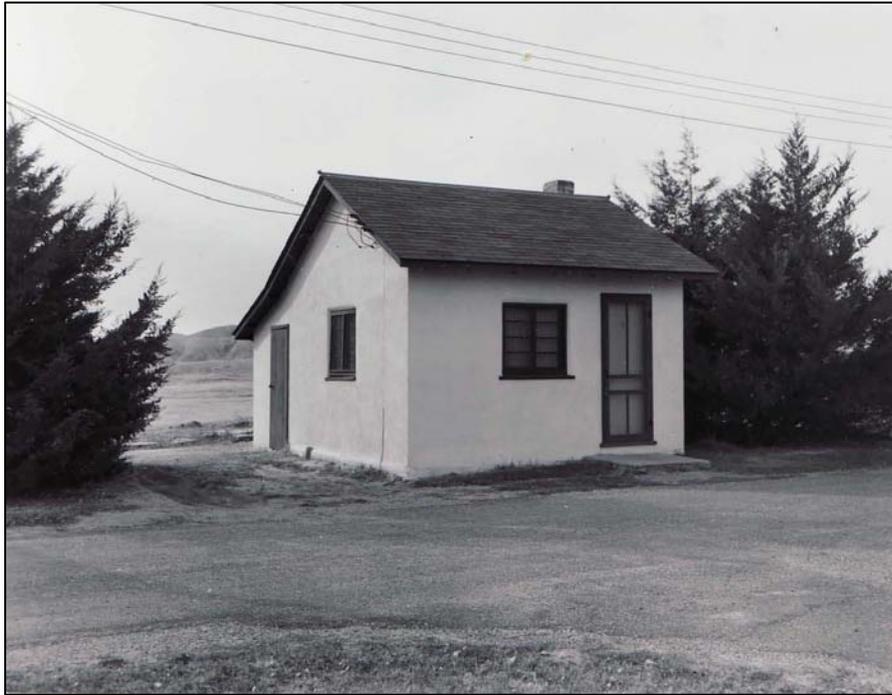
Figure 3: Cabin 9 (November 1965).

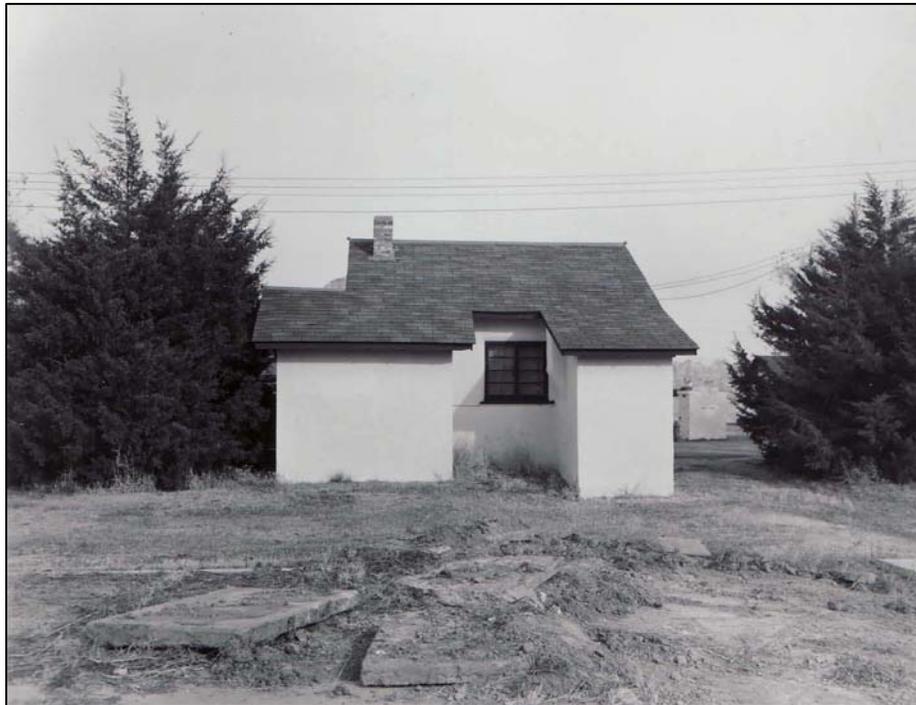
Figure 4: Cabin 9 from Rear (November 1965).
