Naval Air Station Dallas,
Assembly and Repair Hangar
(Naval Air Station Dallas,
Building 21)
Enterprise Drive
Dallas
Dallas County
Texas

HABS No. TX-3408-F

PHOTOGRAPHS
WRITTEN HISTORICAL AND DESCRIPTIVE DATA
MEASURED DRAWINGS

HISTORIC AMERICAN BUILDINGS SURVEY
NAVAL AIR STATION DALLAS,
ASSEMBLY AND REPAIR HANGAR
(NAVAL AIR STATION DALLAS, BUILDING 21)

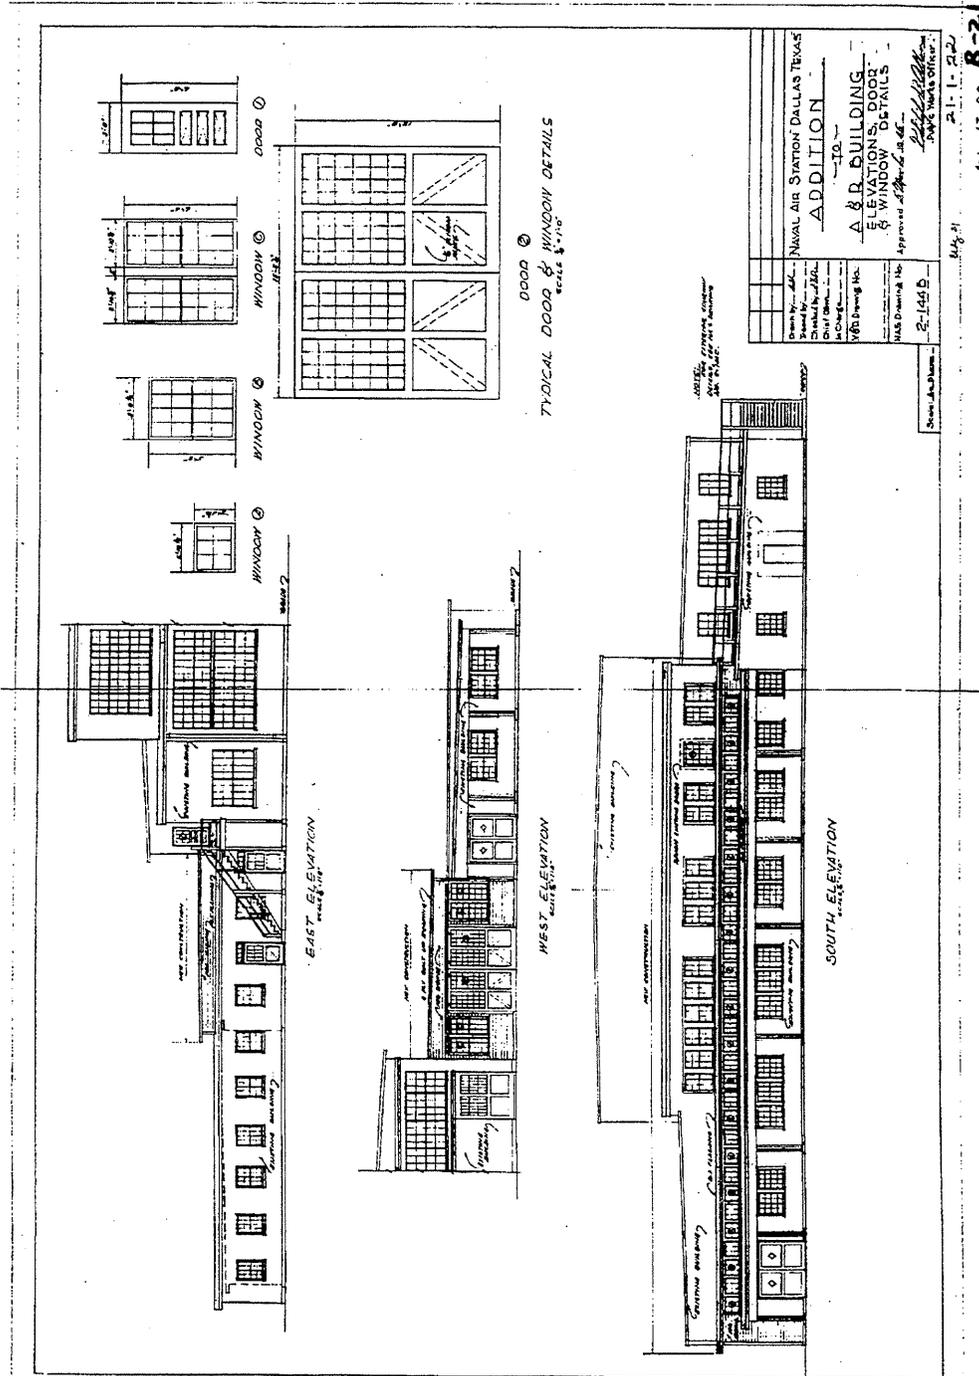
NAVAL AIR STATION DALLAS TEXAS
 ADDITION
 A & R BUILDING
 ELEVATIONS, DOOR
 & WINDOW DETAILS
 Approved by [Signature]
 Date: 1-1-48
 W.B. Dwyer, Inc.
 M.S. Drawing No. 2-145 D
 Show [Signature]

A. Original architectural drawings: The original plans for the building were not located during research efforts. However, reproductions of an incomplete set of architectural drawings from the 1943 alterations are on file at the Public Works Department, NAS Dallas. These drawings list Moore, Cooper, White & Moore, Architects and Engineers, Houston, Texas, as the architects of record, and E .S. White as the architect in charge. Available plans include floor plans, sections, elevations of all but the north facade, and a foundation plan. Two drawings from 1945 generated by the Public Works Department at the base show plans for the construction of the second floor at the rear of the hangar. General information about repairs made to the building in 1971 are indicated on an elevation drawing generated by the Department of the Navy, Naval Facilities Engineering Command in 1971, and plans from the construction of an interior office in 1979 also are found in the Public Works Department at NAS Dallas. No decision has been made as to where the drawings will be moved when the base closes.
