FORT HILL FARM, Mansion

HABS NO. VA-1288-A

LOCATION: West of the Staunton (Roanoke) River between
Turkey Run and Caesar's Run, Clover Vicinity,
Halifax County, Virginia

STATEMENT OF
SIGNIFICANCE: The Fort Hill Mansion is an example of a post-
bellum, rural "manor," built circa 1880 for John,
eldest son of William H. Sims of Black Walnut Farm.
The house displays the stylistic influences of both
Italianate and Greek Revival architecture, as well
as a regionally traditional high-ceilinged, center-
hall, single-pile plan.

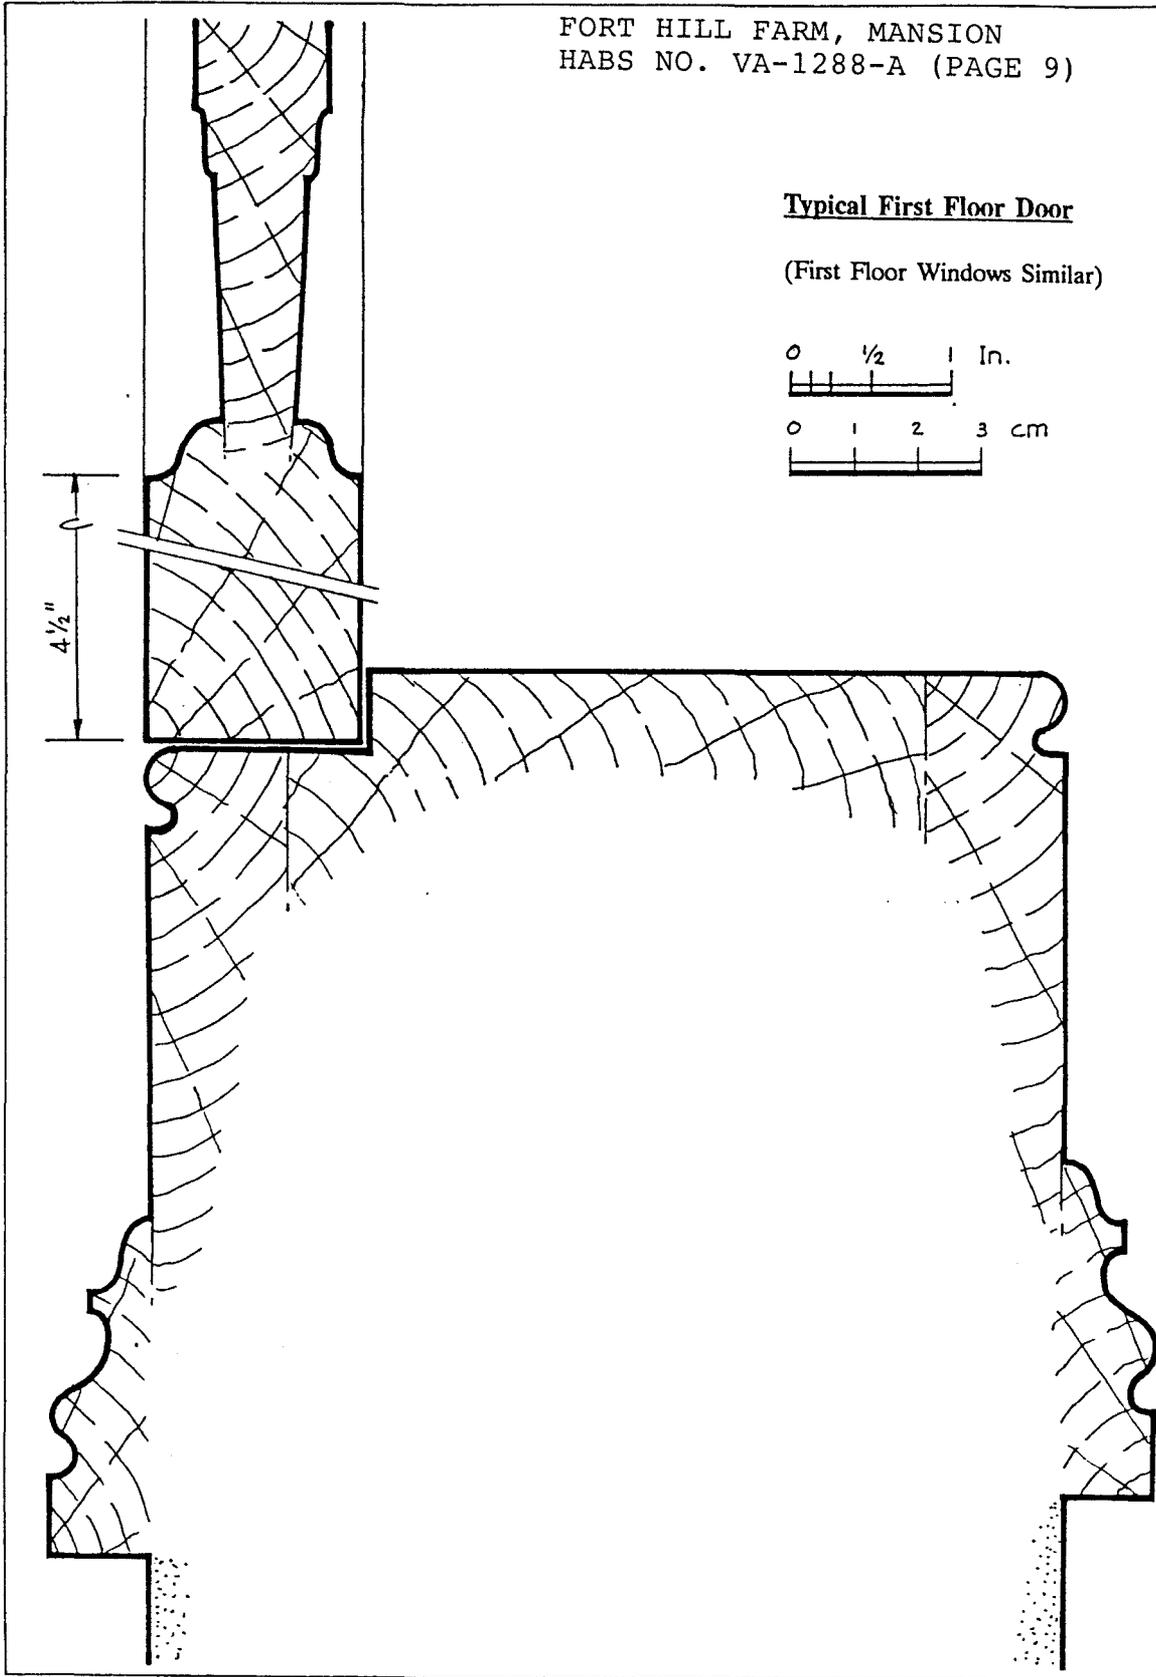
Typical First Floor Door

(First Floor Windows Similar)

a. Doorways and Doors: Treatment of these features is consistent throughout the house. Openings are framed with surrounds with slightly peaked, shouldered hoods. Doors have four raised panels edged with decorative moldings. Most are stained, the panels dark reddish-brown and the stiles and rails dark brown. Most doors are fitted with iron box locks, and several retain brown or white porcelain knobs.

b. Windows: Windows are set in slightly peaked, shouldered surrounds, and all of the first floor windows, except the full length front windows, have panels edged with decorative moldings below the sills. Many of the window surrounds are also stained in two tones, the moldings and sills a dark reddish-brown and the surrounds dark brown. The windows of the southern addition are simpler, set in plain surrounds with slightly peaked heads and no panels below the sill. Isolated panes of crown glass are found in windows throughout the house.

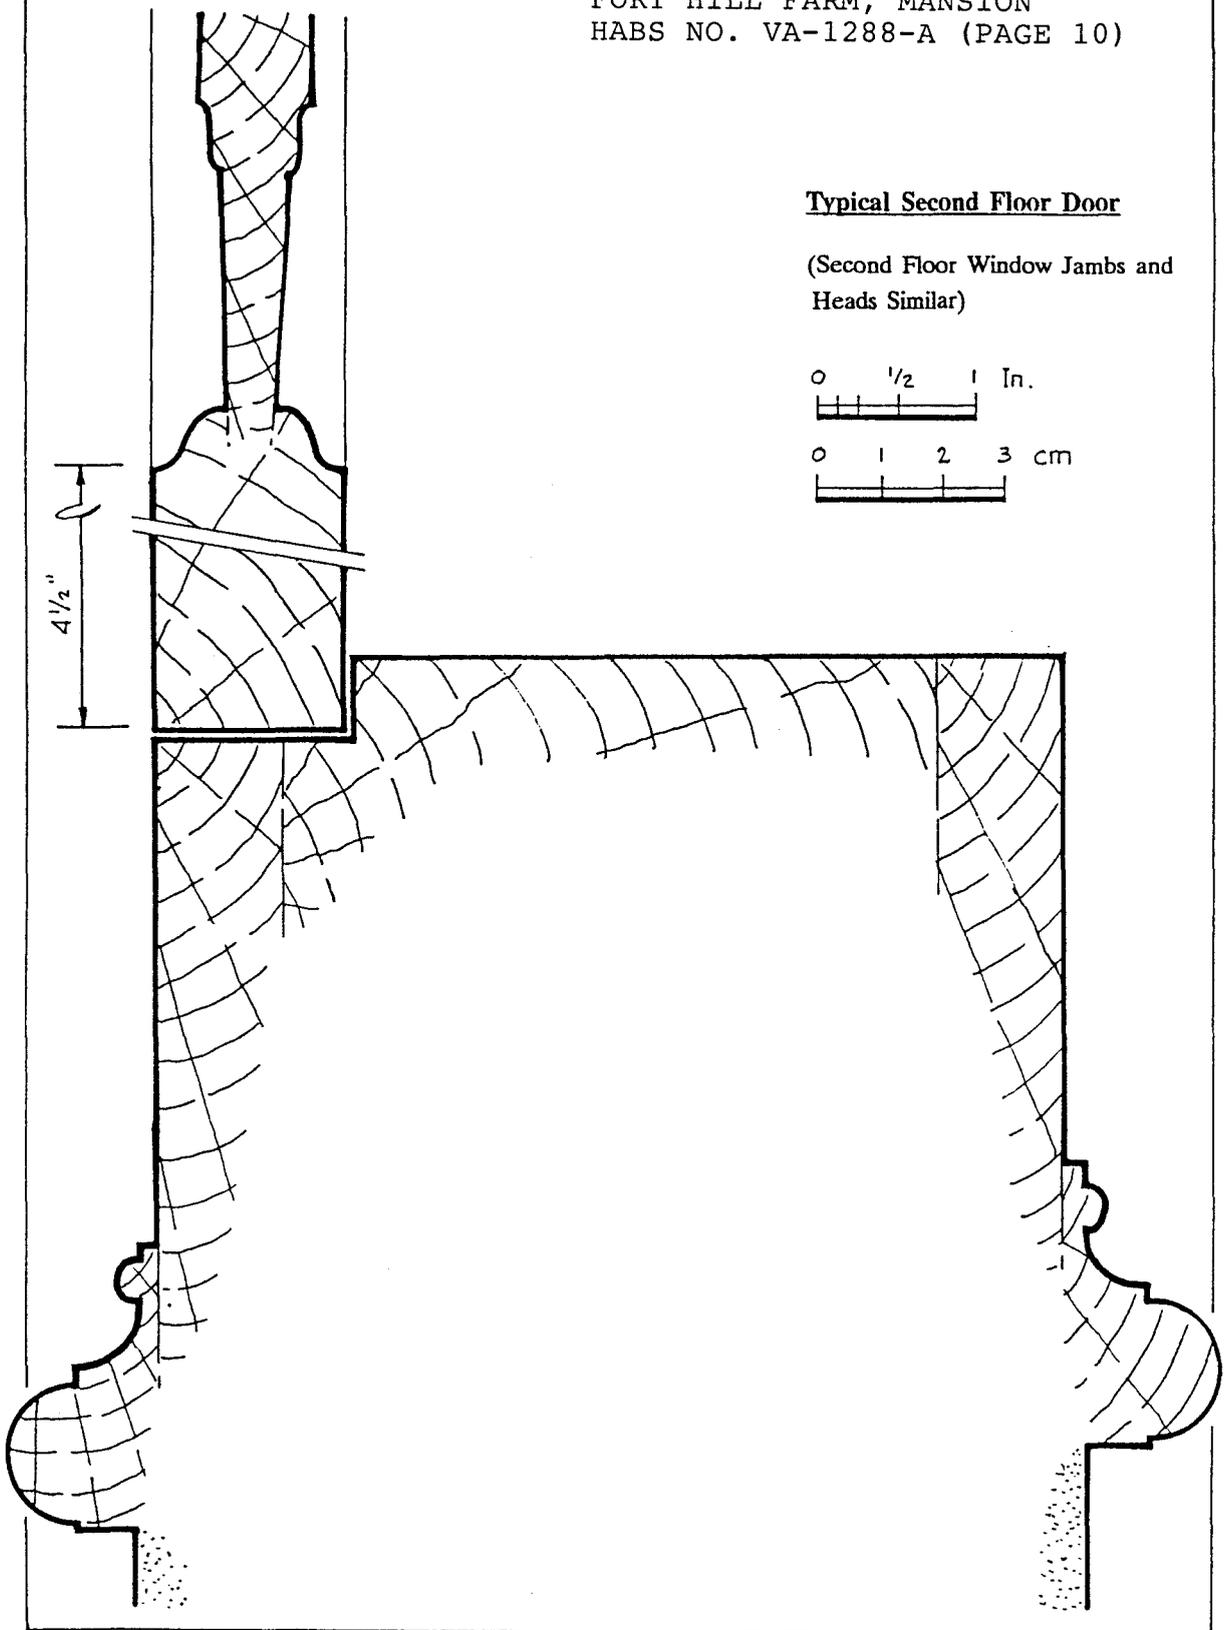
Typical Second Floor Door

(Second Floor Window Jambs and
Heads Similar)
