PAGE'S STORE
Albemarle County Country Stores Survey
Intersection of Route 692 & Route 635
Batesville
Albemarle County
Virginia

HABS No. VA-1383

PAGE'S STORE

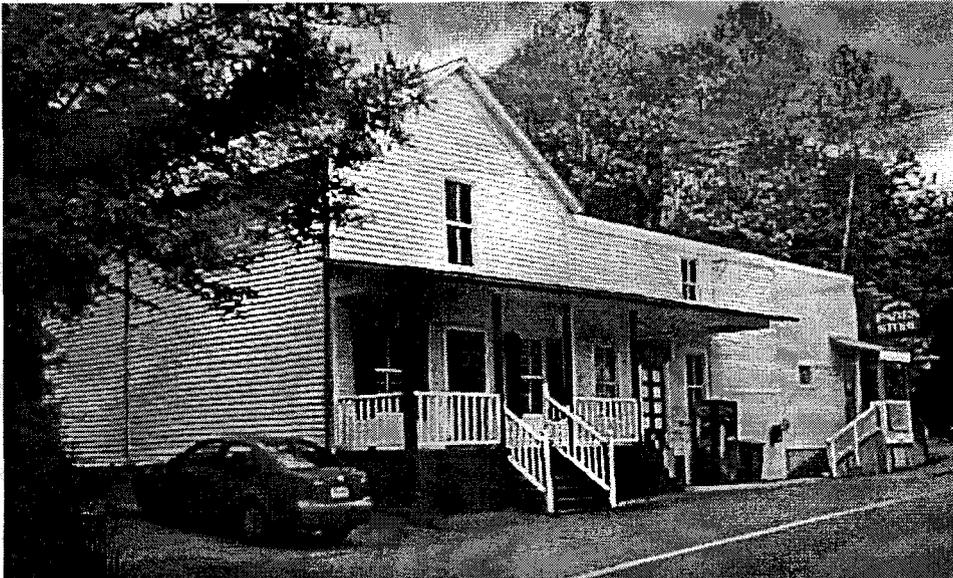
Figure 1. The front facade of the building, seen from the southwest.

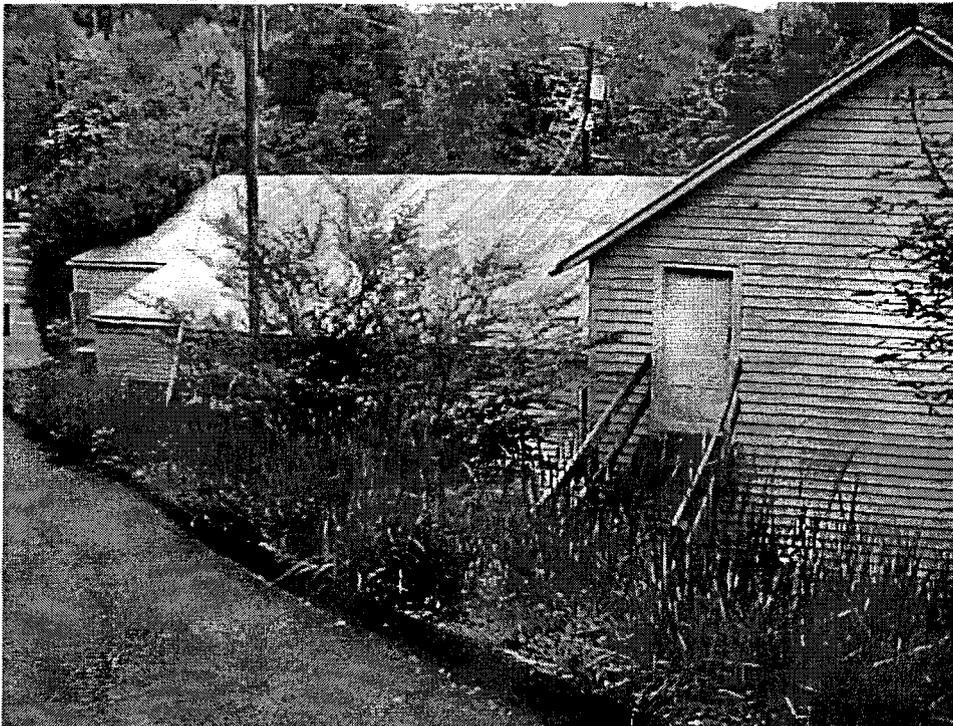
Figure 2. The rear of the structure. On the right is the footbridge and door the second story of Section A. The jog in the standing seam metal shed roof indicated the location of Section D.

north of this door is a small fixed six-light window. The only opening in the rear of the structure is a solid wood door that provides access to the second floor (fig. 2). This is reached by a footbridge that runs between the building and hillside road to the north of the structure. The eastern elevation of the building has a solid wood door at its northern end. There is a brick chimney in the northern portion of the ridgeline (fig. 5).

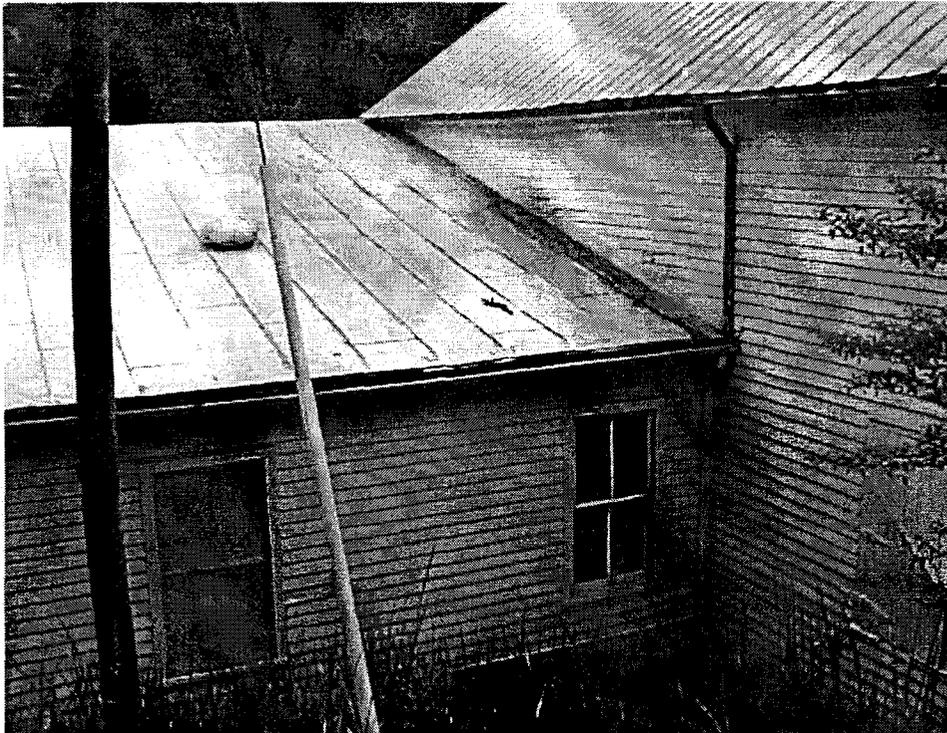
Figure 3. The joint between Section A and B on the northern elevation.

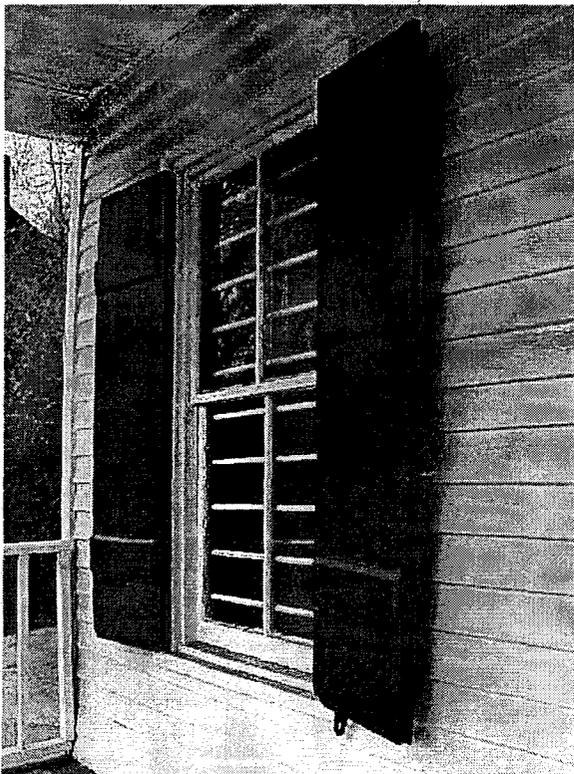
Figure 4. An original two-over-two wooden sash window flanked by shutters. This window is from the southern elevation of Section A.

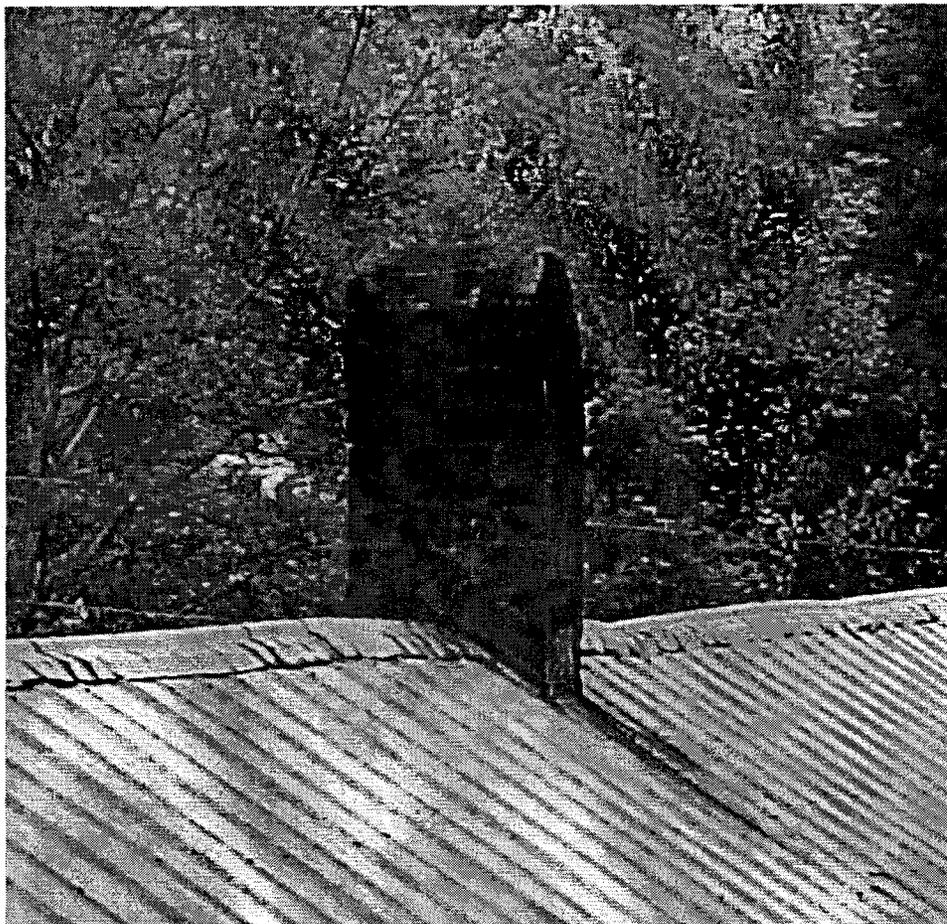
Figure 5. The brick chimney on the ridgeline of Section A.

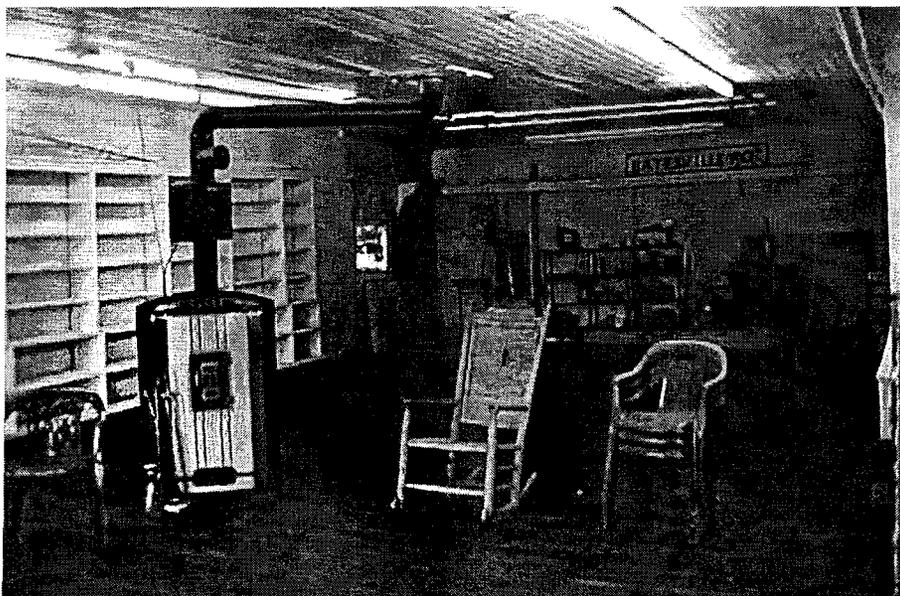
Figure 6. The interior of Section A, looking to the north.

Section A is long and narrow; a partition wall between Section A and B divides the interior into two distinct but connected rooms. The eastern and western walls are both lined with shelving that was used to house shop goods. There is a single shelf on the northern wall, just below the ceiling. The interior walls and ceiling of Section A are sheathed in beaded boards (fig. 6). The floor is made of wood planks and the boards run parallel to the short side of the structure.

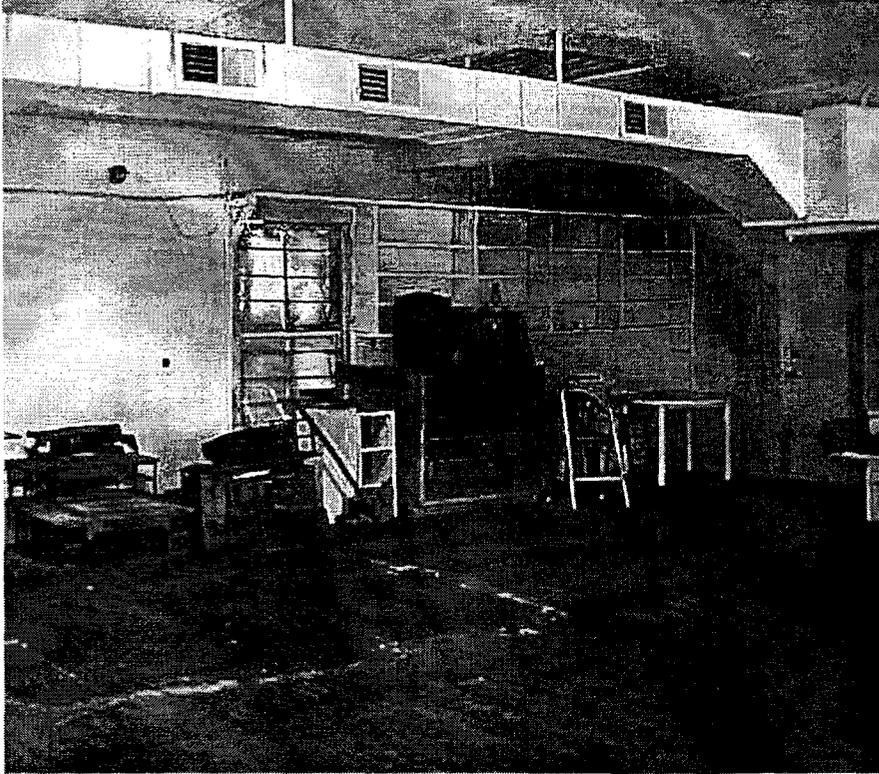
Figure 7. The interior of Sections B and C looking to the northeast.

Sections B and C read as one room on the interior (fig. 7). Here the true period-one becomes most clear. The west interior wall of Section B is sheathed in wood weatherboards, in the same manner as the exterior. It is clear that this is the original exterior cladding of the Section A portion of the store and that the later additions were simply butted against the original structure. The remaining walls in Section B are sheathed in wood planks. The floor is made of hardwood, but the boards run perpendicular to those in Section A. The ceiling has been covered with drywall. HVAC ductwork and fluorescent lighting have been added to the ceiling as well. Section B is categorized as period-two because of its position adjacent to - but butted against rather than incorporated into - Section A.

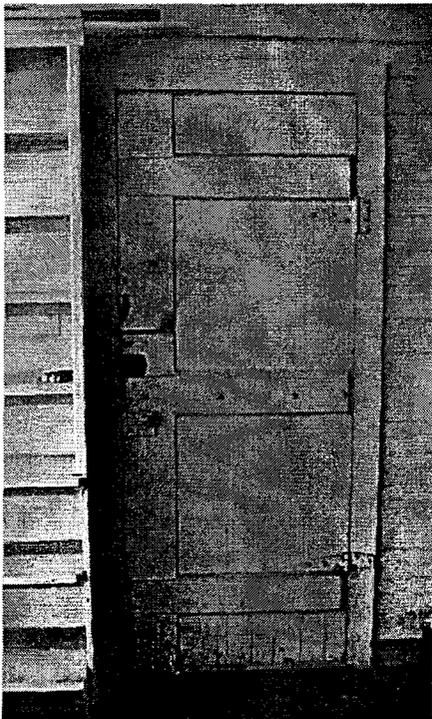
Figure 8. The interior of the door in the western wall of Section A.

The western end of the building is the short leg (called Section A here). It is a two-story, three bay, gable-roofed mass. The gable end faces the street. A one-story, three bay porch with a shed roof stretches across the entire facade of this portion of the structure. The porch is reached by a set of seven concrete steps that run perpendicular to the building. The posts, railings, and balusters of the porch are made of wood. The posts and balusters are square, but the newel post is turned. The first floor wall is pierced by a door (solid wood) flanked by sash windows glazed with two-over-two lights. Both windows have wood shutters. On the second story, there is one sash window, also glazed with two-over-two lights, centered in the gable end. The western side of this portion of the structure has a solid wood door near its northern end (fig. 8). Just to the
