312 YELLOW MOUNTAIN ROAD (HOUSE)  
(Rose Hill Farm)

HABS No. VA-1389

WRITTEN HISTORICAL AND DESCRIPTIVE DATA

# HISTORIC AMERICAN BUILDINGS SURVEY

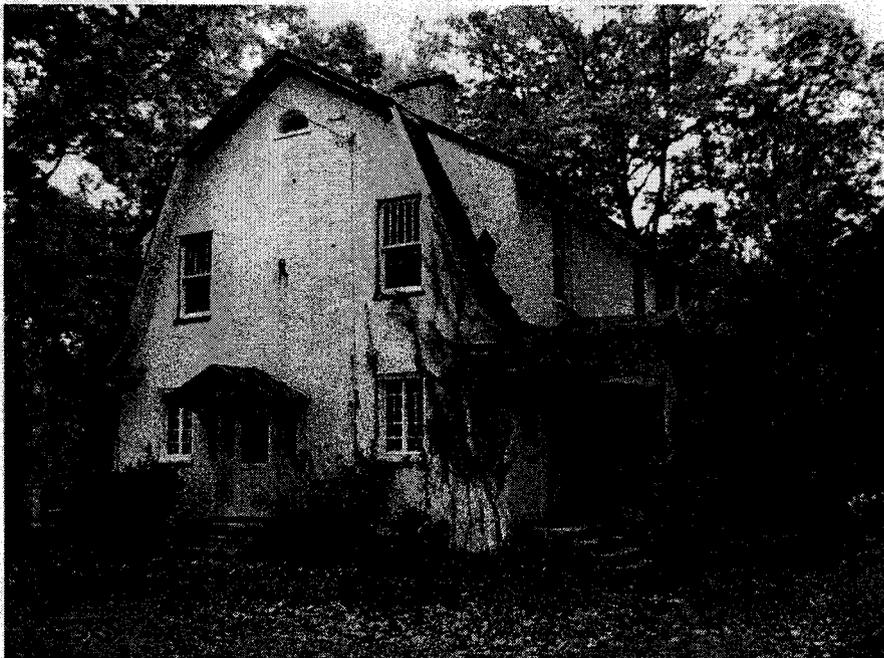
Figure 1: Eastern and Northern Facades.

**Exterior:** The house site is located at the top of a small wooded hill. The house is built in a picturesque Dutch Colonial Revival-style, having a gambrel roof covered in asphalt shingles. The gable ends of the house face east and west and show three stories of the house. The east facade is the main entrance to the house. The entry is placed slightly to the left of center, marked by a concrete stoop and a small gable roof. The east facade has two windows on the first floor, two on the second, and a lunette on the third. The south facade has a porch supported by four posts. It provides access to the interior through a pair of French doors with sidelights. French doors also lead to the roof of the porch from the second floor. The south facade is the most elaborate and symmetrical of the four facades. The west facade has no doors but has two types of windows. On the right, four windows are placed directly next to each other, separated only by casing. On the left, a bay window extends from the house by about 1 ½'. The final (north) facade has a small gabled porch at the extreme left. This roof covers a concrete pad that leads to an entrance to the first floor and a concrete stairway that leads to the basement. The right portion of the roof covers a one-story protrusion from the house. The north facade has four windows on the first floor and four on the second. (Figs. 1-4)

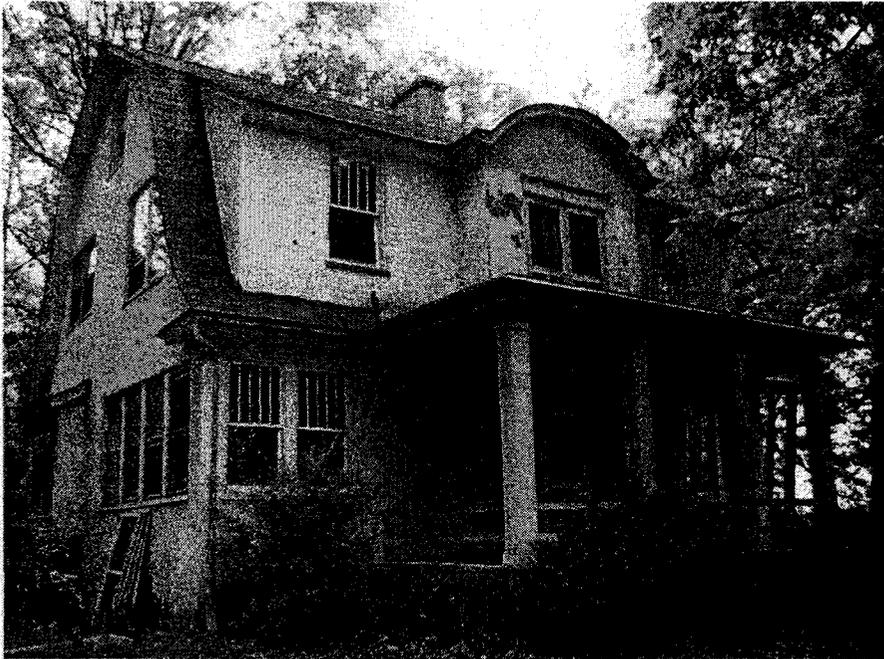
Figure 2: Western and Southern Facades.

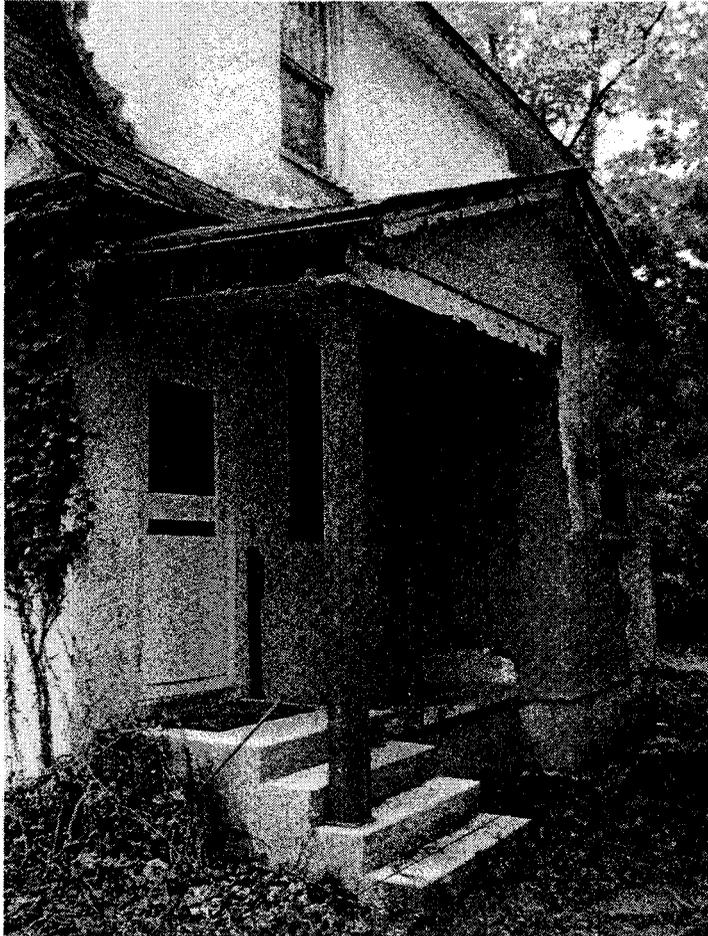
Figure 3: Northern façade detail showing second phase bathroom addition, kitchen entry porch, and exterior basement stairs.

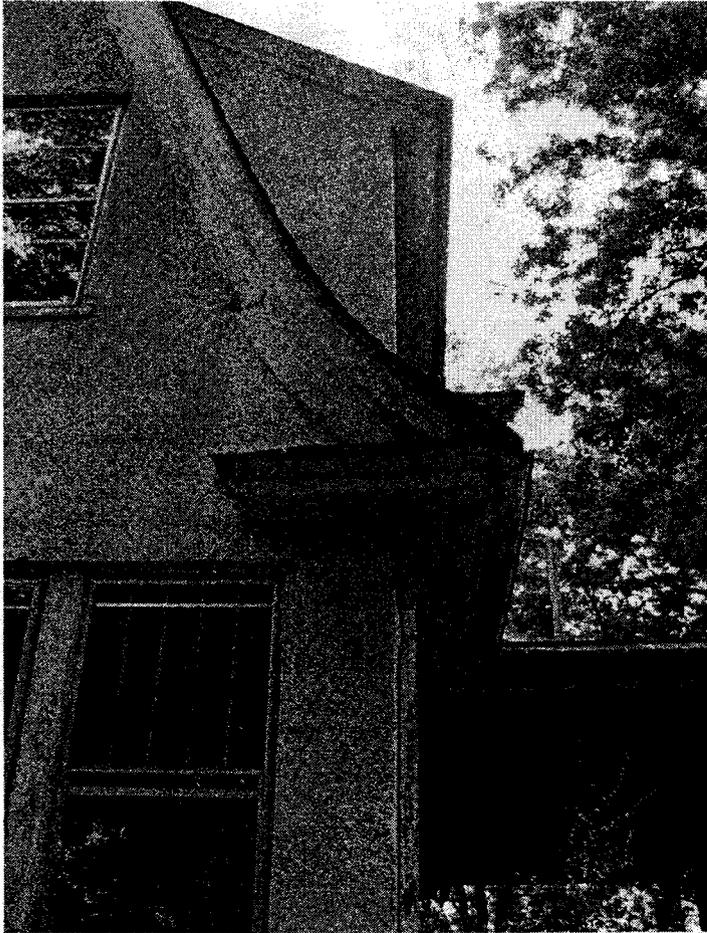
Figure 4: Southwestern corner eave detail.

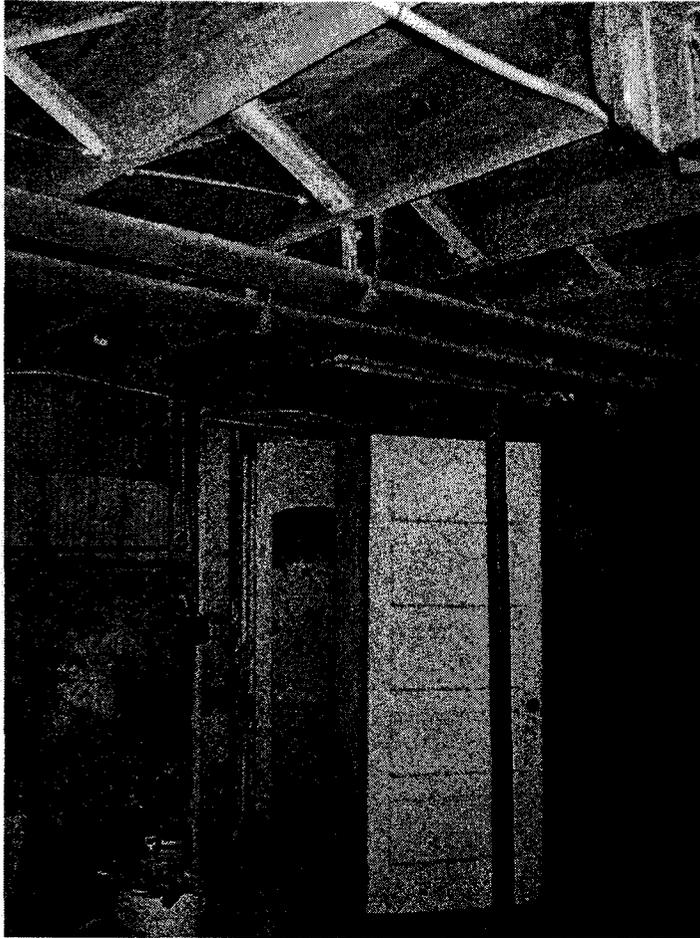
Figure 5: Basement view showing concrete foundation, terra cotta blocks and first floor joists.

A narrow exterior staircase adjacent to the house wall leads to an unfinished basement (fig. 5). A poured-in-place basement floor slab rests on grade and carries a 5' high concrete foundation wall that is 9" thick. Directly on top of the concrete wall rests the first courses of terra cotta blocks that are used to construct the entire height of the exterior walls. Basement windows have been punched in the walls at intervals above the outside grade line.

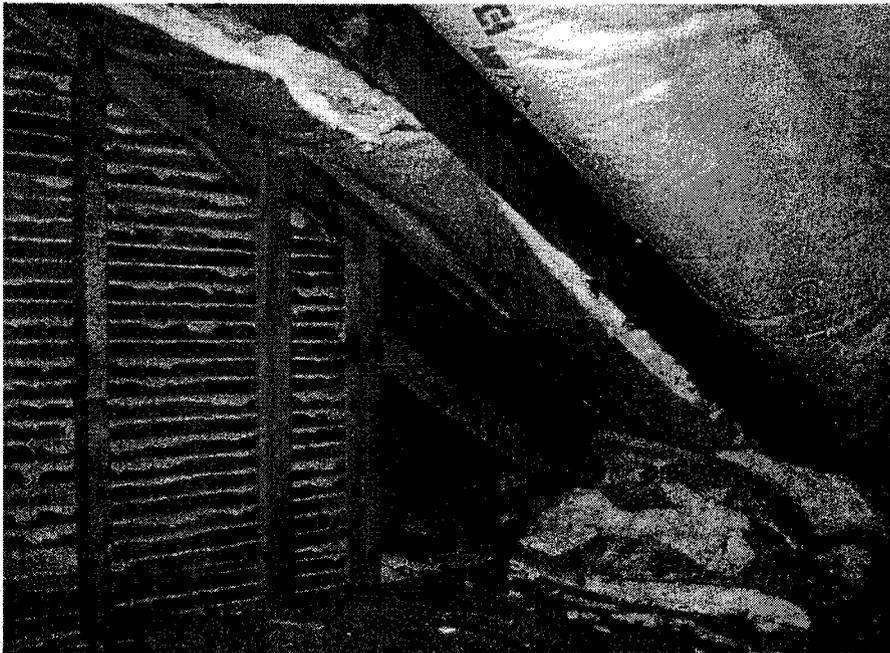
Figure 6: Attic view showing roof rafters and back of enclosed stair leading from the second to the third floor.

The third floor contains the attic (fig. 6) to the east and a finished room in the western half of the space. Doors separate the two areas. The ceiling of the finished room is much lower than the ceiling heights on the other floors and is clipped by the roof rafters above. There is one window centered within the width of the room. The floor is finished with the same hardwood flooring used throughout the house.

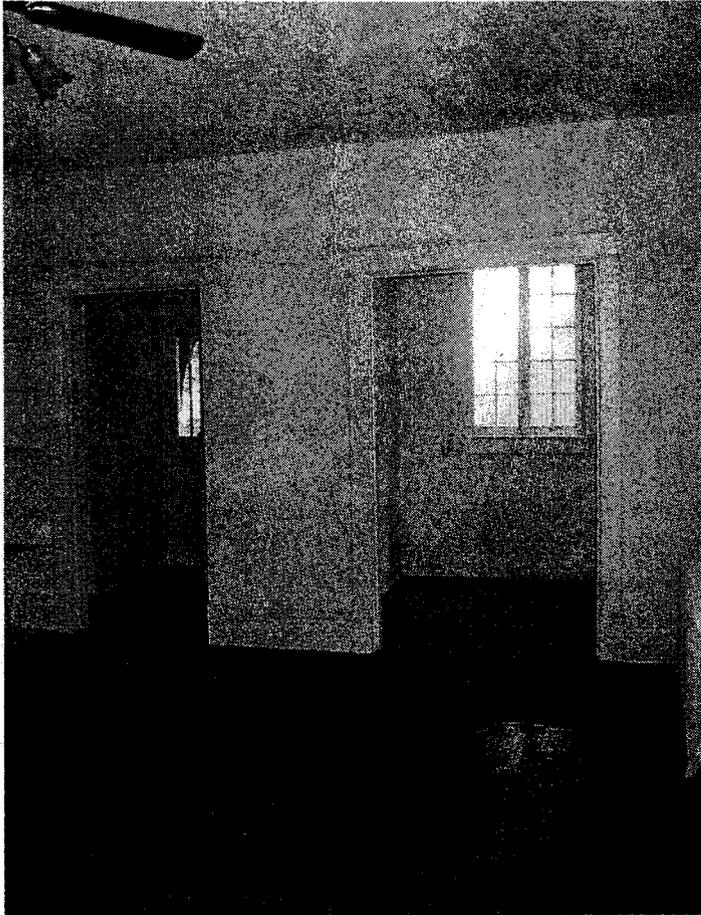
Figure 7: Interior view from living room looking northeast towards entryway and adjacent small room.

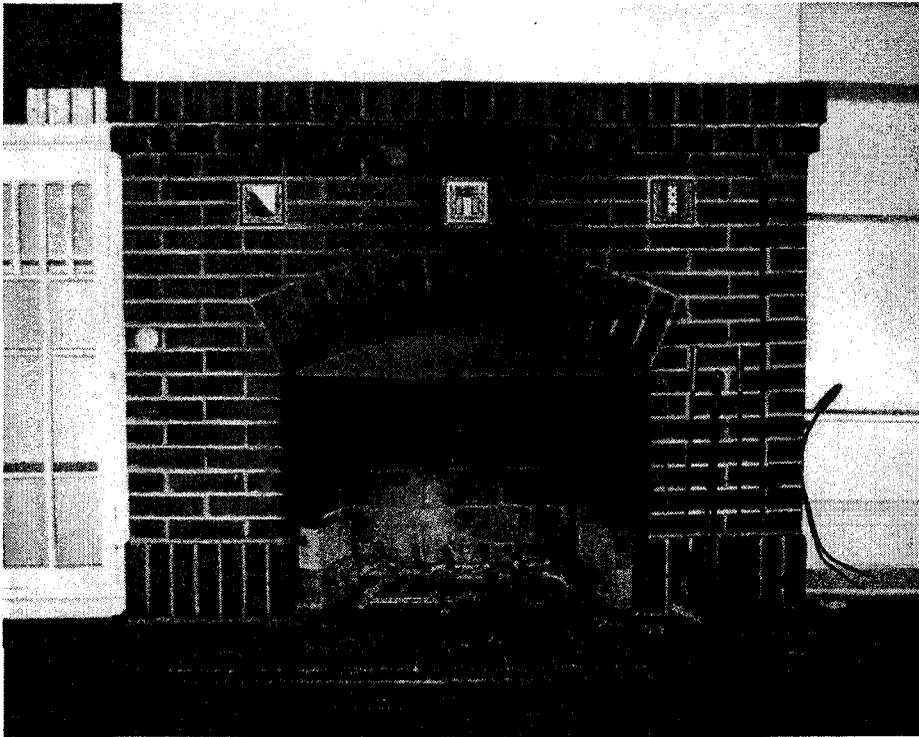
Figure 8: Living room fireplace and surround.
