WIND RIVER ADMINISTRATIVE SITE, BUILDING
No.1057
Gifford Pinchot National Forest
Chapman Road, near Lookout Mountain Road
Carson Vicinity
Skamania County
Washington

HABS WA-232-C

WIND RIVER ADMINISTRATIVE SITE

BUILDING #1057

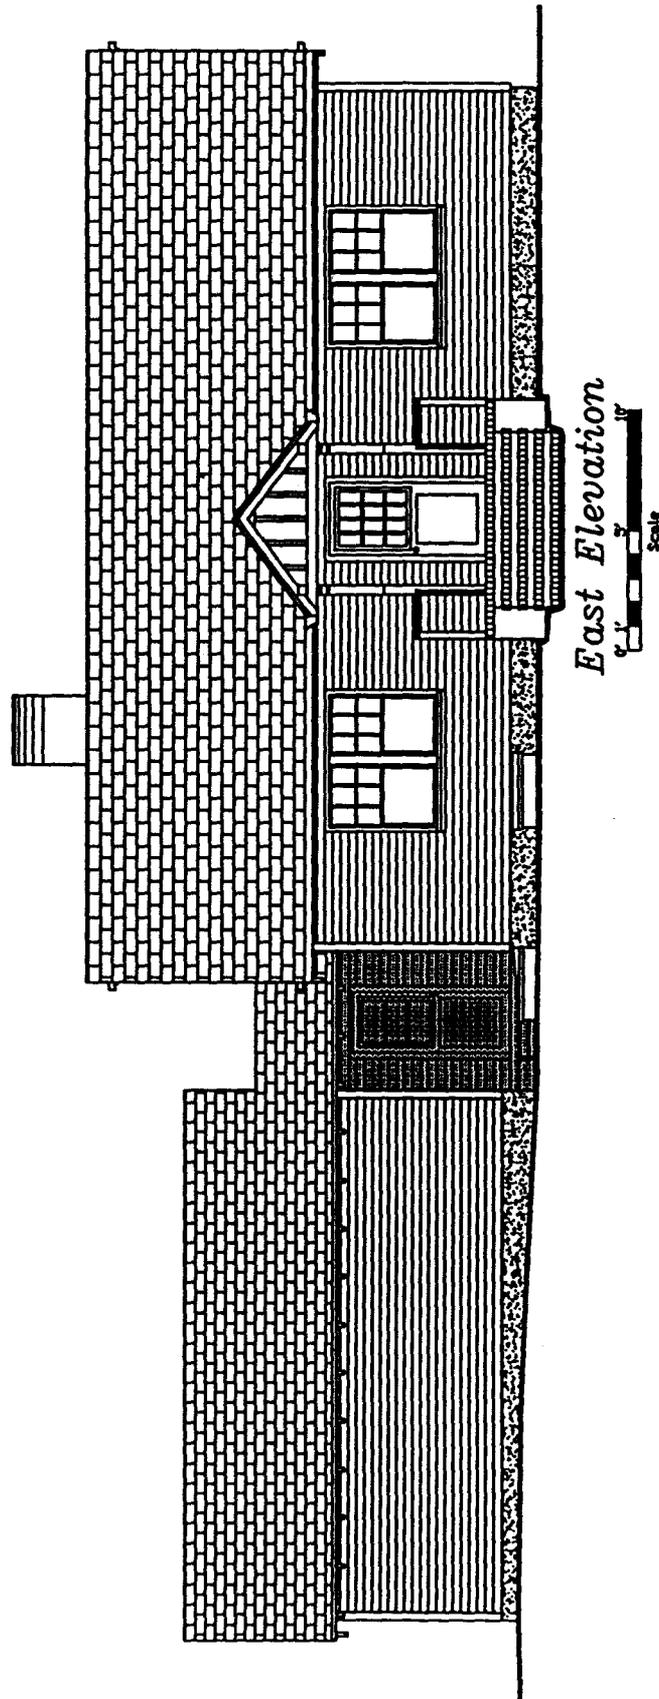
**Experiment Station Assistant's Residence
Constructed 1917 – Reconstructed 1942**

Building elevation adapted from USDA Forest Service drawing dated 1978 and Forest Service photographs dated 1986.

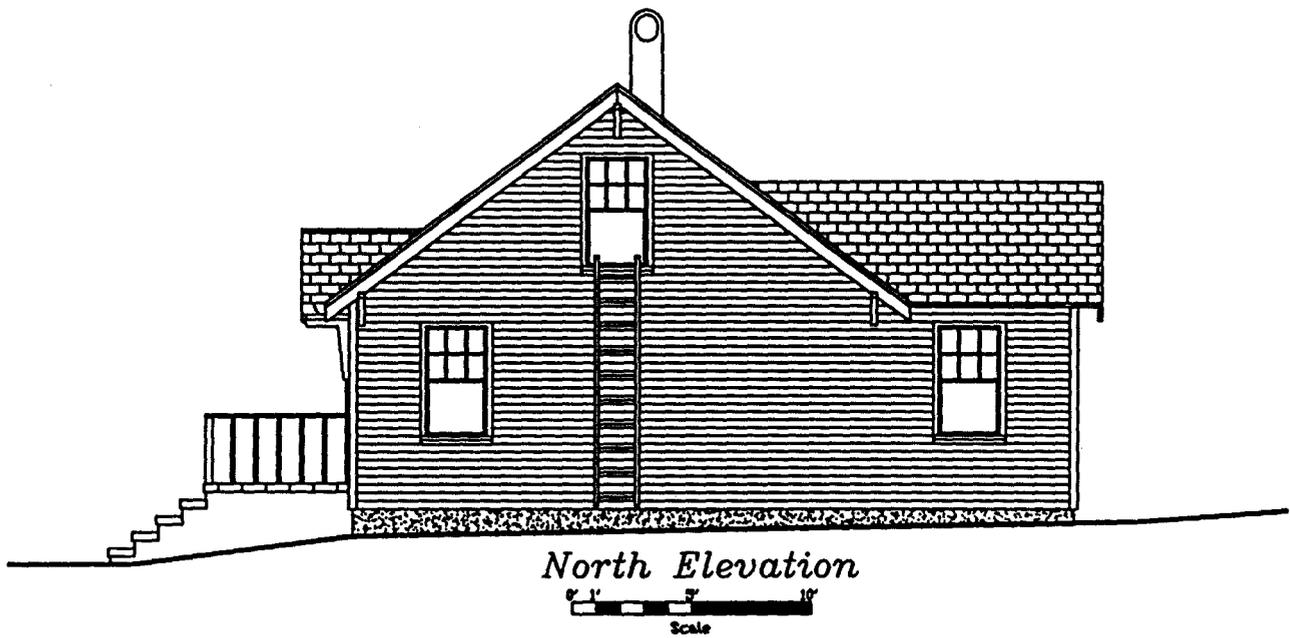
**Experiment Station Assistant's Residence
Constructed 1917 – Reconstructed 1942**

Building elevation adapted from USDA Forest Service drawing dated 1978 and Forest Service photographs dated 1986.

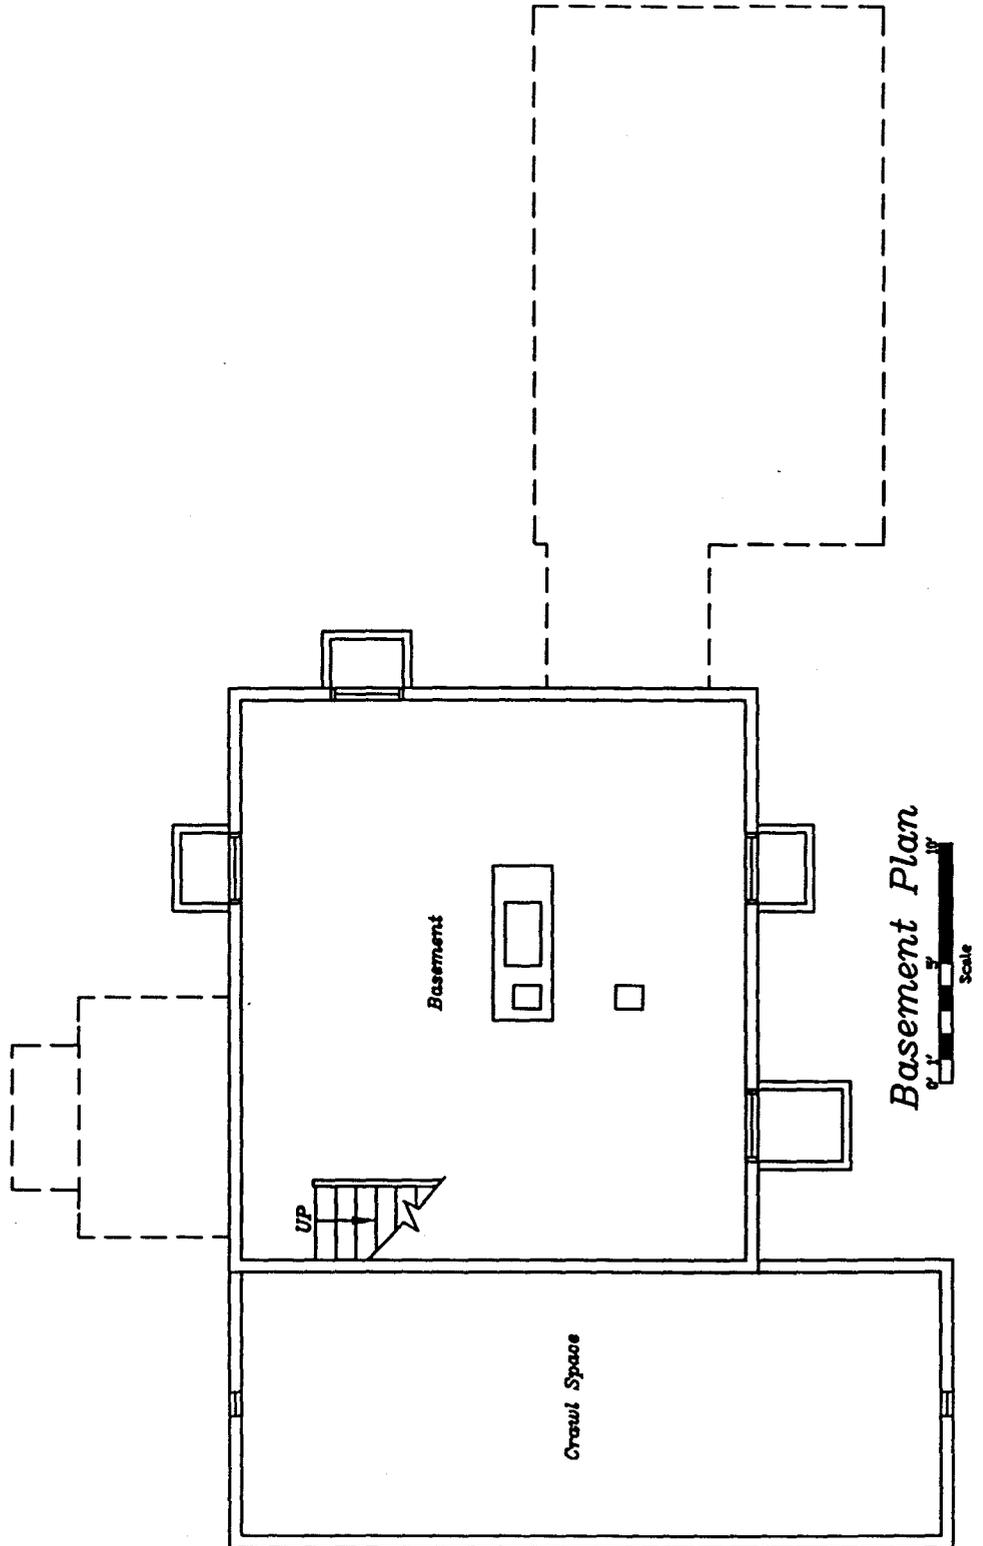
**Experiment Station Assistant's Residence
Constructed 1917 – Reconstructed 1942**

Building basement plan adapted from USDA Forest Service drawing dated 1978 and
Forest Service photographs dated 1986.

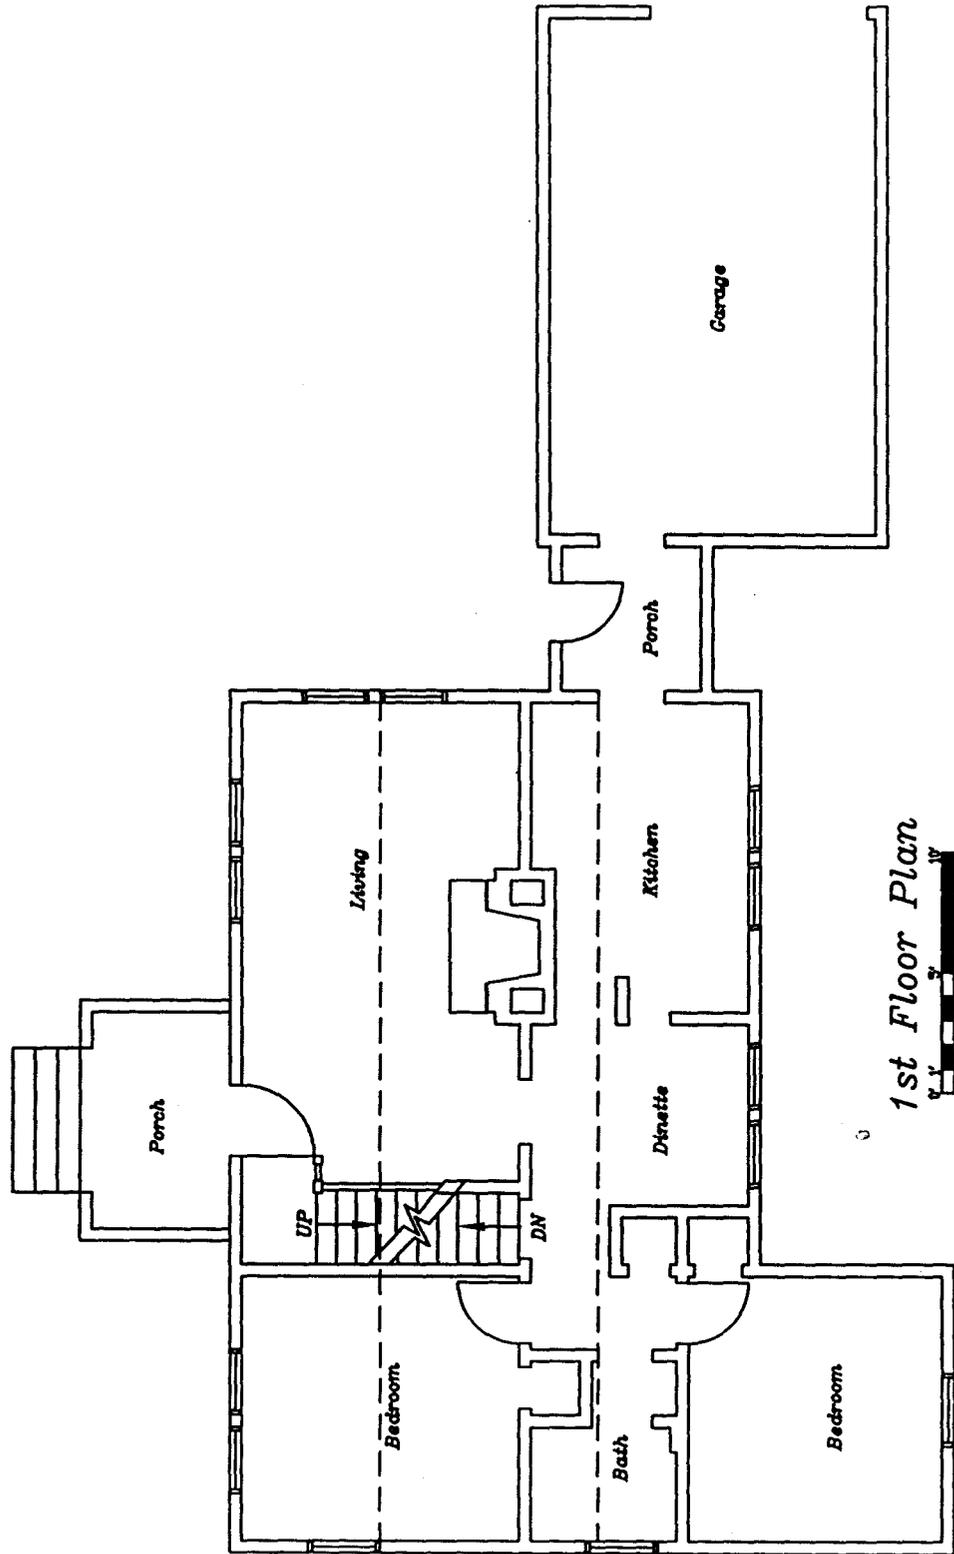
**Experiment Station Assistant's Residence
Constructed 1917 - Reconstructed 1942**

Building floor plan adapted from USDA Forest Service drawing dated 1978 and Forest Service photographs dated 1986.

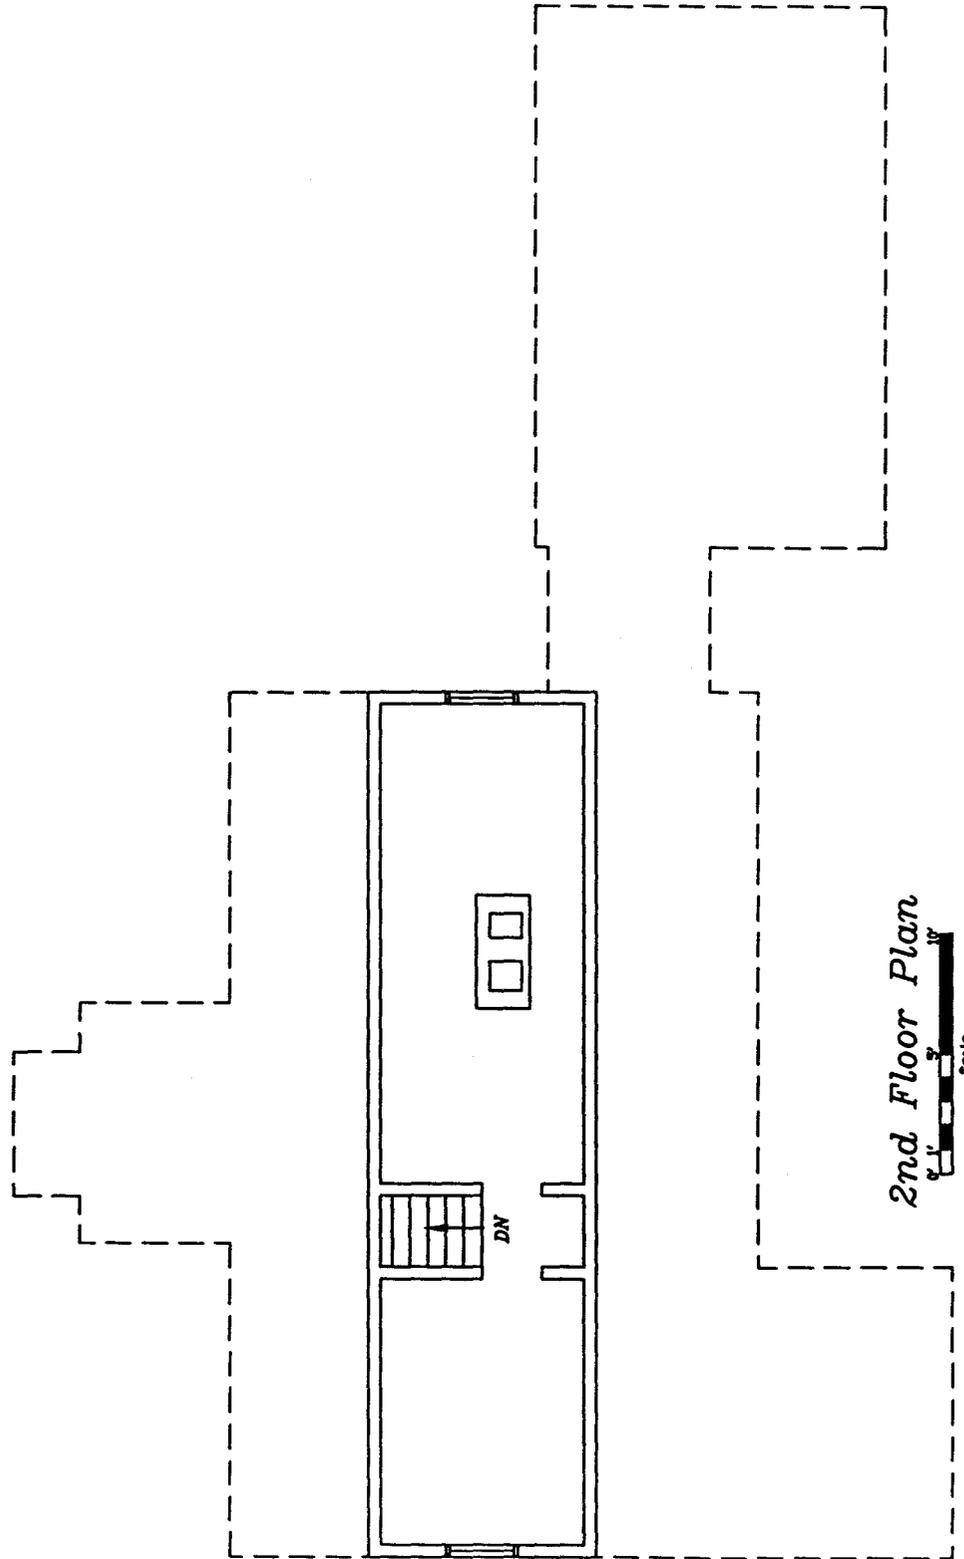
**Experiment Station Assistant's Residence
Constructed 1917 – Reconstructed 1942**

Building floor plan adapted from USDA Forest Service drawing dated 1978 and Forest Service photographs dated 1986.
