WRITTEN HISTORICAL AND DESCRIPTIVE DATA

THOMAS FARM, HOUSE (Araby)

HABS No. MD-1251-A

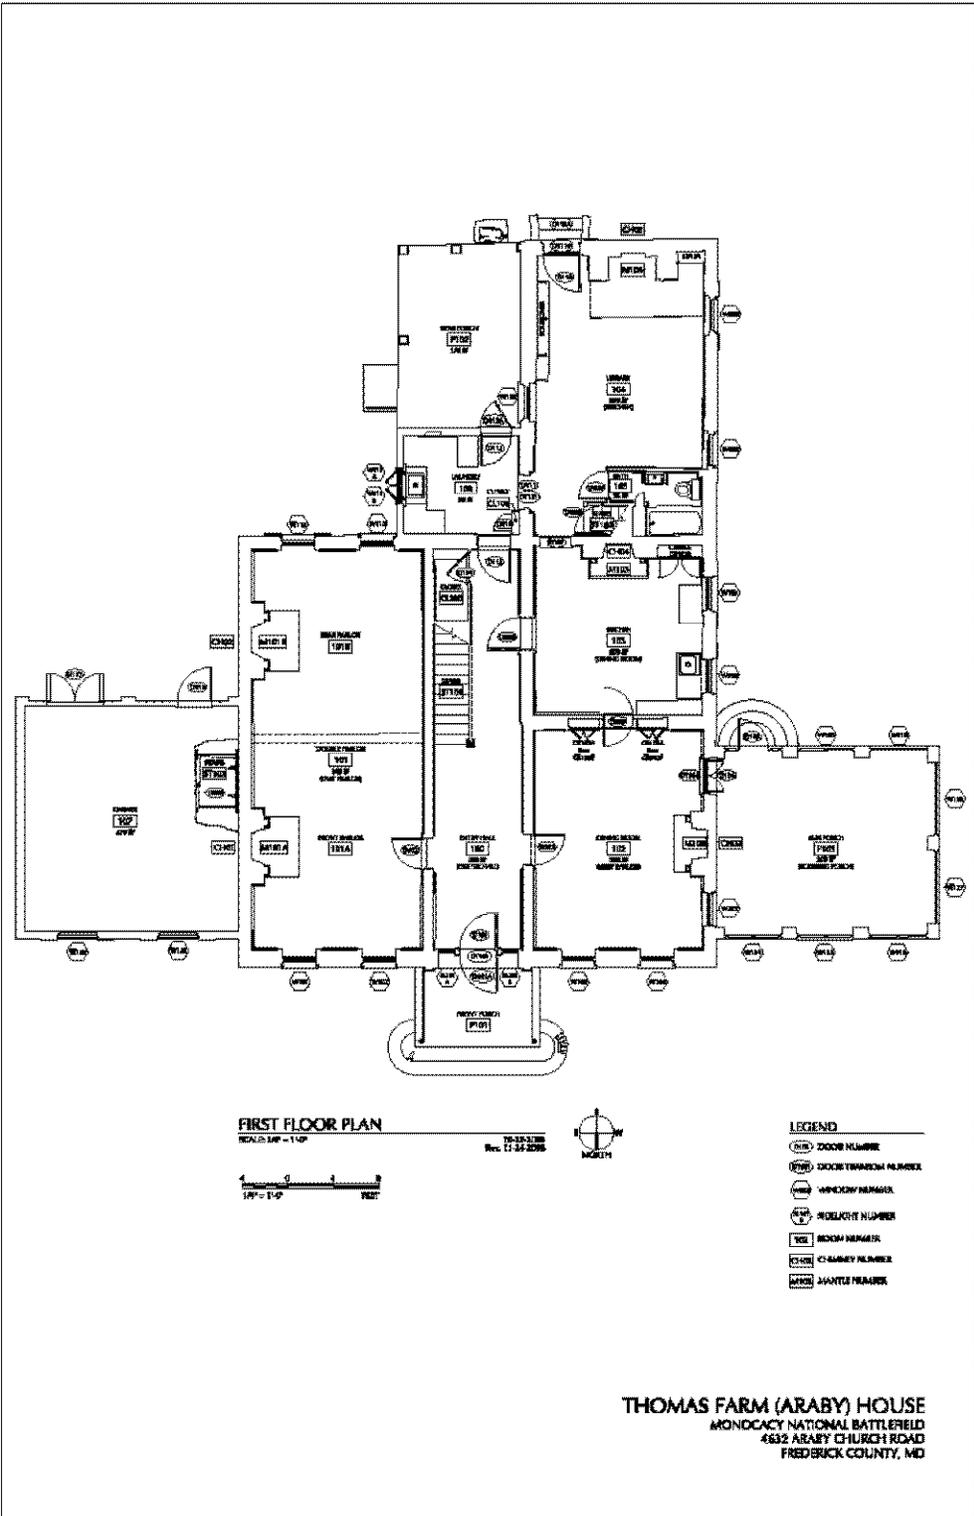
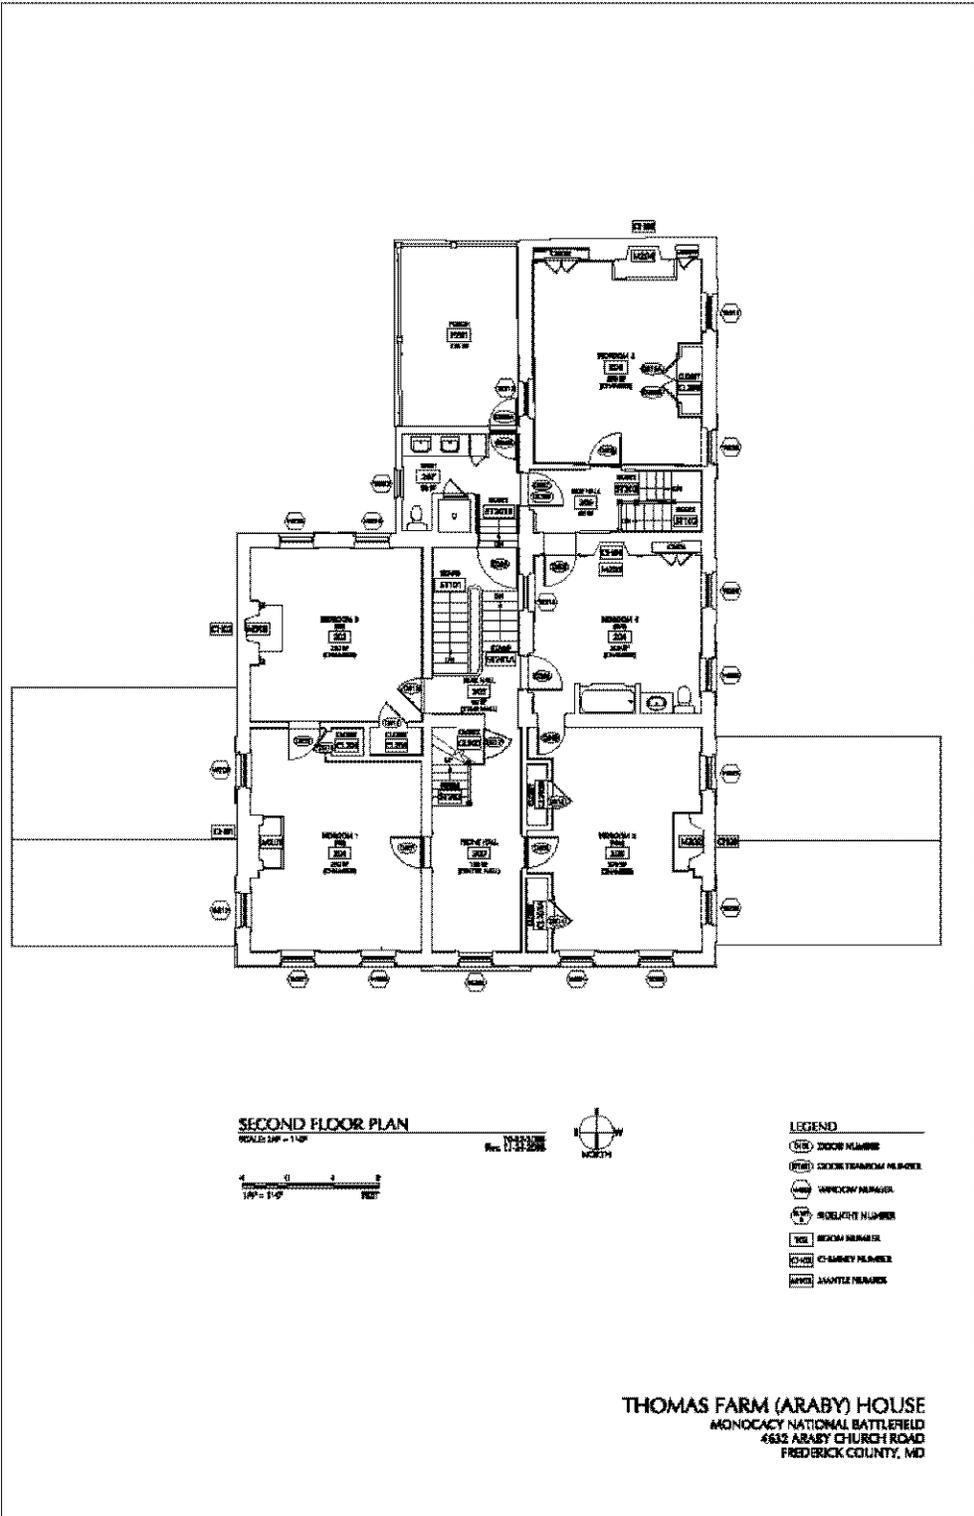
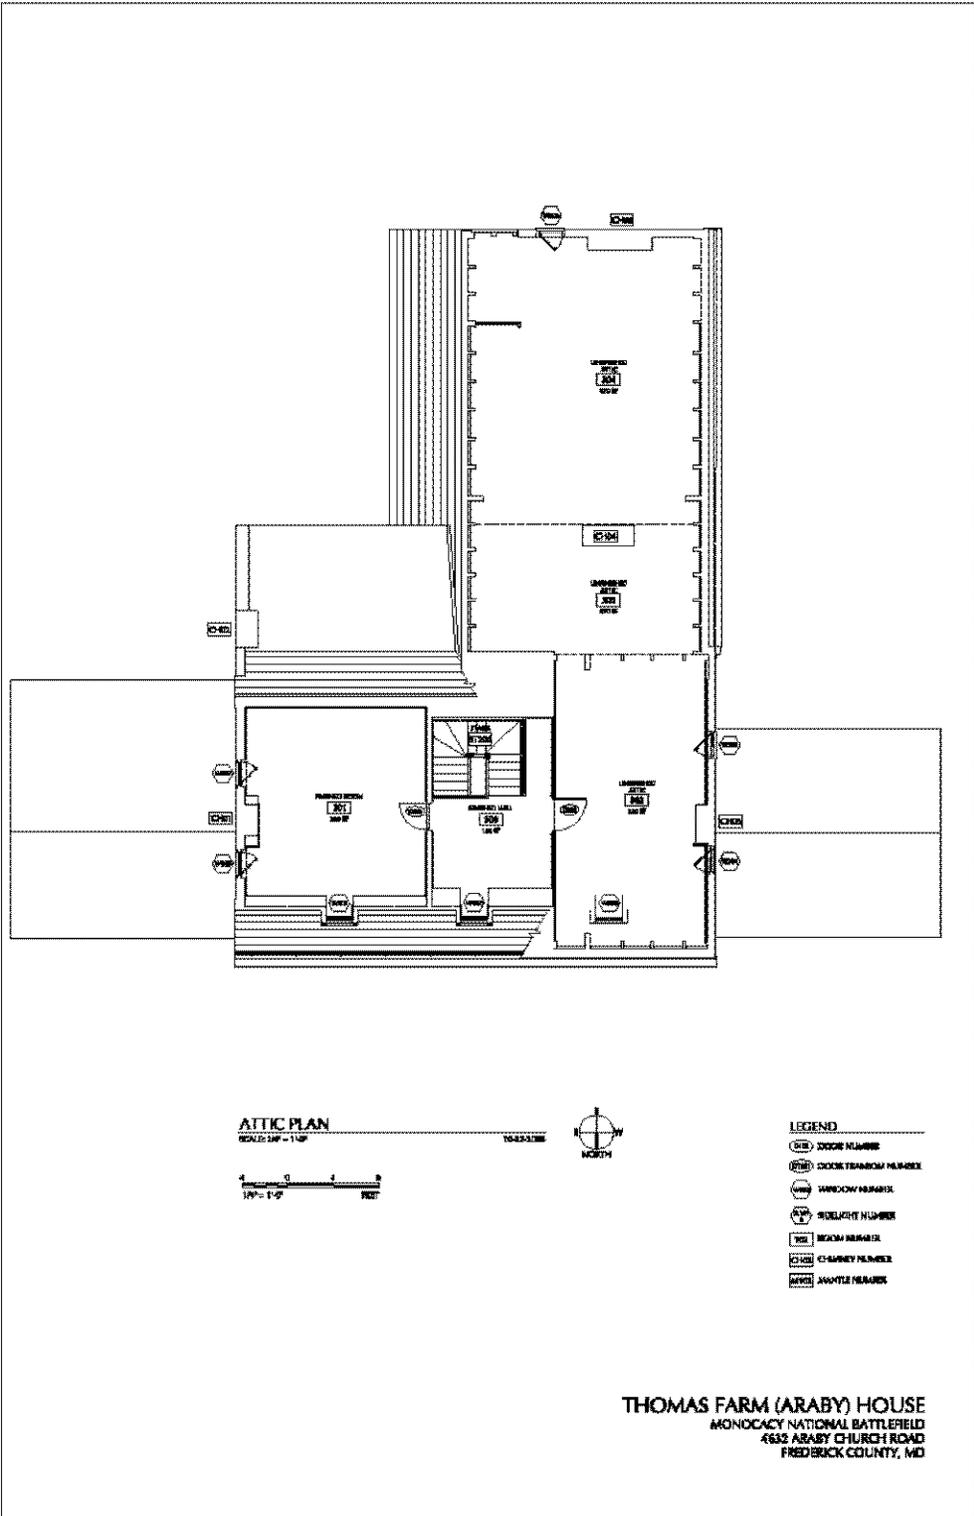
Drawings depicting the floor plans of the Thomas House with the rooms, windows, doors and fireplaces identified by number for the purposes of the HSR and referenced throughout the above text.

Historically the attic has been described as having two rooms suggesting that the present hall (300) and east room (301) were originally one large interior space plainly fitted out, leaving the area to the west (302) unfinished. There is a baseboard and shoe mold along the west side, but only a quarter-round shoe molding along the north and east walls. The difference in finish corroborates the understanding that the southeast side was subdivided after 1847. The stair hall contains about 100 square feet, and is lit by one of the dormer windows (W302). Doors (D301, D302) open off the hall into the adjoining spaces.
