HABS No. AZ-145-G

### PHOENIX INDIAN SCHOOL, ELEMENTARY SCHOOL (Band-Chorus Building) HABS NO.: AZ-145-G

Location: Northeast Corner of Central Avenue and Indian School Road  
Phoenix  
Maricopa County  
Arizona

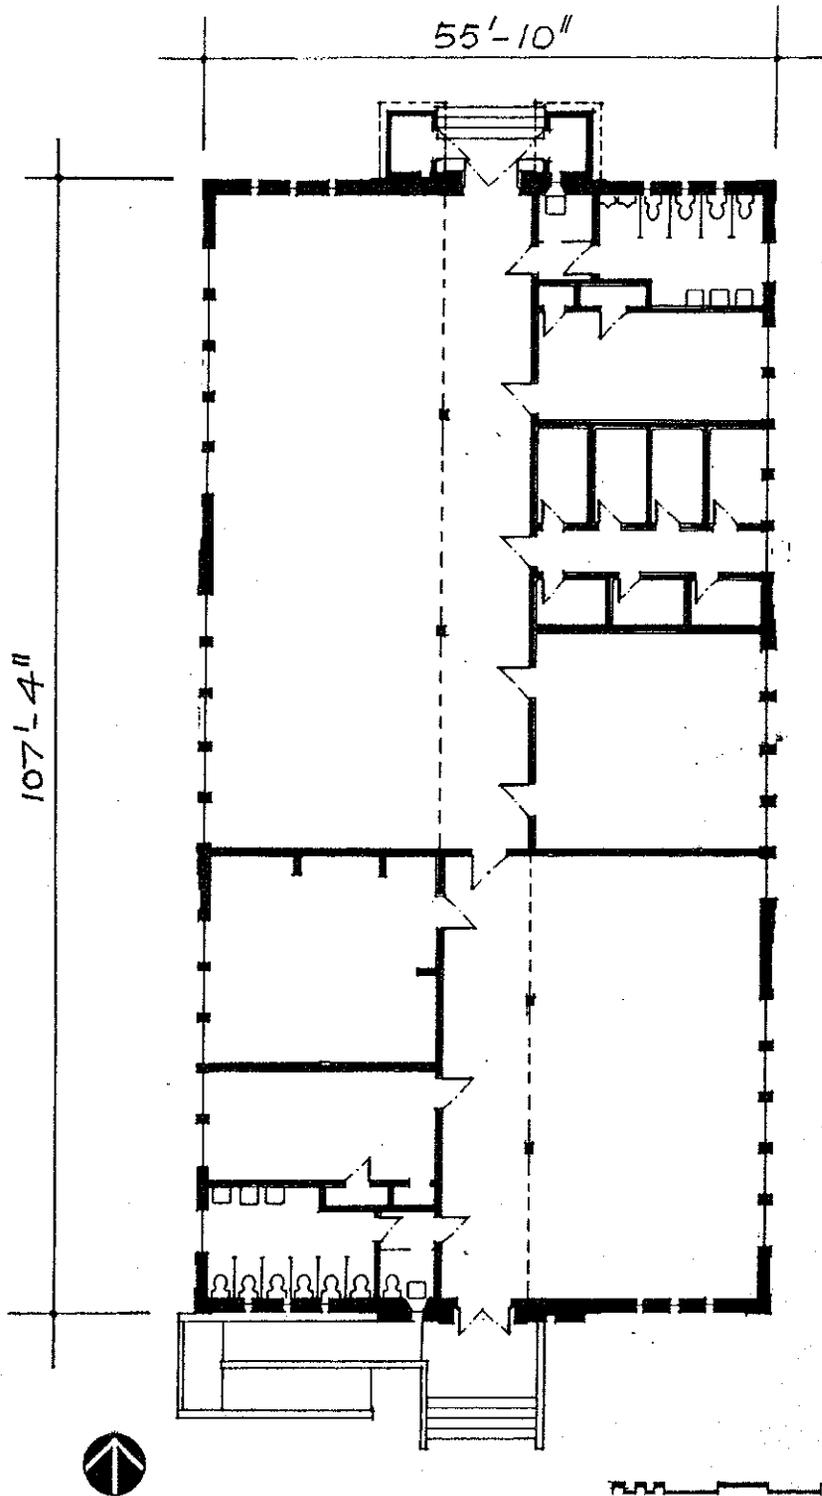
ELEMENTARY SCHOOL, Sketch Floor Plan

The Elementary School was divided internally by a corridor running from the south to the north entrance. Inside the south entrance, to the left, the Girls' Toilet, with beyond it a row of 3 classrooms; to the right, another row of 3 classrooms, with beyond it the Boys' Toilet. The asymmetry of the internal dispositions was reflected in the asymmetry of the east and west faces. Each classroom was 30' x 22", with windows in the outer wall, blackboards on the three inner walls.
