FORT DEFIANCE INDIAN HOSPITAL,
PHYSICIAN'S COTTAGE
(Fort Defiance Indian Hospital, FD-34)
Navajo Indian Reservation
Bonito Drive
Fort Defiance
Apache County
Arizona

HABS No. AZ-227-A

HISTORIC AMERICAN BUILDINGS SURVEY
Fort Defiance Indian Hospital, Physician's Cottage
(Fort Defiance Indian Hospital, FD-34)

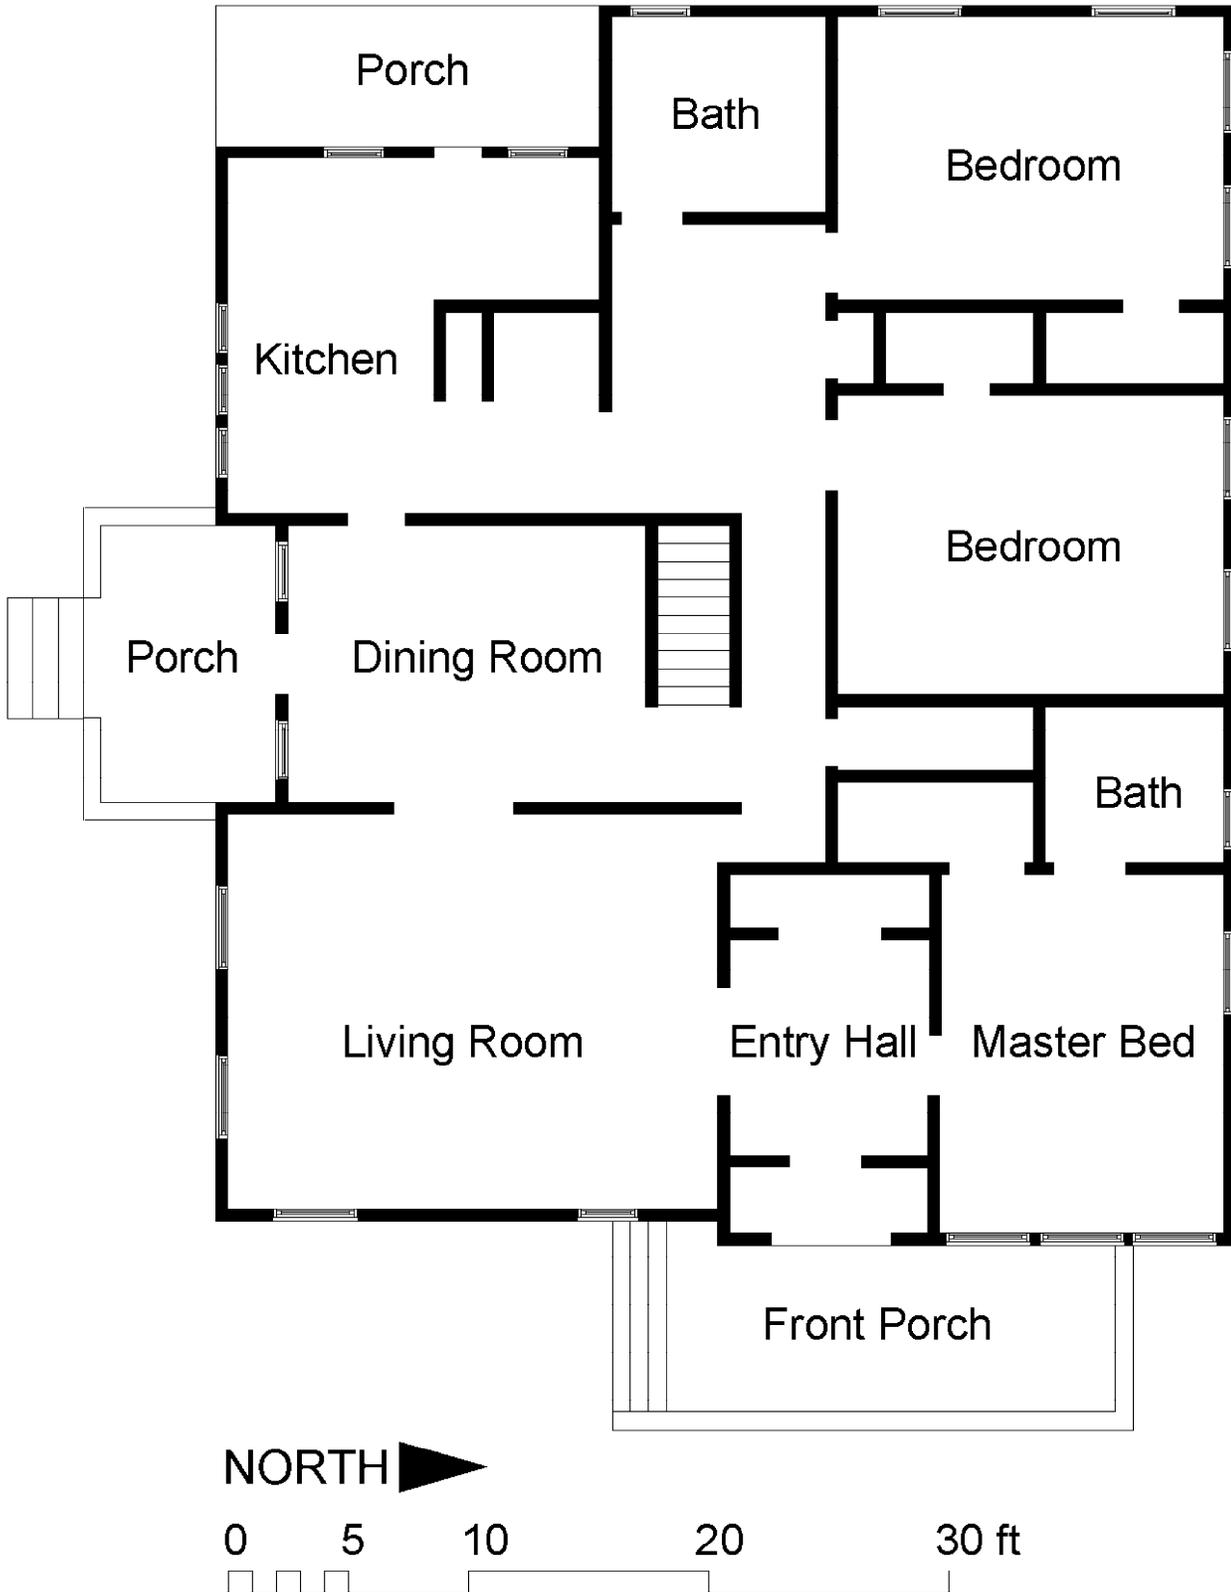
Floor Plan:

A hall on a front-to-rear axis divides the public and private spaces with the living room, dining room, and kitchen and breakfast nook lying to the south, and the three bedrooms paralleling them to the north. A wood stairway leads from the hall to the (cellar).
