Scandia Hotel
225 1st Street
Eureka
Humboldt County
California

HABS No. CA-2685

HISTORIC AMERICAN BUILDINGS SURVEY

SCANDIA HOTEL

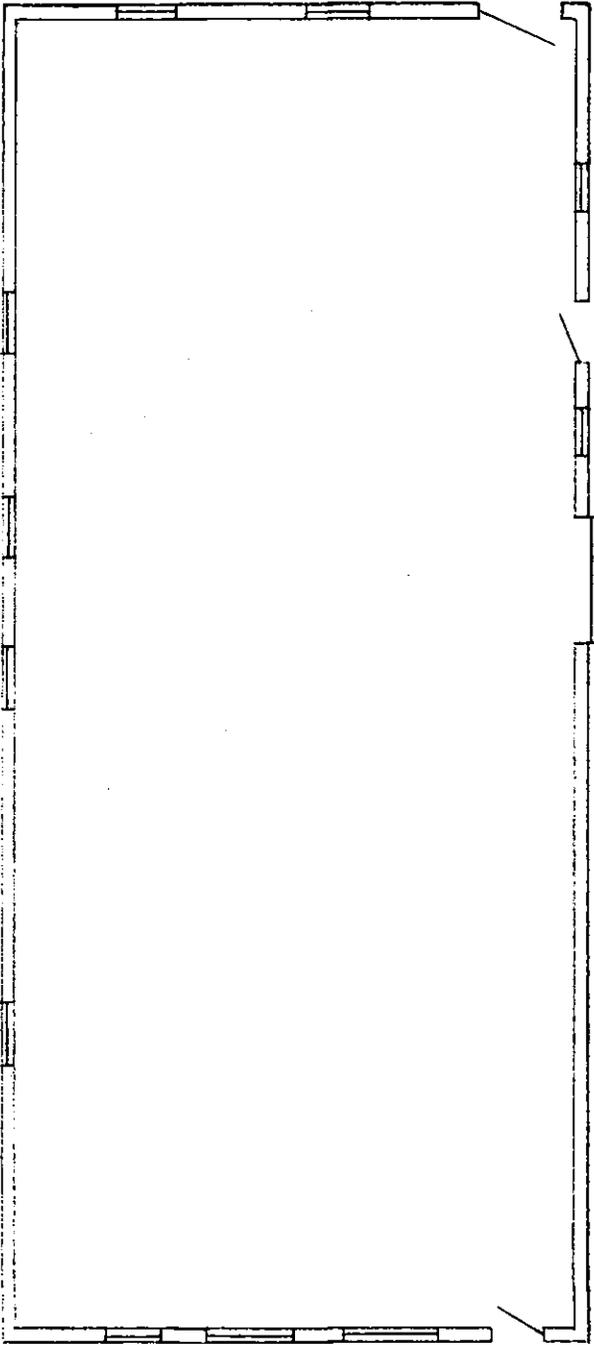
FLOOR PLAN

Interior: The building's interior is virtually gutted, and now serves as a storage or disposal area for appliances. The first floor is completely open. The second floor is currently inaccessible, but also appears to be open and partitionless. Interior side and end walls are sheathed in wide, circular-sawn planks placed horizontally on the studs. Any original finish (cloth and paper, paper, etc.) has long since vanished. Remnants of painted paper hang from the plank ceiling. The building also has a simple plank floor. Remnants of vertical wainscot and evidence of a chair rail are visible on the west wall of the first floor. Access to second floor was originally by stairs along the east wall; these are now gone, leaving only the opening in the second floor as evidence of their location. First floor height is presently approximately six inches below grade of the adjacent sidewalk.
