Washington Lodge #15  
(B.P.O. Elks Lodge #15)(Convention  
Center Site, District of Columbia)  
919 H Street, NW  
Washington, D.C.

HABS No. DC-386

WASHINGTON LODGE # 15, THE BENEVOLENT AND PROTECTIVE ORDER OF ELKS  
(Convention Center Site, Elks Lodge)HABS,  
DC,  
WASH,  
253-

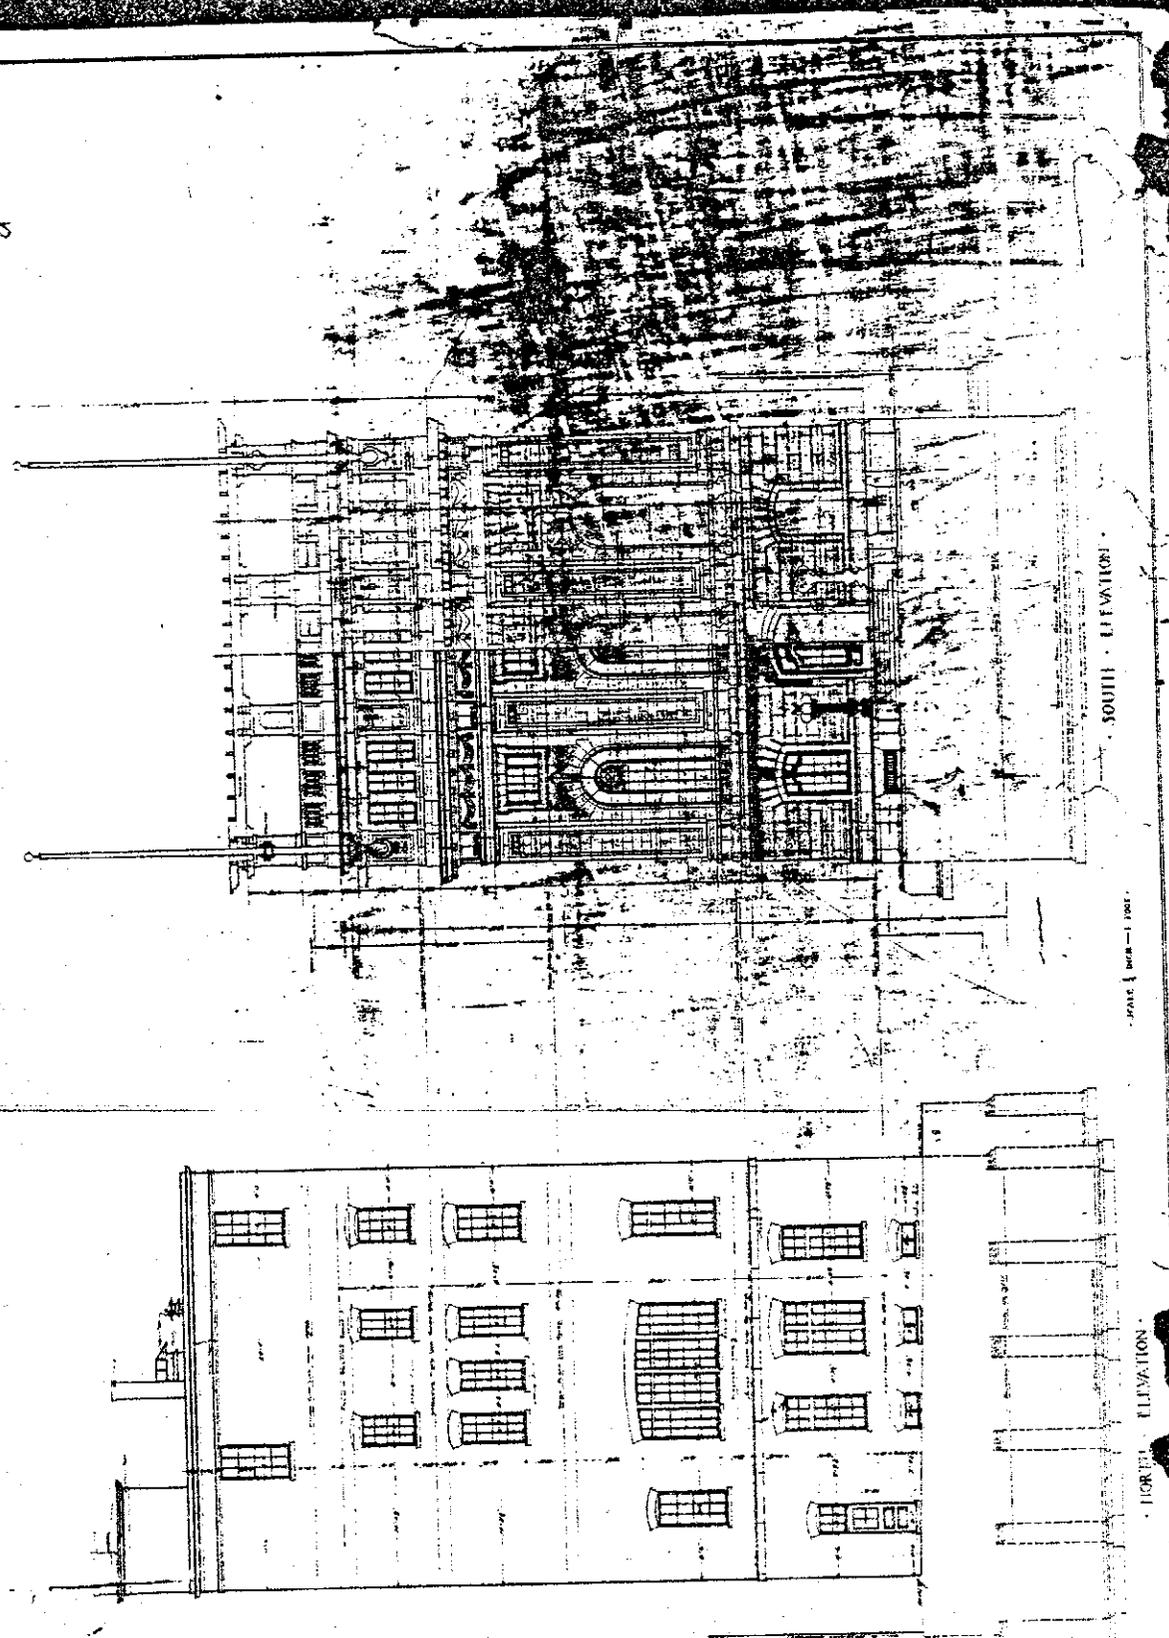
SOUTH ELEVATION

NORTH ELEVATION

1. Overall dimensions: 44'5" wide, 132'10 $\frac{1}{2}$ " deep; 3 bays wide, 3 stories, plus mezzanine.
2. Wall construction, finish and color: This building is faced with beige brick with stone ornaments. The first floor has rusticated brick bands. The tall second floor is broken into three bays. Each bay has a stone balcony which is flanked by brick pilasters with a stone base and capital. Stone portrait busts rest on the keystones which top the round arched windows. Garlands flank the busts, and also adorn the frieze of the modillioned cornice above the second floor. The third floor maintains the same bay arrangement, only with shorter pilasters and tripartite window arrangements in place of the large single one to each bay. The two pilasters at either extreme of the third floor carry large antlered elk head ornaments. The roof line is marked by a plain stone cornice which supports a balustrade. Pedestals rise above the roof line directly above the pilasters.

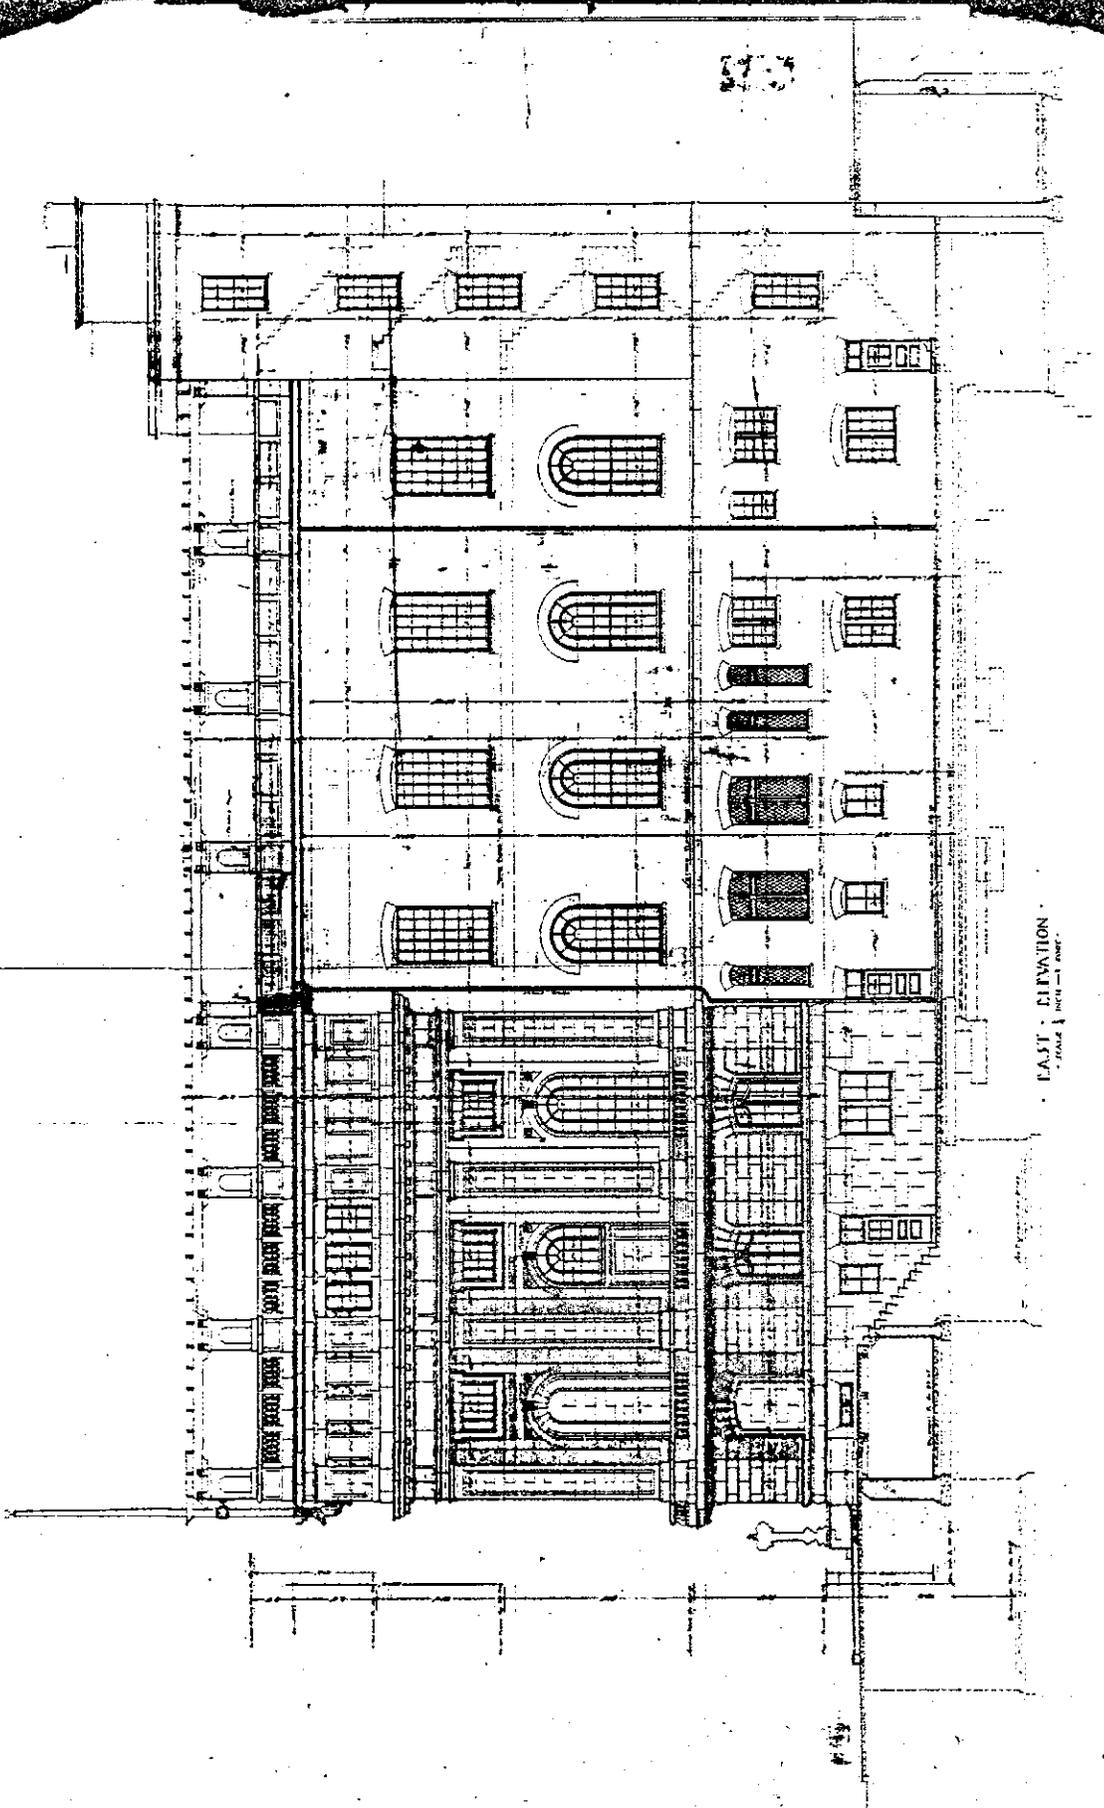
Convention Center Site, Elks Lodge  
 HABS No. DC-386 (Page 4) Supp. Mat. 2

EAST ELEVATION  
 SCALE 1/4" = 1'-0"

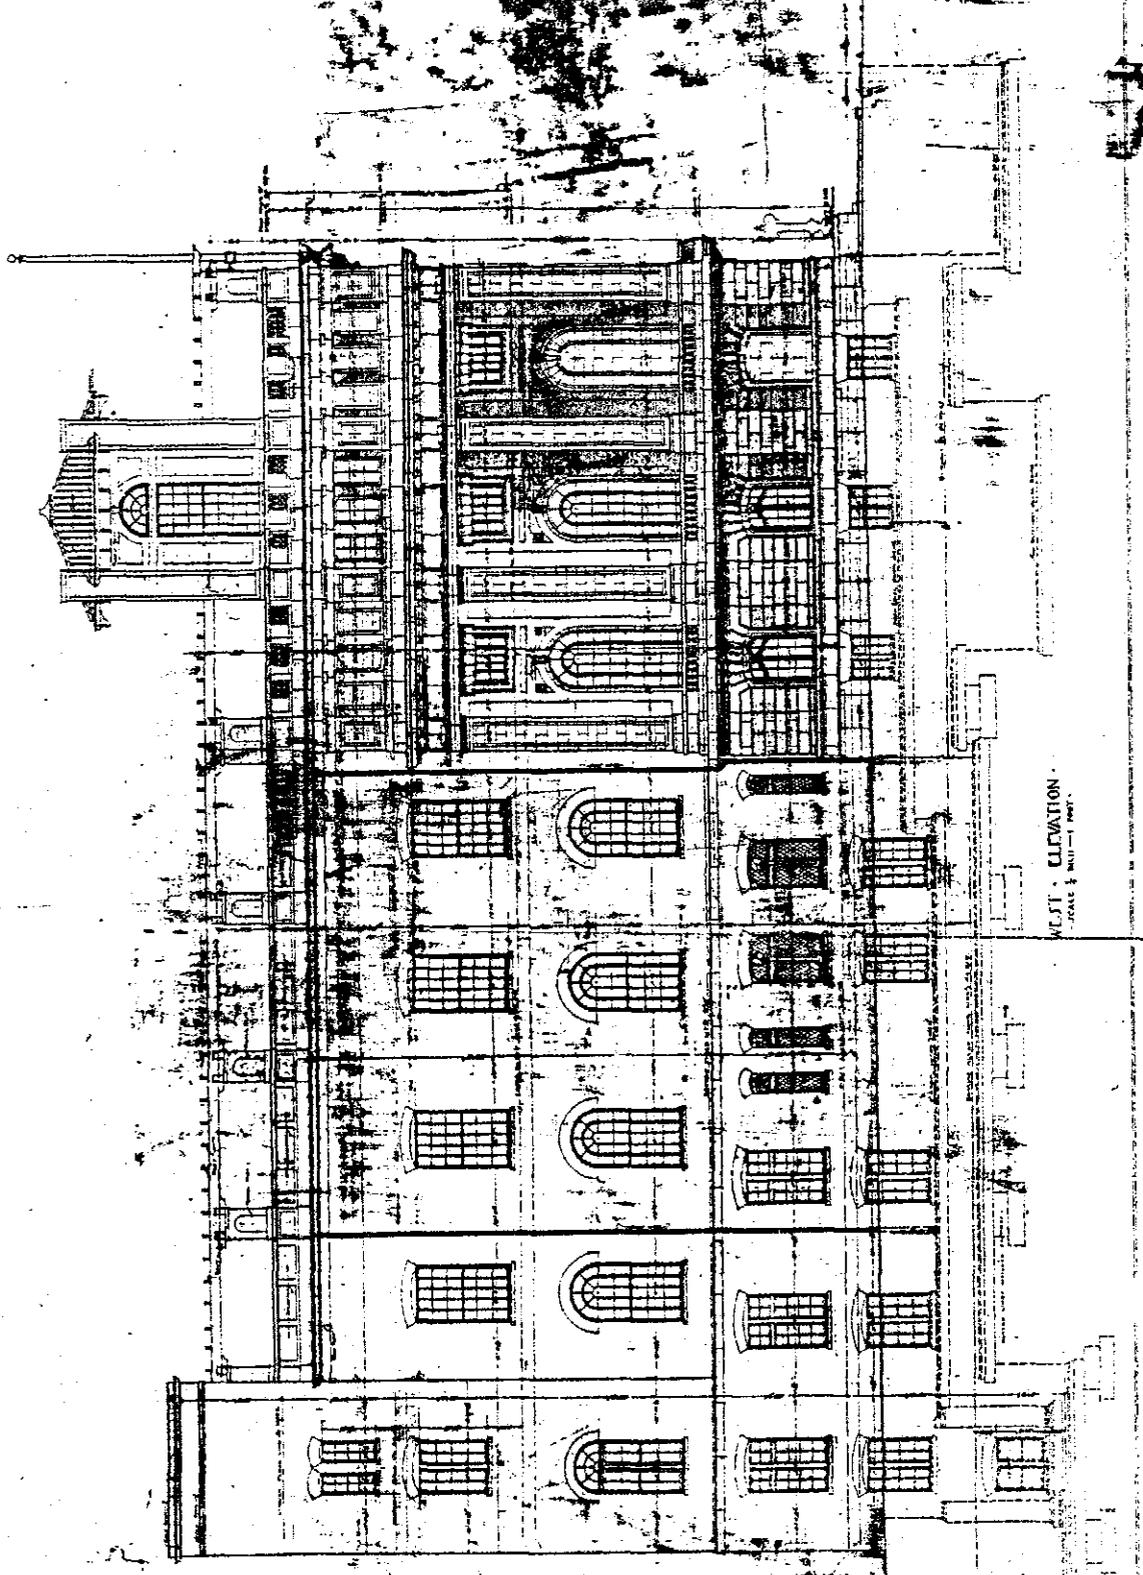
Convention Center Site, Elks Lodge  
HABS No. DC-386 (Page 5) Supp. Mat. 3

WEST ELEVATION  
SCALE 1/4" = 1'-0"

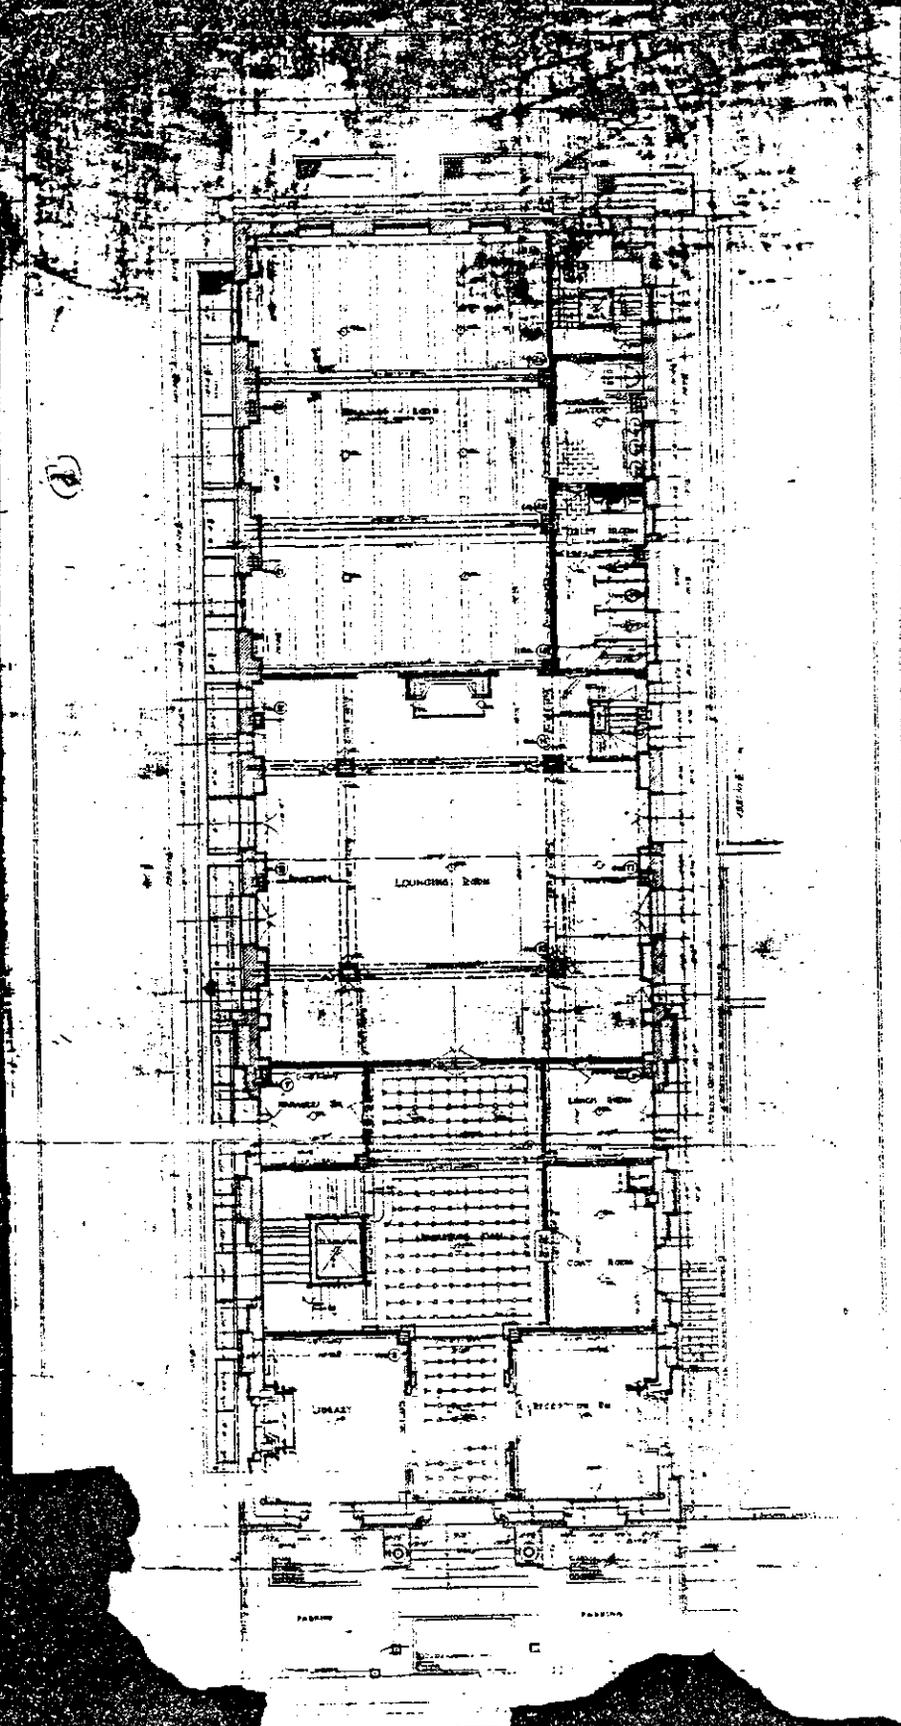
Convention Center Site, Elks Lodge  
HABS No. DC-386 (Page 6) Supp. Mat. 4

FIRST FLOOR  
SCALE: 1/8" = 1'-0"

1. Floor plan: Of particular interest is the ordered vertical arrangement of major spaces for gatherings. A dining room and lounge is at the first floor, lodge room at the second, and ballroom at third. These large rooms are the width of the building allowing through ventilation and natural light from east and west. At the rear of the building (north) is a vertical service core of stairs, dumbwaiter, and pantries. Kitchens and storage areas are in the basement. At approximately one-quarter of the depth of the building from the entrance is the public vertical core of lobbies, toilets, and an open steel cage elevator that rises through the stairwell. Attention should be drawn to the translucent material of the elevator wall that allows the pattern of the moving elevator cage to be seen by the public. On axis with the entrance doors is a vestibule flanked at left (west) by a library, and right (east) by ladies' sitting room and toilet facilities; next is the lobby (with elevator and stair at left); and then through glazed wooden doors and sidelights, through the "Edwardian" dining room to a "Tudor" fireplace flanked by doors to the lounge beyond. Behind the new ceiling of acoustical tile is the original plaster ceiling and run-plaster cornice. The walls are panelled in wood with carved-applied swags and BPOE emblazoned escutcheons. Hardware in this area is custom made using emblems of the Elks. The lounge beyond the dining room

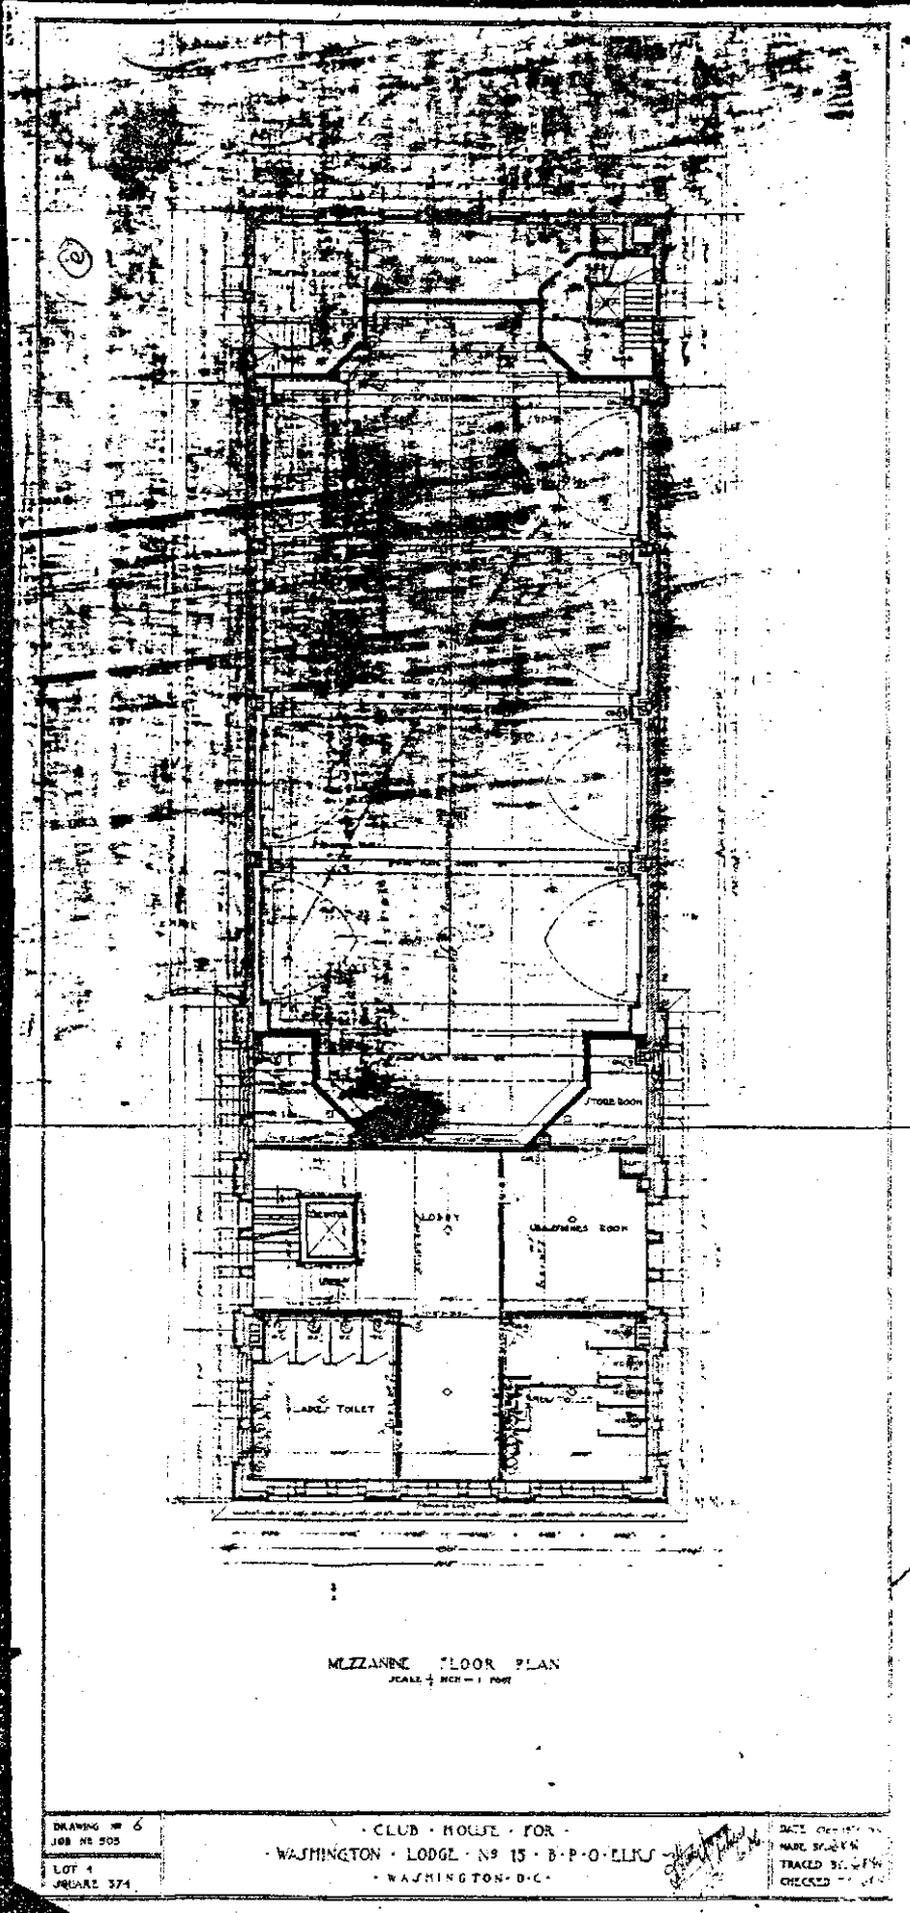
Convention Center Site, Elks Lodge  
HABS No. DC-386 (Page 7) Supp. Mat. 5

MUZZANINE FLOOR PLAN  
SCALE 1/8" = 1'-0"

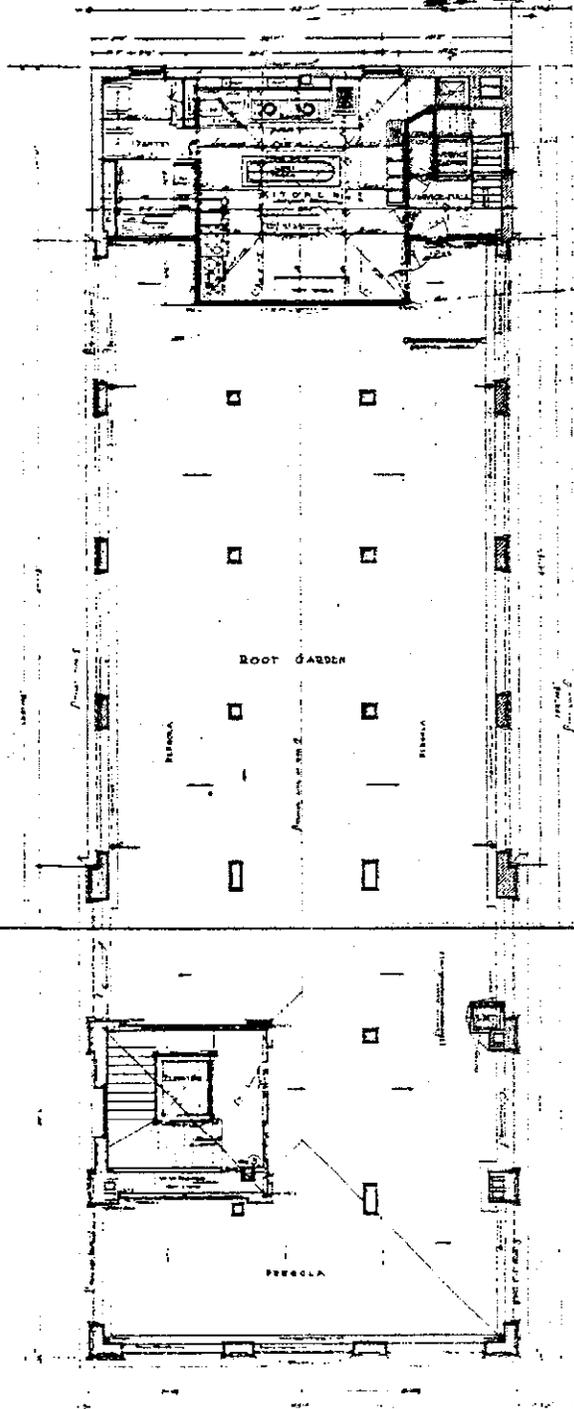
Convention Center Site, Elks Lodge  
HABS No. DC-386 (Page 10) Supp. Mat. 8

ROOF DECK  
SCALE 1/8" = 1'-0"

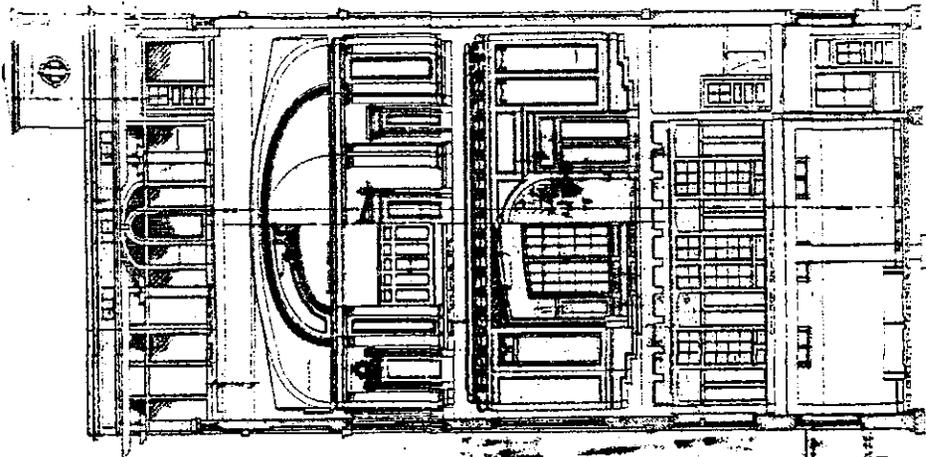
HABS No. DC-386 (Page 11) Supp. Mat. 9

CROSS SECTION

ELEVATION OF IND. ROOM LOOKING NORTH

ELEVATION OF LOUNGE ROOM

ELEVATION OF LIVING ROOM

INTERIOR ELEVATIONS

is a darker, more intimate chamber of clustered tables, stained glass, and a great panelled wood bar and backbar along one wall. In the space above the dining room and lounge is the Elks Lodge room which, notwithstanding its window to the east and west, is an inward-looking room, this character being accentuated by banks of theatre seats stepped up at the walls, and running the depth of the lodge, the ends terminating at large throne-like chairs for the officers. Paraphernalia of the Order, the tables (altars), lecterns, and large antlered elks heads all contribute to the fraternal air. At the second floor front are two offices and central reception hall, each opening to a balcony overlooking the street. At the third floor front, at floor level and on a mezzanine, are meeting and sitting rooms and toilets. The two-story high vaulted ballroom is above the second floor lodge room, and the ballroom's proscenium and state is at the north end, surrounded by two floors of service stairs and pantries for supplying the needs of patrons.

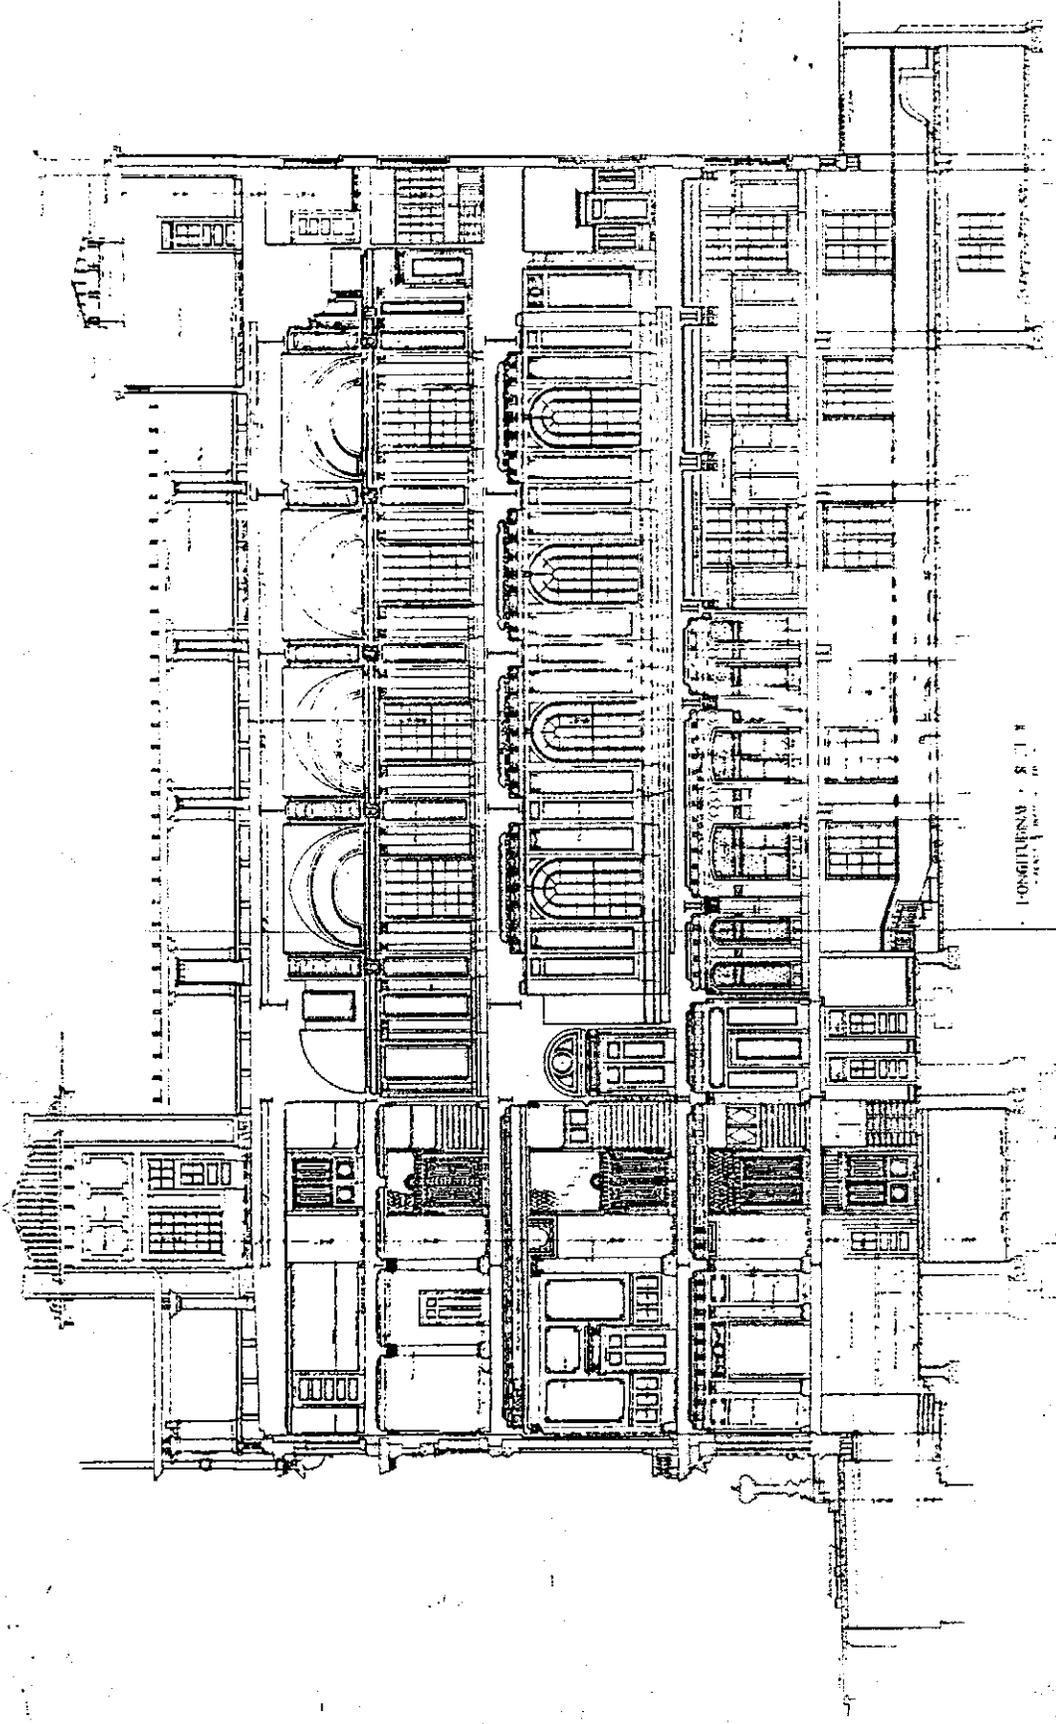
Convention Center Site, Elks Lodge  
HABS No. DC-386 (Page 13) Supp. Mat. 11

LONGFURNAY - 8-11-18
