WILLIAM HOUSE FARM , HOUSE
East side of West Wilson Road
approximately 0.7 mile north of
Breakneck Road
Flintstone vicinity
Allegany County
Maryland

HABS No. MD-1081-A

WILLIAM HOUSE FARM, HOUSE HABS No. MD- 1081 -A

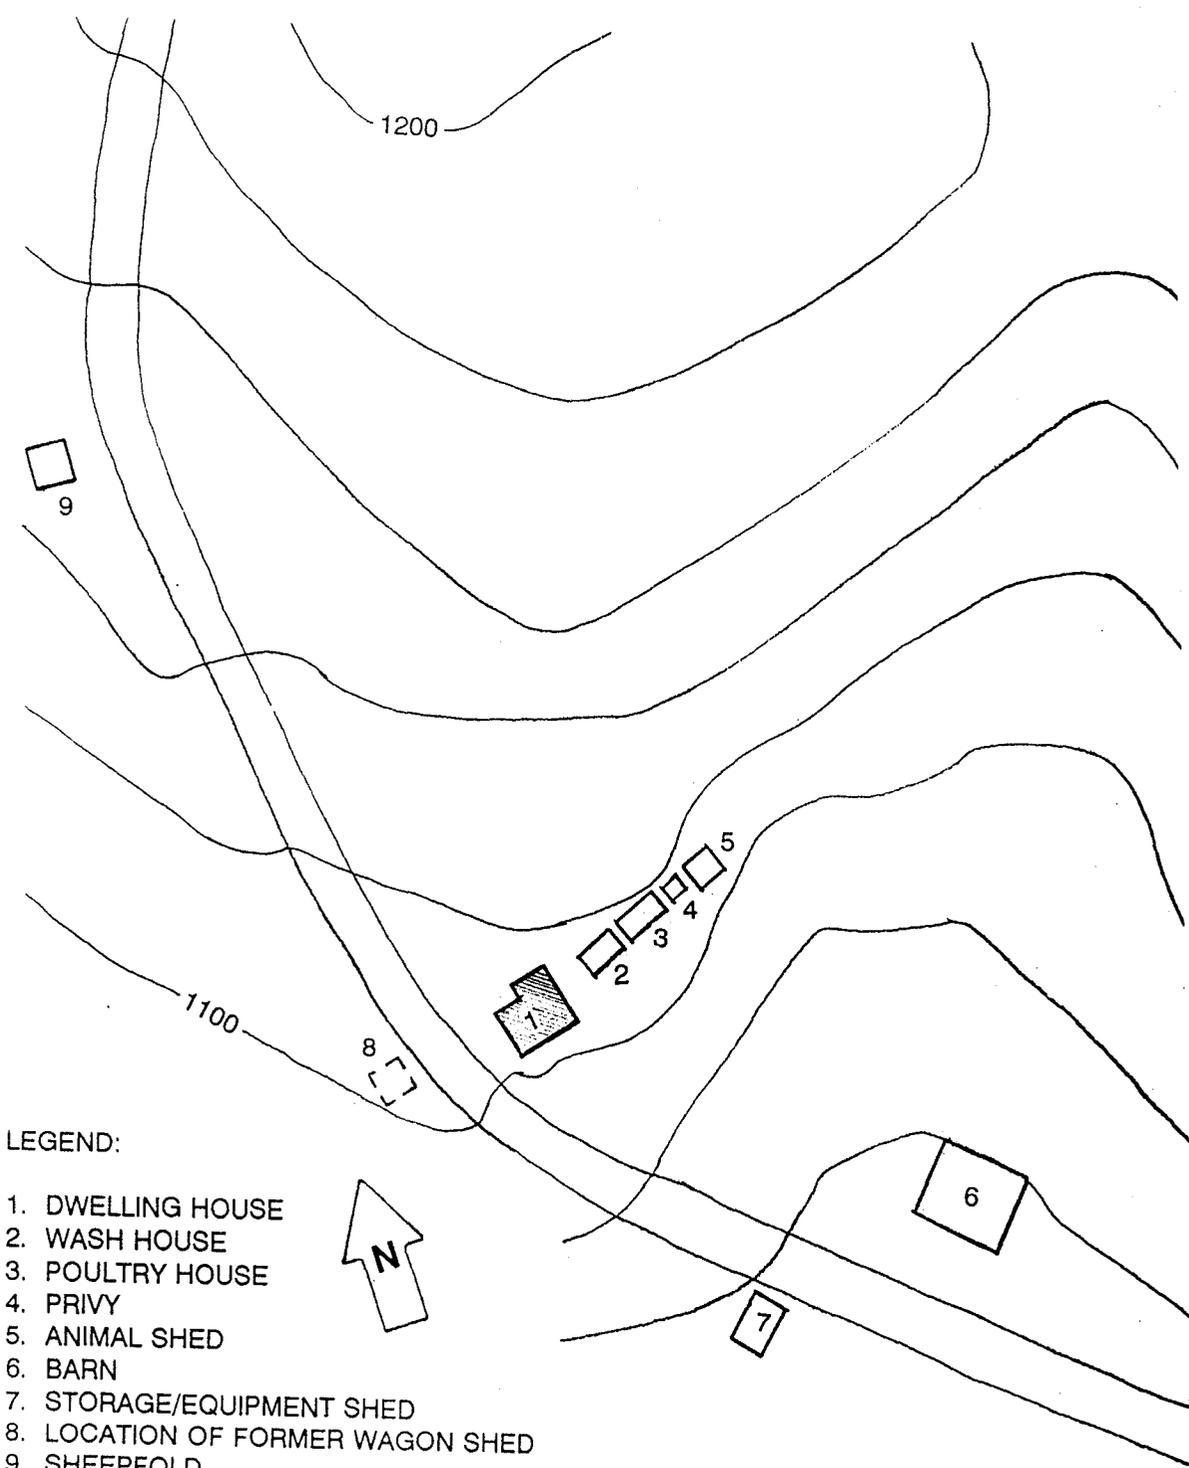
Location Plan
not to scale

1. DWELLING HOUSE
2. WASH HOUSE
3. POULTRY HOUSE
4. PRIVY
5. ANIMAL SHED
6. BARN
7. STORAGE/EQUIPMENT SHED
8. LOCATION OF FORMER WAGON SHED
9. SHEEPFOLD

3. Outbuildings: A row of frame outbuildings is located to the east of the house. Closest to the house is a mid nineteenth century wash house of vertical-plank construction. Beyond the wash house are a poultry house, privy, and animal shed, all of frame construction on earthfast piers; these structures incorporate a great deal of salvaged lumber, and all appear to date from the twentieth century. A wagon shed, now demolished, stood to the west of the house. A timber-frame bank barn is located to the southeast. There is a frame storage/equipment shed northwest of the barn. About 100

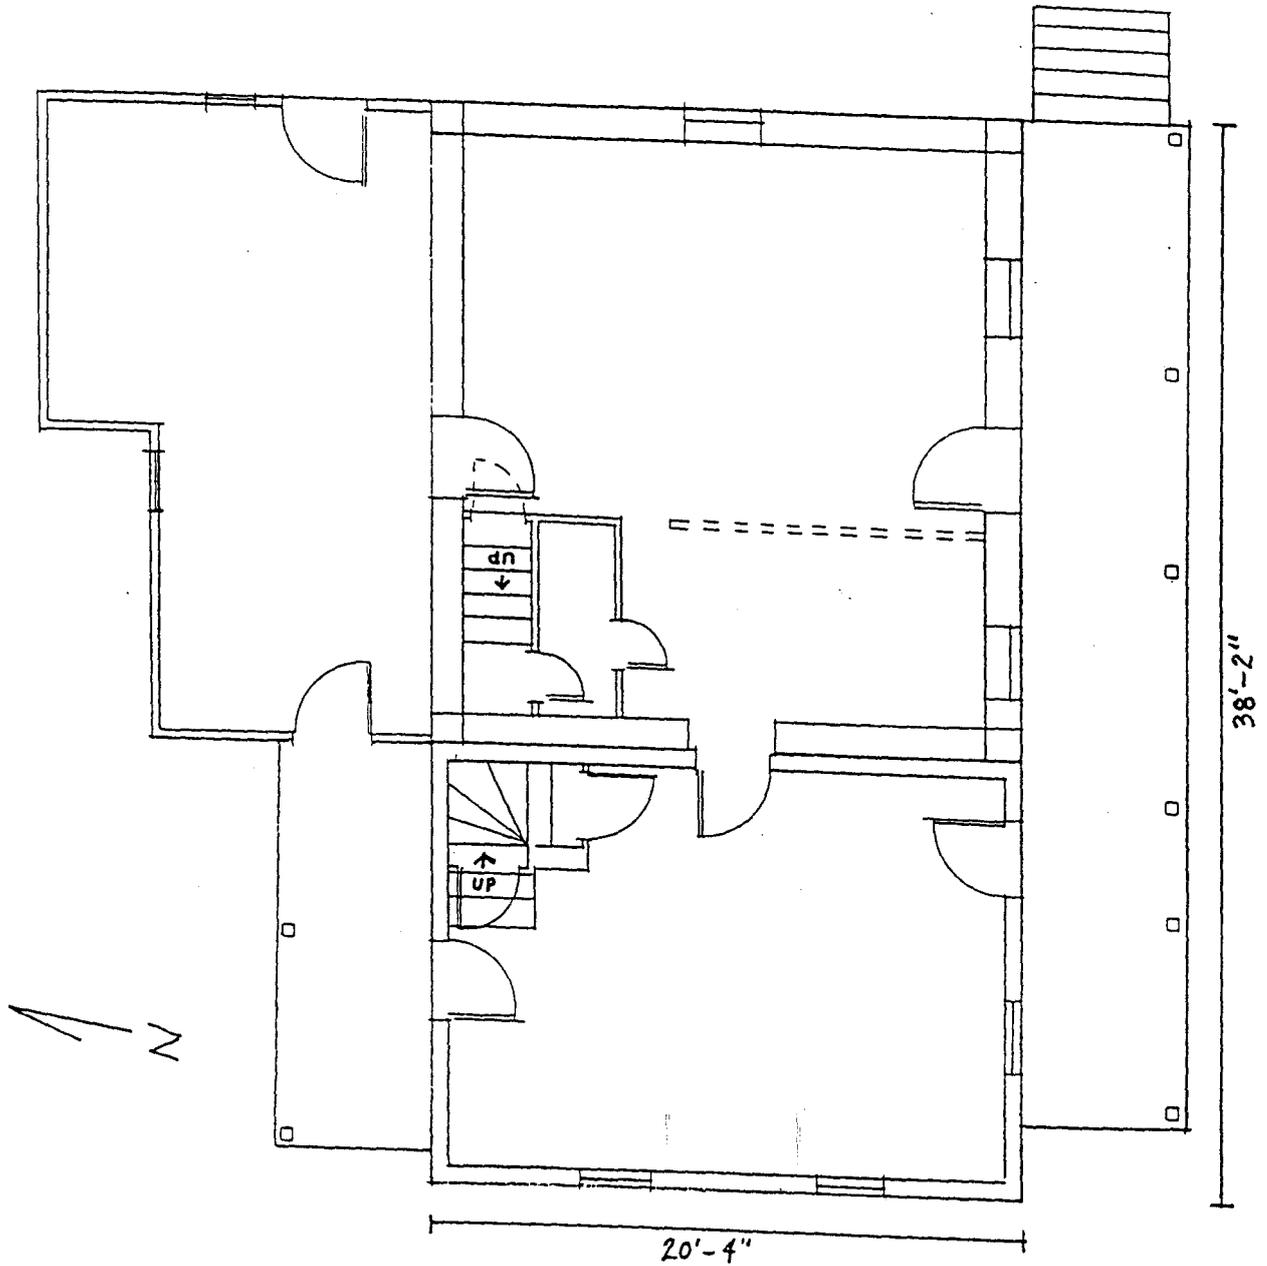
Sketch Plan, first floor
not to scale

- a. Basement: The basement under the log section comprises a single room with a dirt floor, partially excavated into a bank.
- b. First floor: The first floor of the log section was originally organized in a two-room, hall-parlor plan, with an enclosed stair in the northwest corner. At an undetermined date, the southern half of the partition which separated the two rooms was removed, and the remainder was incorporated into a large closet adjacent to the stair; the other wall of the closet is constructed of narrow beaded wainscoting, suggesting a late nineteenth or early twentieth century date for this alteration. Within the very recent past, an area in the southwest corner was subdivided to create a bathroom; these partitions have since been removed, and only a few framing members remain. The first floor of the 1880s addition comprises a single room, most recently used as a kitchen, with an enclosed stair in the northeast corner.

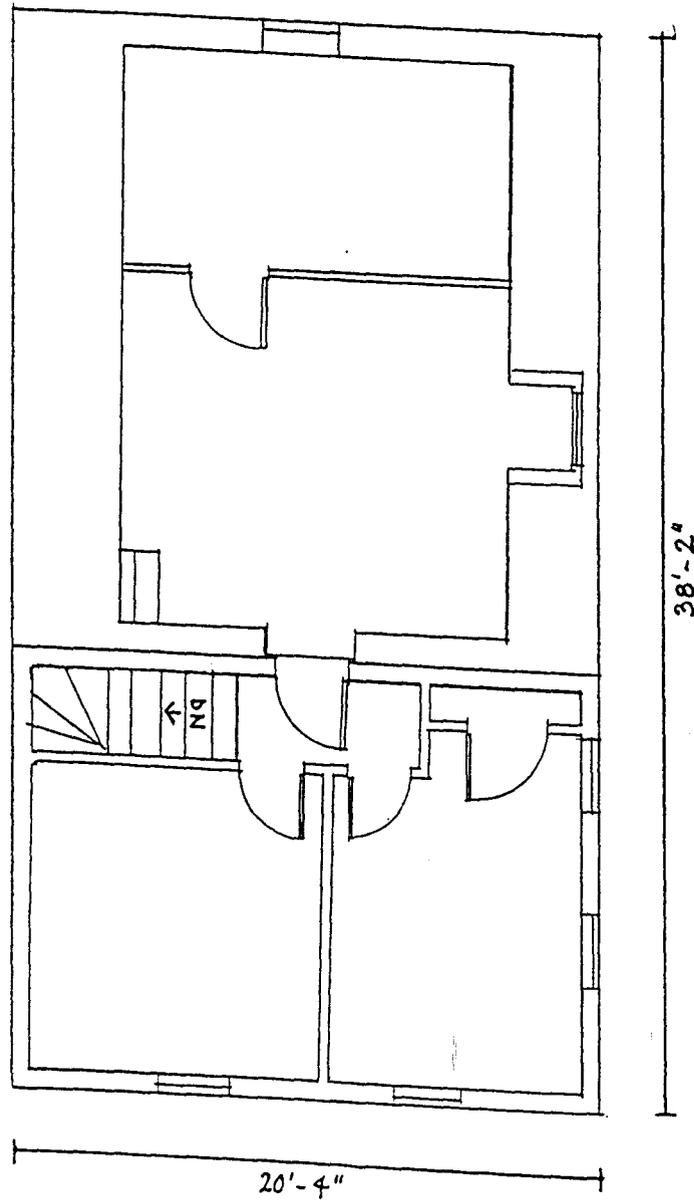
Sketch Plan, second floor
not to scale

- c. Second floor: The second floor of the log section comprises two unequal-sized rooms separated by a board partition with a batten door. The stair rises into the western room; this is the larger of the two, measuring 12'-4" by 19'-2". The east room measures 9'-4" by 19'-2", and is lighted by a window centered in the gable end. The west room is lighted by a dormer window in the south slope of the gable roof, installed in the 1880s renovation. The random width, tongue-in-groove boards in the partition were repositioned at an undetermined date, apparently in order to relocate the opening between the two rooms toward the north from its original central location; this feature suggests that the west room was once subdivided to create a passage across the northern portion of the space. On the second floor of the frame section, two chambers open off a narrow stair passage. The southwest room measures 10'-9" by 8'-11", and has a shallow closet in its southeast corner; windows are located in the south and east walls. The dimensions of the northwest room are 10'-9" by 9'-9"; this room has a single window in its west wall,

and a trap door to the attic in the northeast corner of its ceiling. A stovepipe formerly rose from the kitchen below, through this room, and exited via a brick stack constructed upon a shelf in the attic.
