Governors Island, Half Moon Battery
(South Battery, Corbin Hall, Officers Club, Building #298)
Governors Island
New York Harbor
New York City
New York County
New York

HABS No. NY-5715-11

PHOTOGRAPHS
WRITTEN HISTORICAL AND DESCRIPTIVE DATA

ARCHITECTURAL DATA FORM

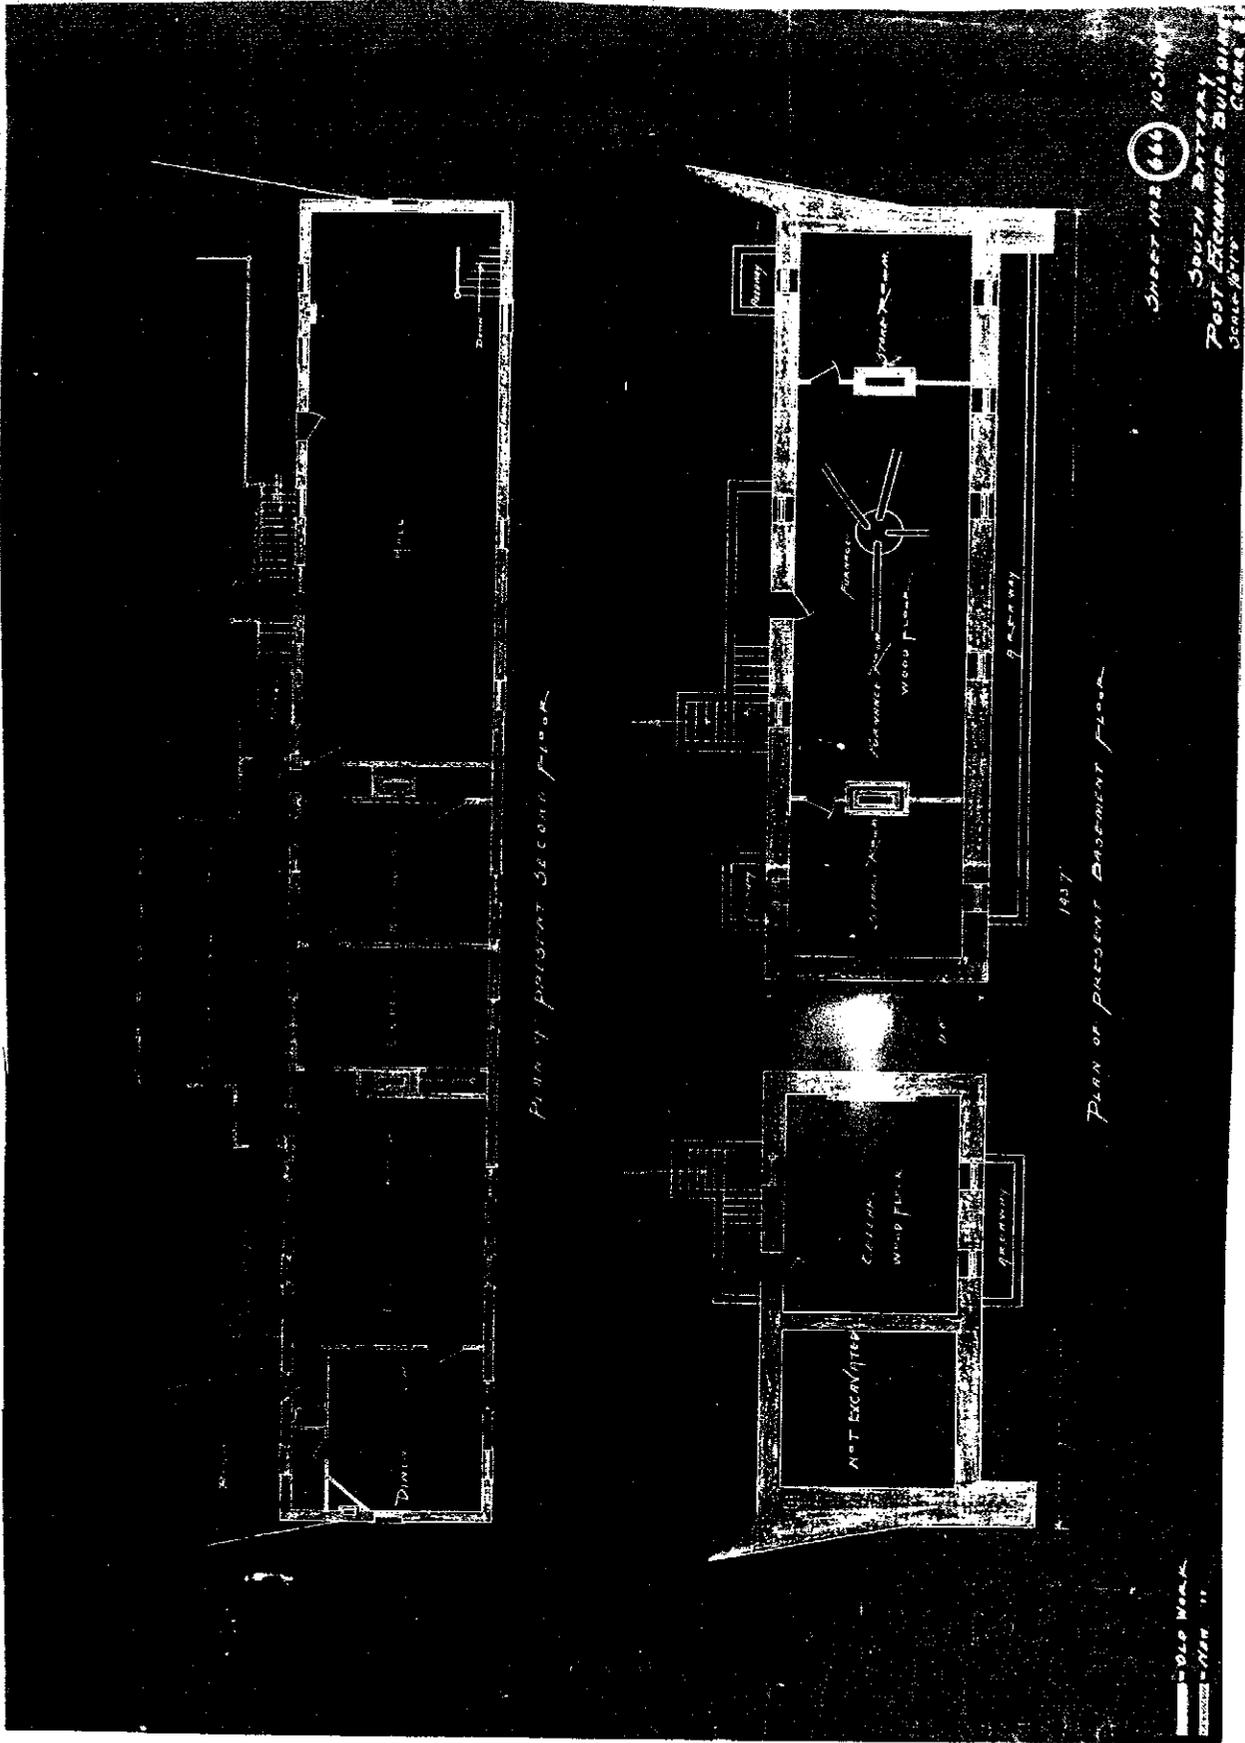
Photocopy of Drawing of South Battery, Building #298
National Archives, Architecture and Cartographic Branch
Record Group 77-Miscellaneous Forts File
Plans of Present Second and Basement Floors
Unknown Delineator and Date

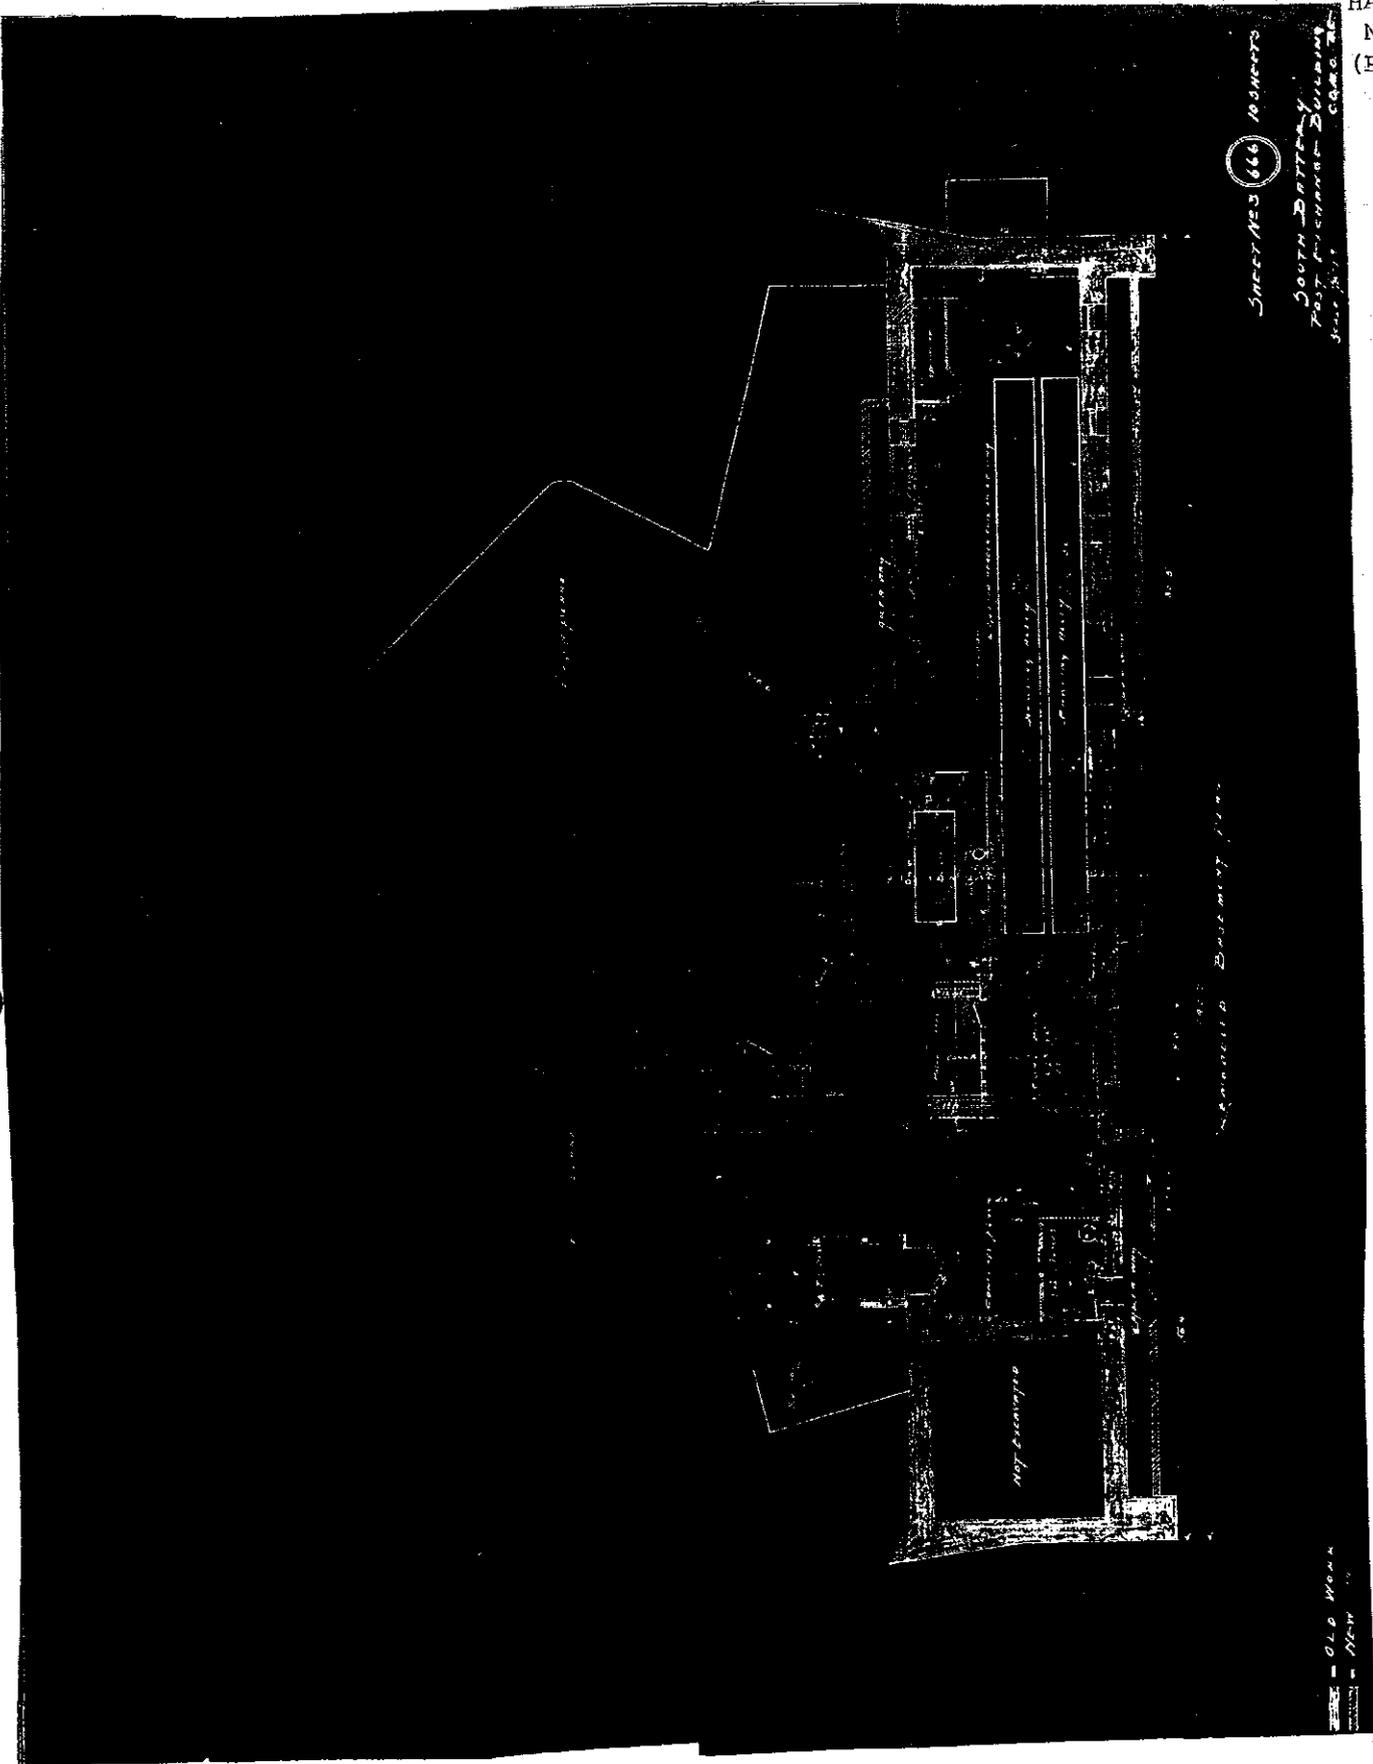
Photocopy of Drawings of South Battery, Building #298
 National Archives, Architecture and Cartographic Branch
 Record Group 77-Miscellaneous Forts File
 Plan of Remodeled Basement of Post Exchange Building
 Unknown Delineator and Date

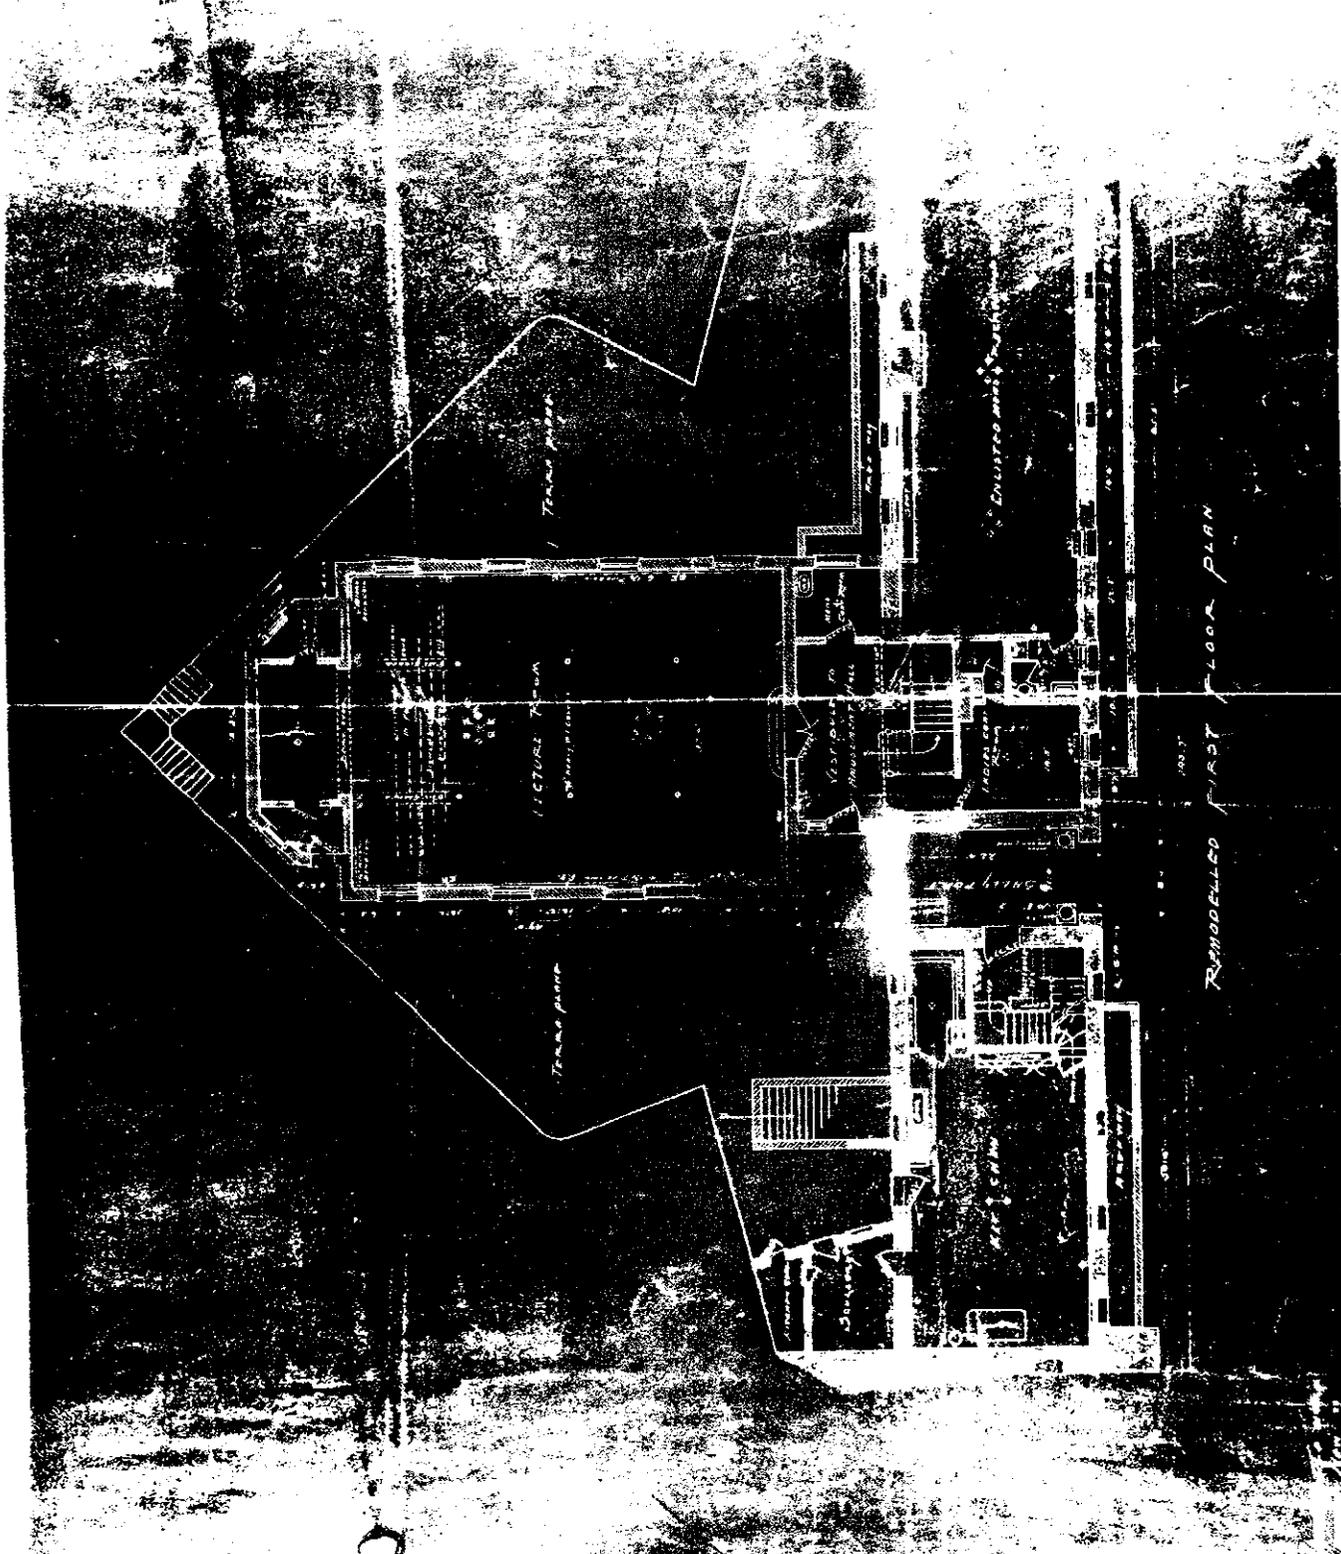
Photocopy of Drawings of South Battery, Building #298
National Archives, Architecture and Cartographic Branch
Record Group 77-Miscellaneous Forts File
Plan of Remodeled First Floor of Post Exchange Building
Unknown Delineator and Date

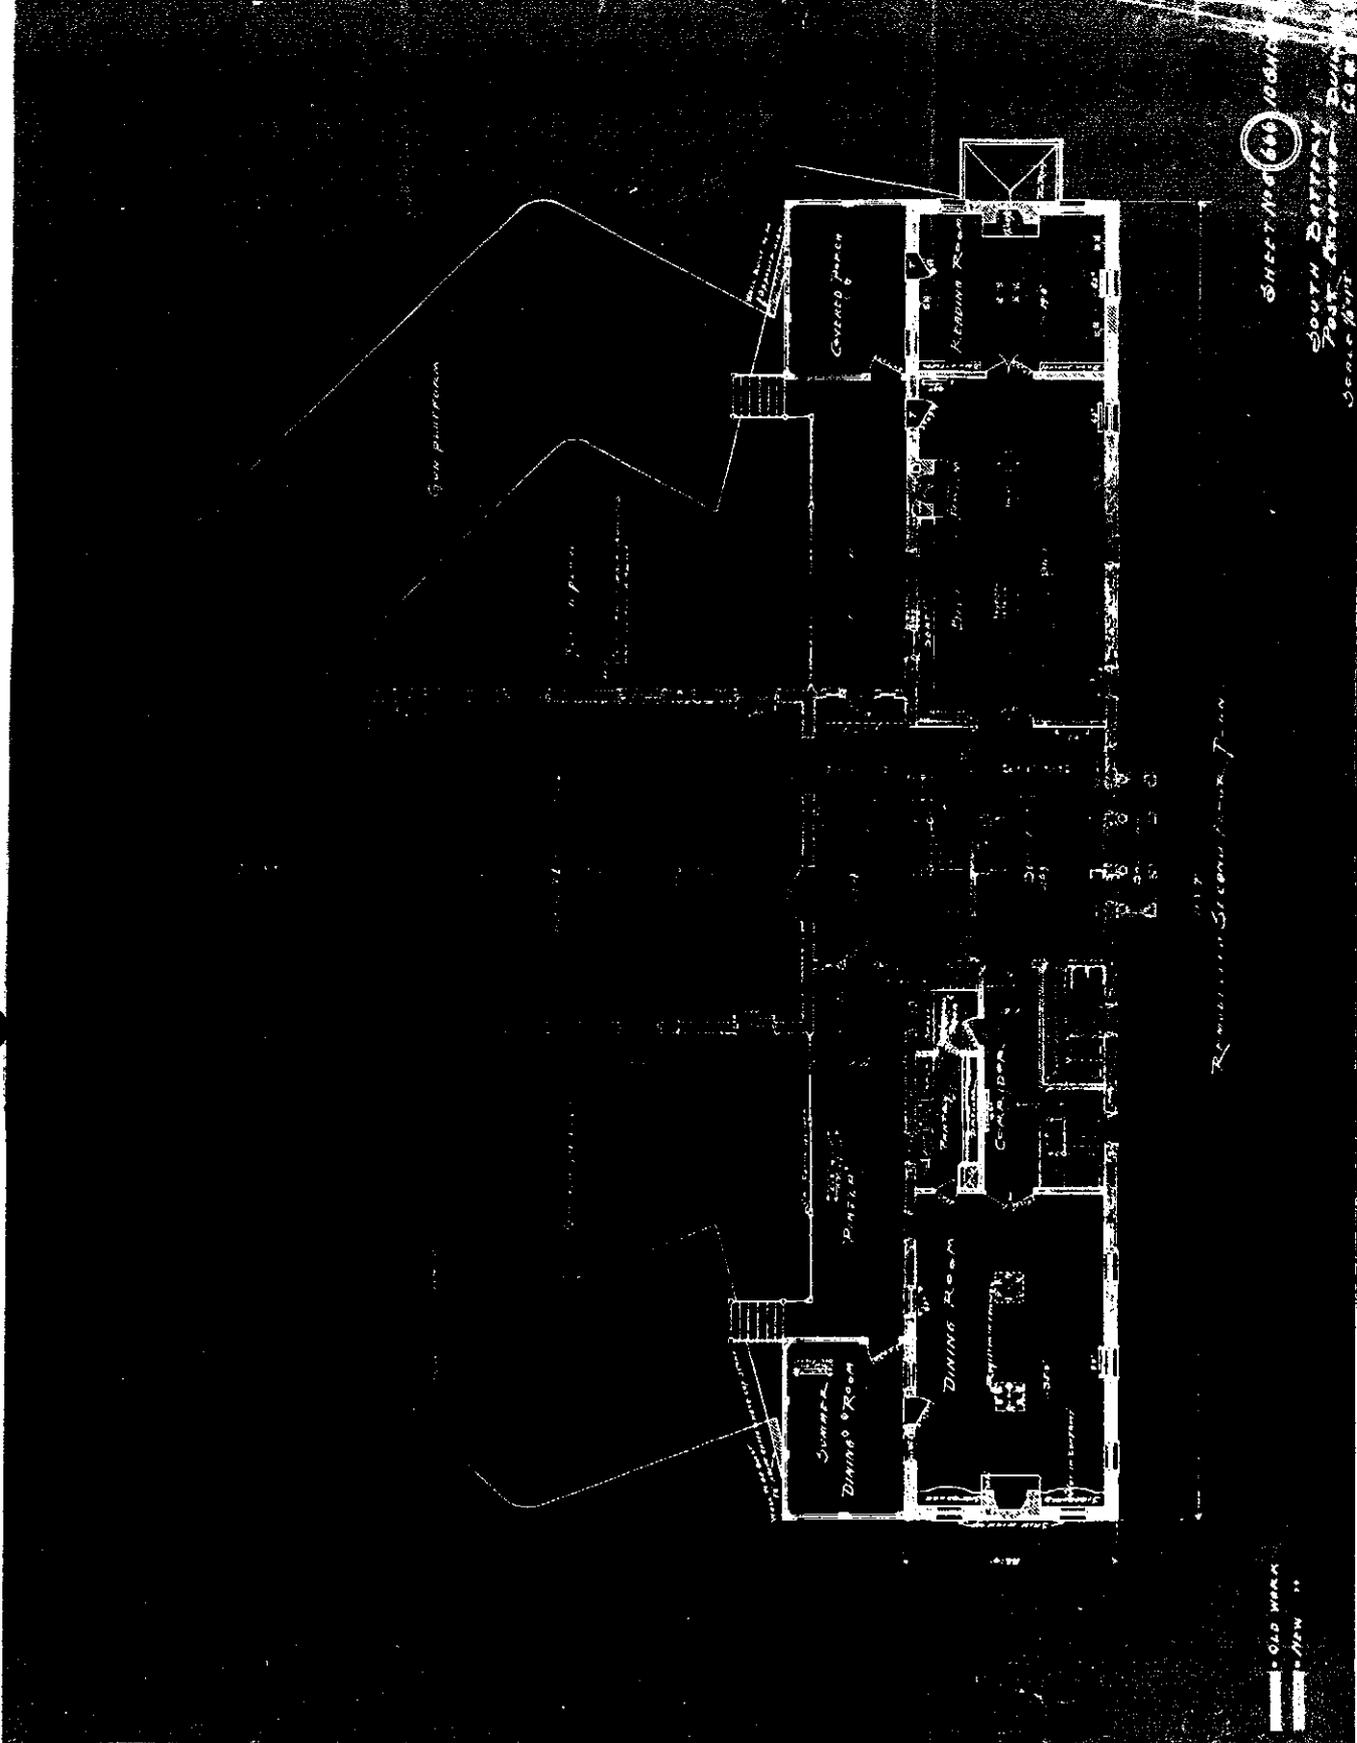
Photocopy of Drawings of South Battery, Building #298
National Archives, Architecture and Cartographic Branch
Record Group 77-Miscellaneous Forts File
Plan of Remodeled Second Floor of Post Exchange Building
Unknown Delineator and Date

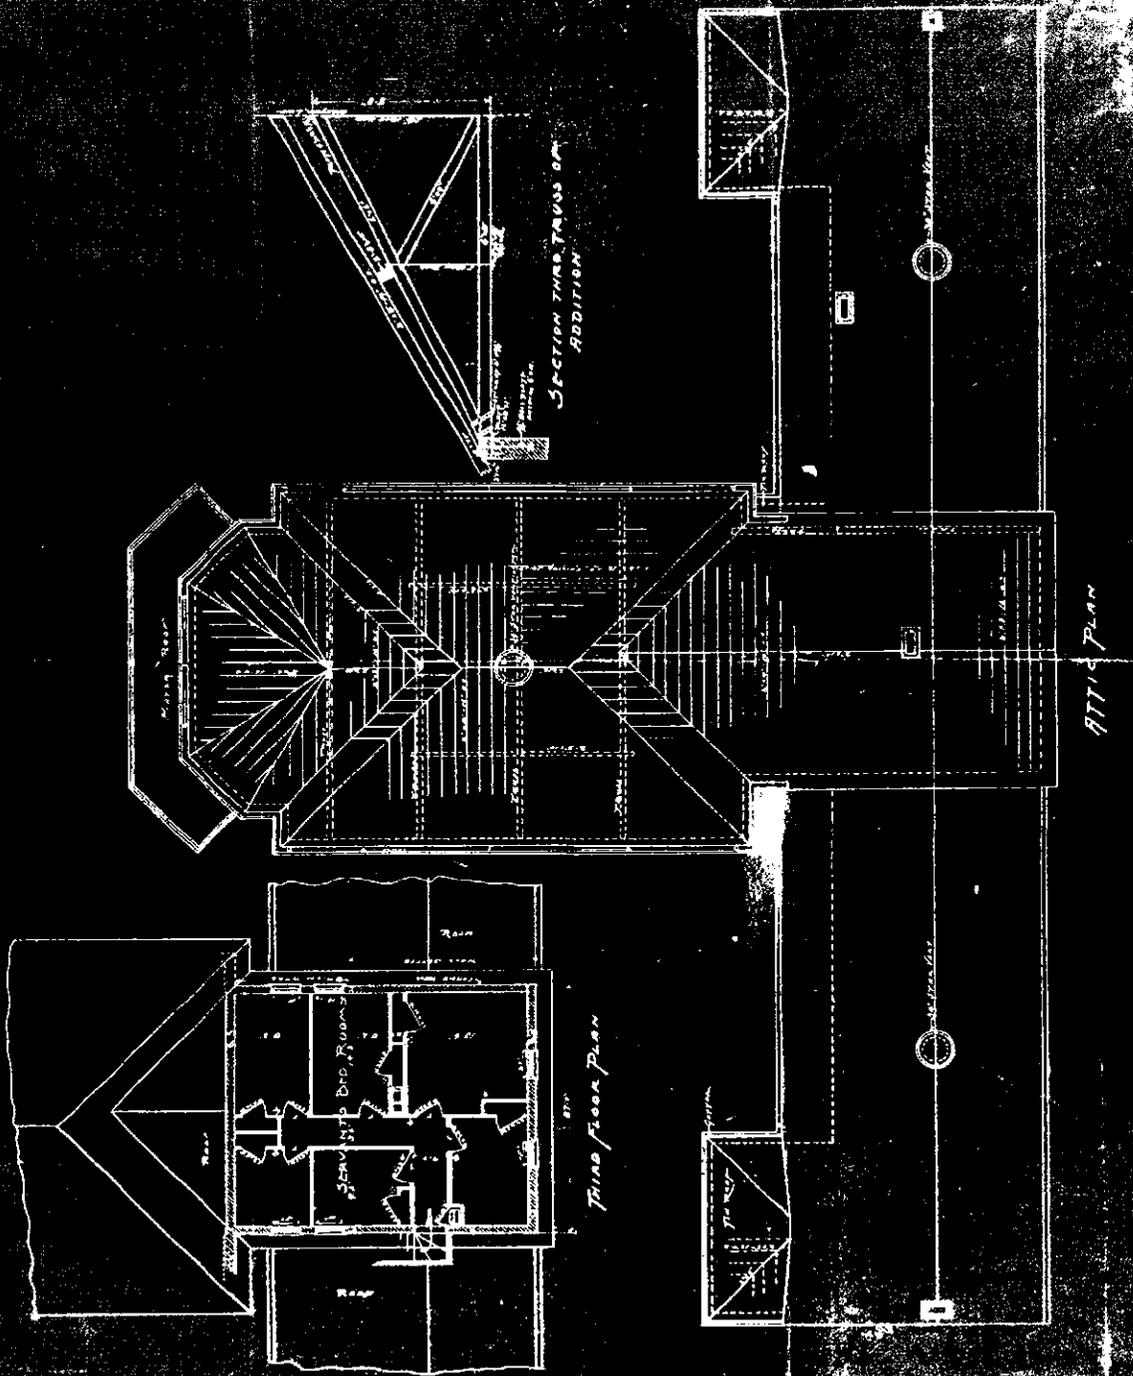
SHEET NO. 64
South Battery Building
East Battery Building
Star Building

Photocopy of Drawings of South Battery, Building #298
 National Archives, Architecture and Cartographic Branch
 Record Group 77-Miscellaneous Forts File
 Plans of Third and Attic Floors of Post Exchange Building
 Unknown Delineator and Date

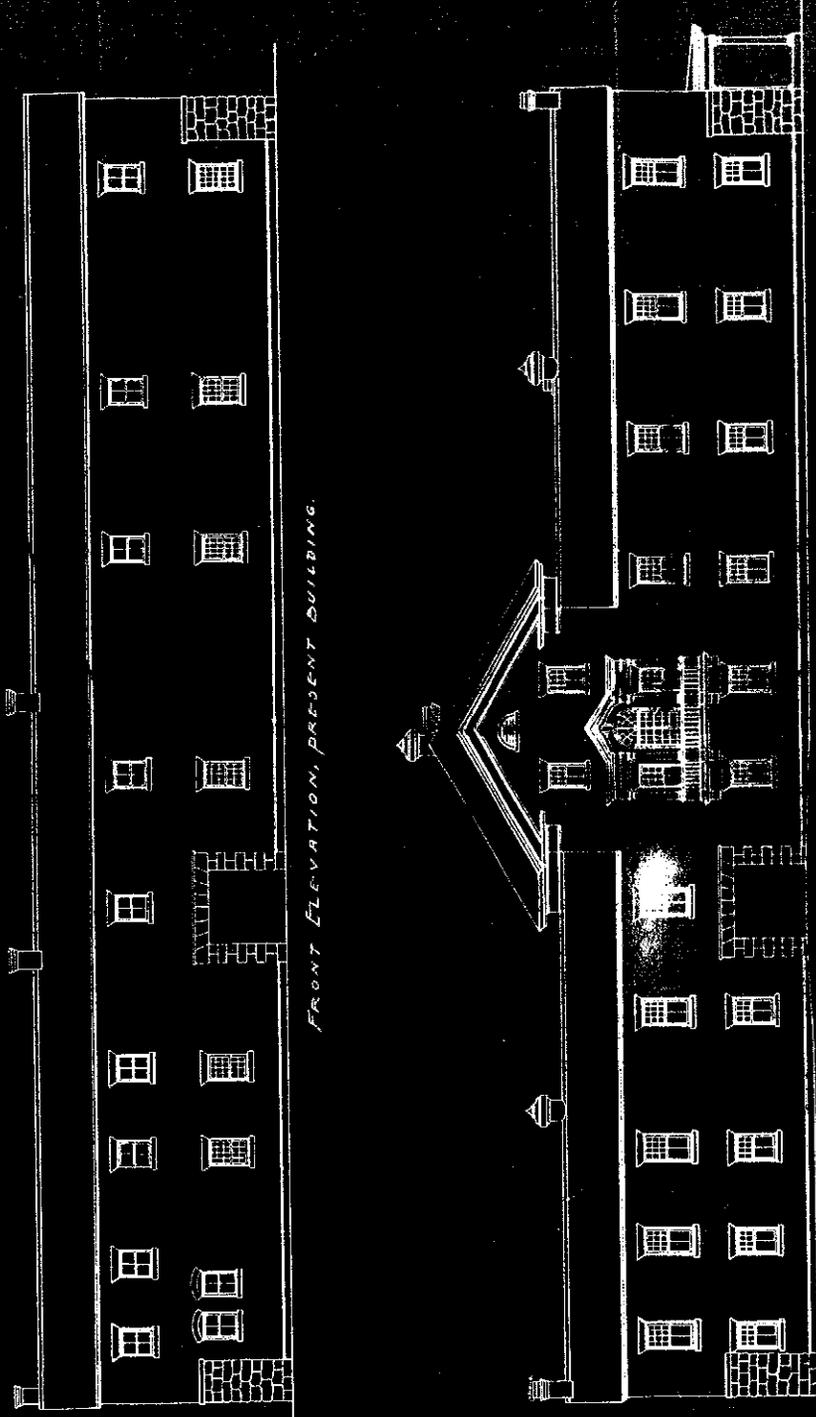
Photocopy of Drawings of South Battery, Building #298
National Archives, Architecture and Cartographic Branch
Record Group 77-Miscellaneous Forts File
Plans of South Front
Unknown Delineator and Date

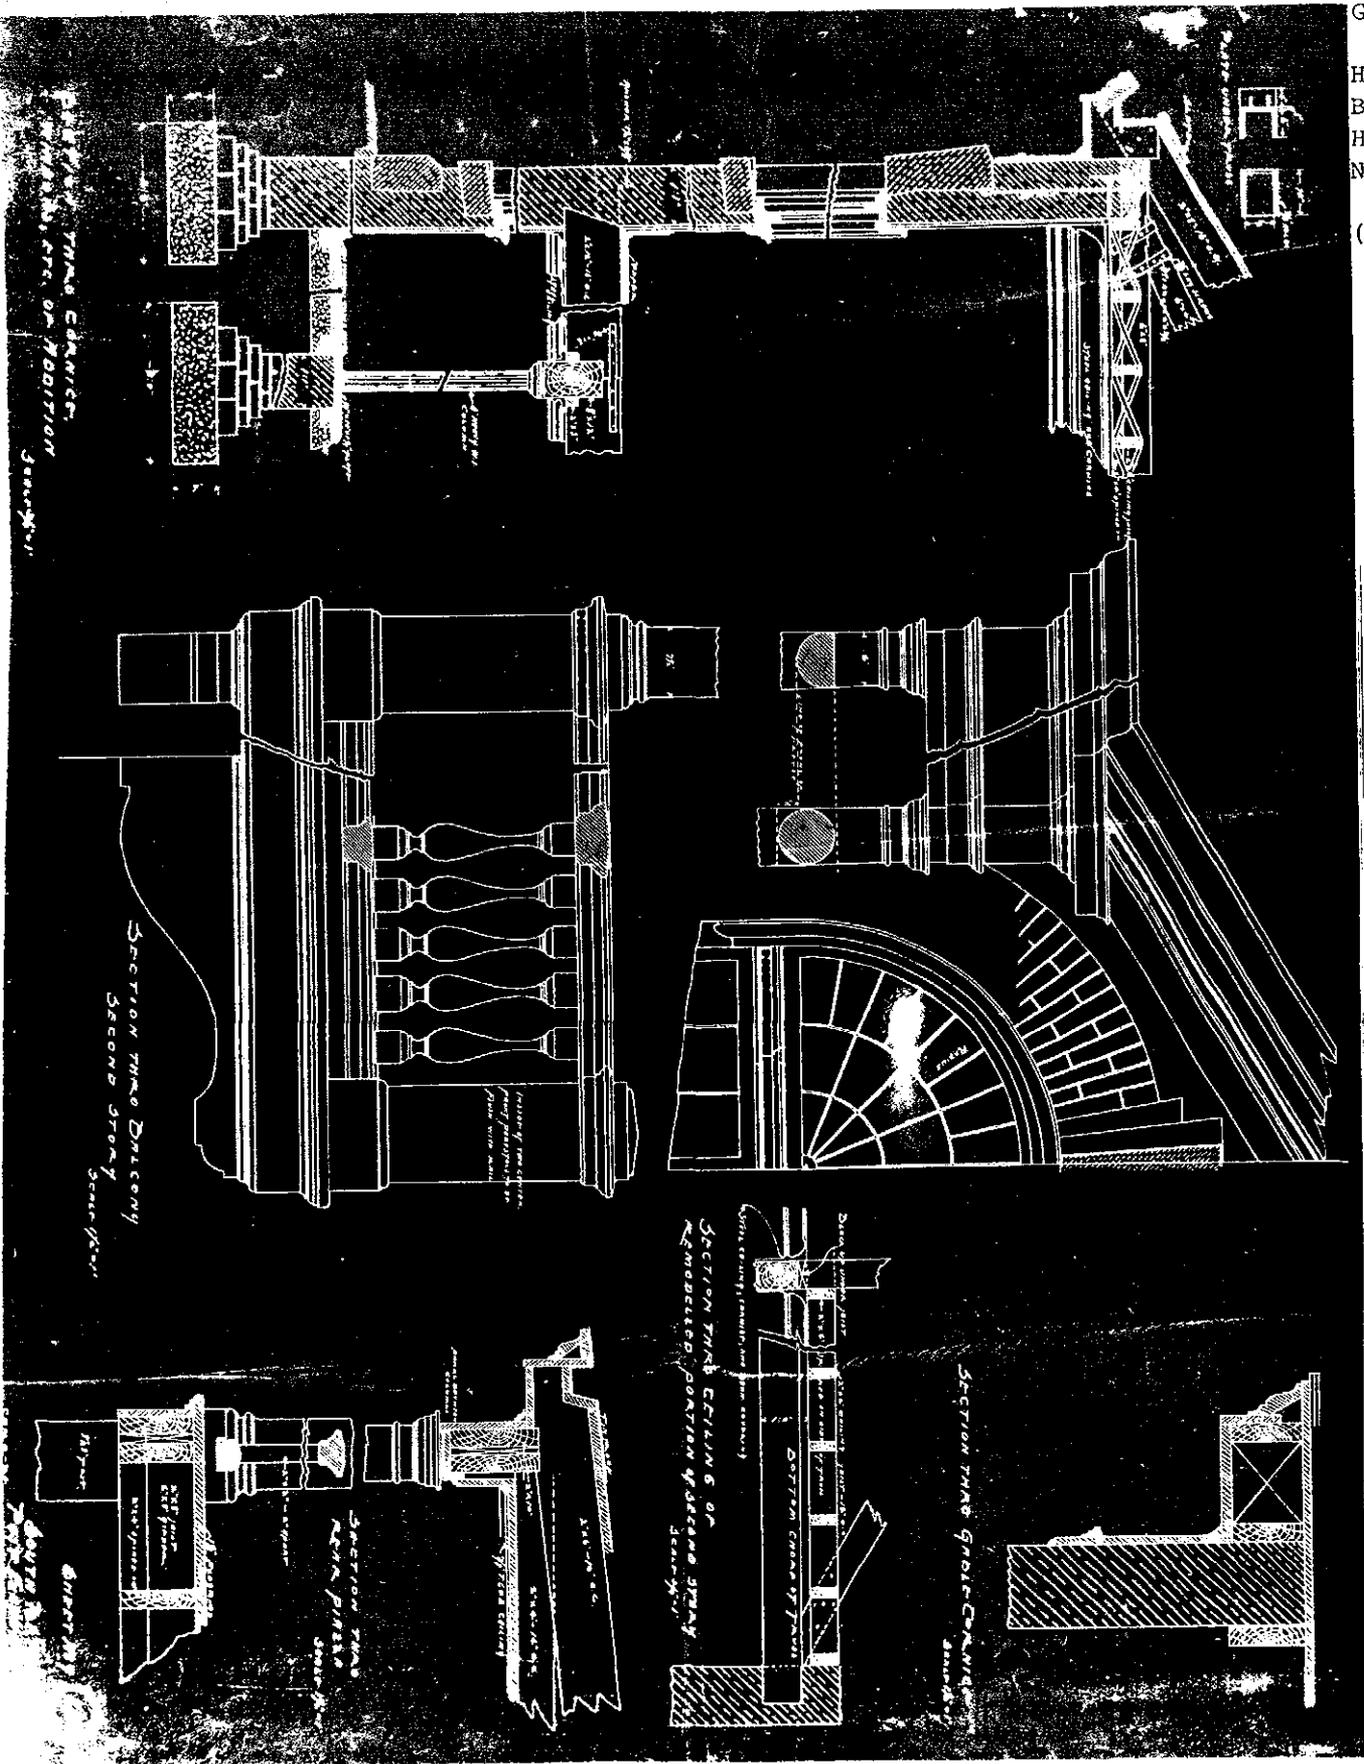
Photocopy of Drawings of South Battery, Building #298 National Archives, Architecture and Cartographic Branch Record Group 77-Miscellaneous Forts File Details of South Front Remodeling Unknown Delineator and Date

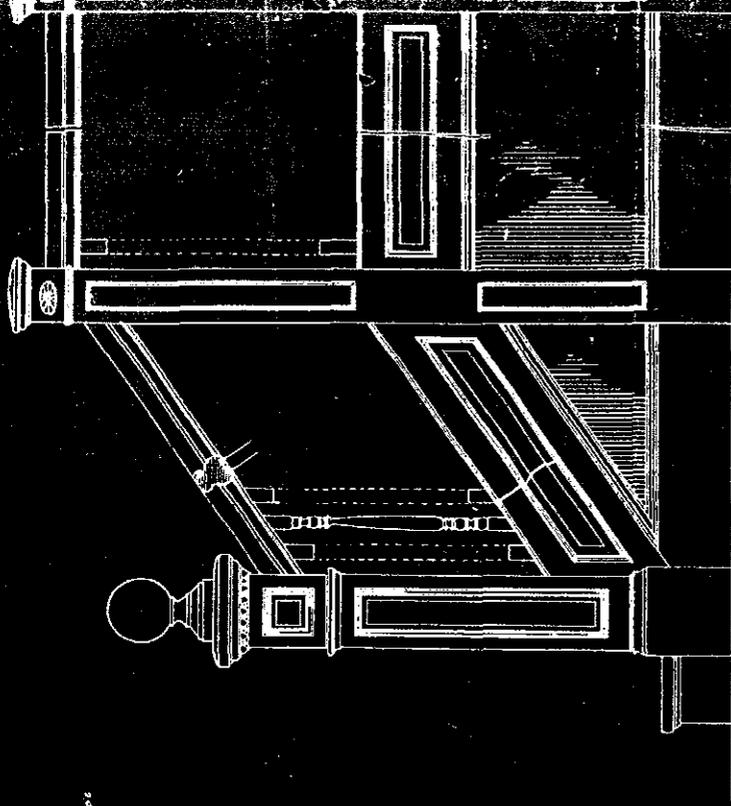
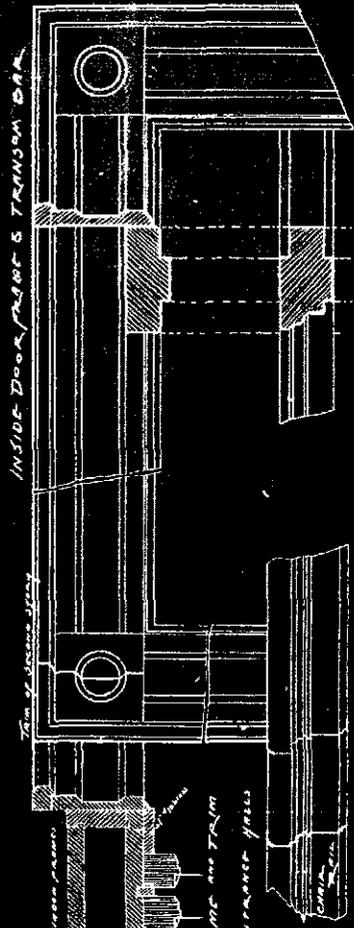
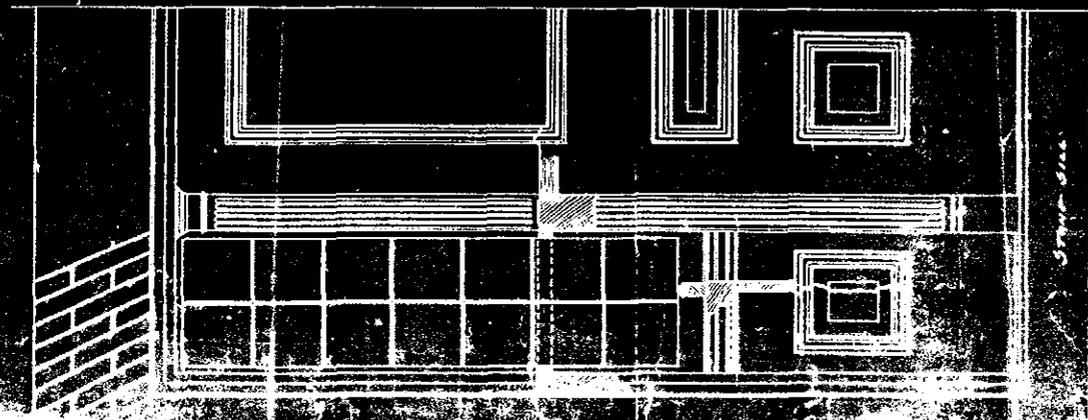
DETAIL OF MAIN STAIRWAYS
Scale 1/4" = 1'-0"

INSIDE DOOR, FRAME & TRANSOM BAR

SECTION THROUGH
SECOND STORY AND ENTRANCE
SCALE 1/4" = 1'-0"

Photocopy of Drawings of South Battery, Building #298
National Archives, Architecture and Cartographic Branch
Record Group 77-Miscellaneous Forts File
Exterior and Interior Details of Main Entrance
Unknown Delineator and Date
