**ADDENDUM TO:
HISTORIC AMERICAN ENGINEERING RECORD**

**NEW YORK STATE BARGE CANAL, LOCK E2
(Erie Canal, Lock E2)**

HAER No. NY-371

Appendix: Images of Current Conditions

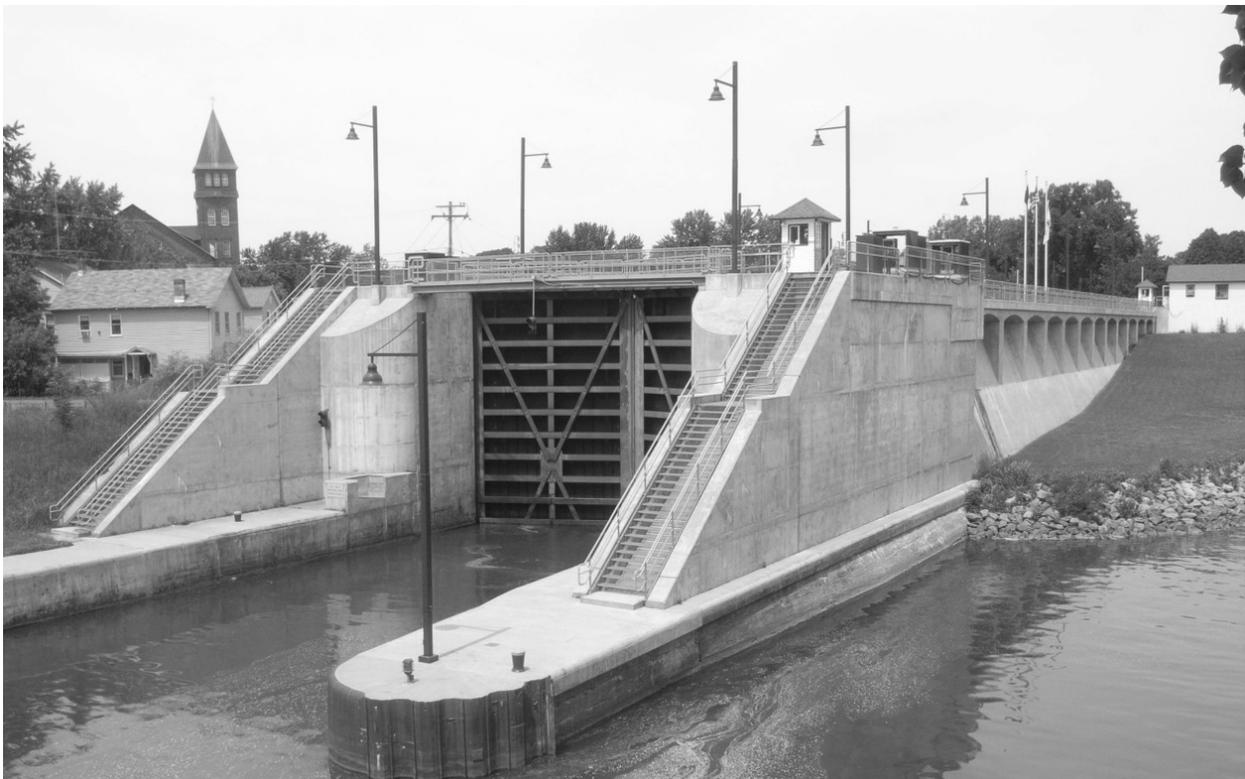
Image 1: Perspective view of lock gates and exposed exterior chamber wall. Field photograph taken by HAER recording team, summer 2009.

Lock E2 has a 33.5' lift with normal pool elevations of 15.20' below and 48.75' above. The east end of the north chamber wall is exposed, revealing twelve arches supporting the walkway and machinery. There are double-leaf, steel miter lock gates at each end of the chamber, operated by spars and gear trains powered by electric motors. The flow of water through the culverts in the chamber walls is controlled by valves also operated by electric motors. Control stand shelters are located at the upstream and downstream ends of the chamber. These consist of frame structures with horizontal wood siding, aluminum sliding windows, and a modern door. The shelters have asphalt shingle, pyramidal roofs. Modern chain-link fencing is attached to the lower sections of the pipe railings surrounding the lock, while modern light fixtures illuminate the site. The lock and control stand shelters are generally in good condition.

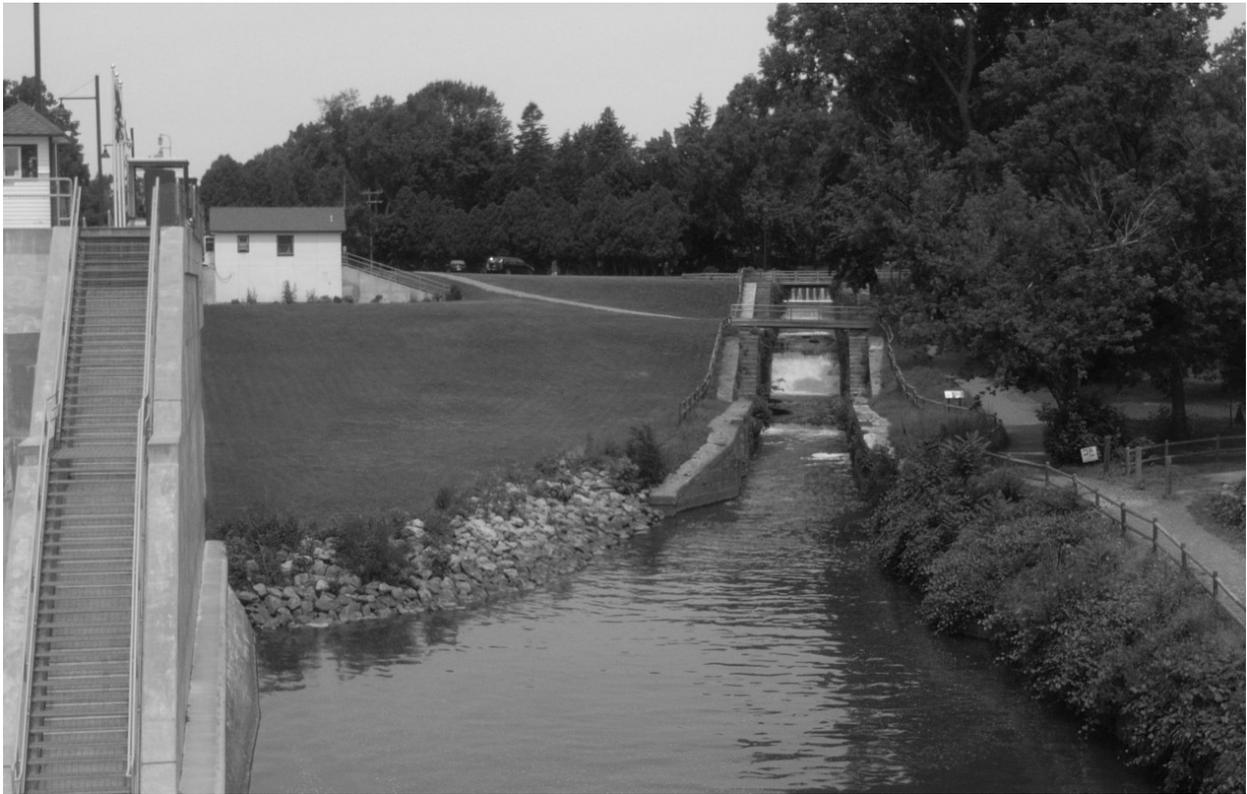
Image 2: View of nineteenth-century “Waterford Side Cut” with lock. Field photograph taken by HAER recording team, summer 2009.

A 1913 law required that the portion of the nineteenth-century Champlain Canal in this area be retained, and it serves as the spillway for the lock.³ The Champlain Canal remnant is lined with stone walls that are in good condition. A steel sheet-pile spillway at the inlet of this remnant is in good condition and helps regulate the pool level between locks E2 and E3. Sluice gates between the Champlain Canal alignment and the Erie Canal are in poor condition with only the concrete remnants visible. A modern pedestrian bridge also spans this alignment.
