NEW YORK STATE BARGE CANAL, WASTE WEIR (EAGLE
HARBOR)
(Erie Canal, Waste Weir (Eagle Harbor))
East of Eagle Harbor Road Bridge on south side of the canal
Gaines
Orleans County
New York

WRITTEN HISTORICAL AND DESCRIPTIVE DATA

HAER No. NY-493

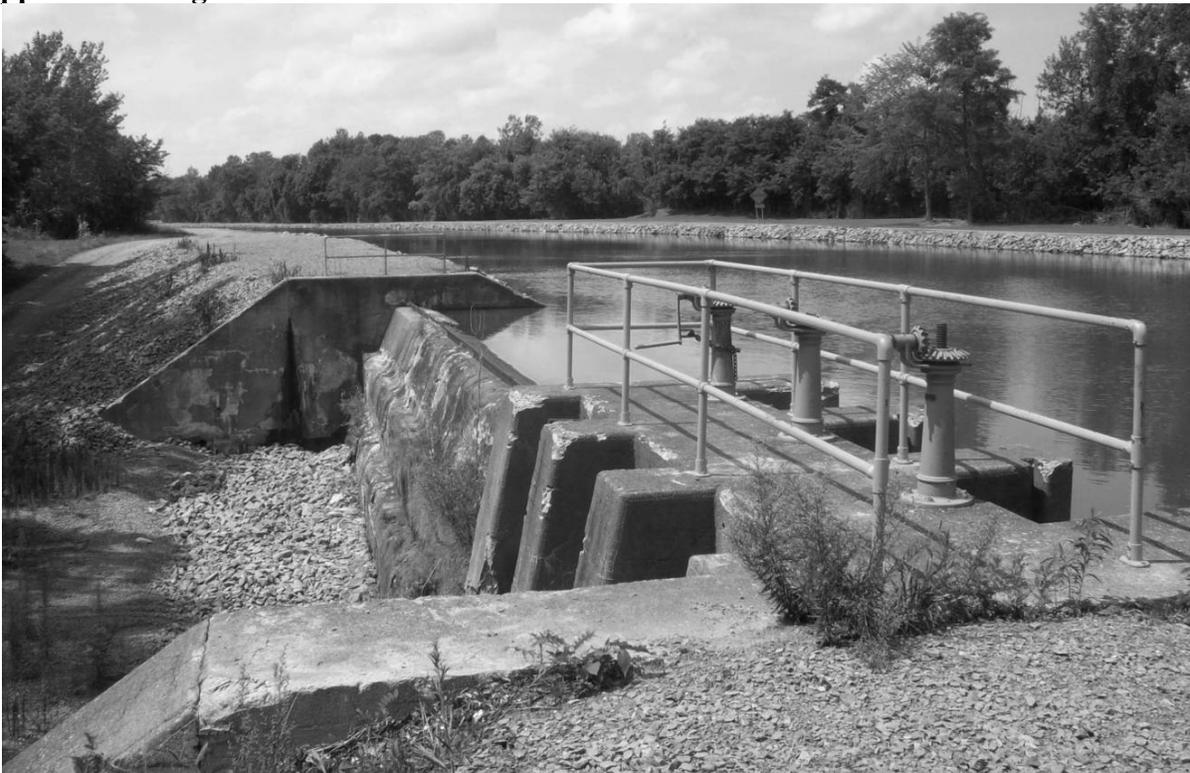
Image 1: Spillway in background and waste weir in foreground. Field photograph taken by HAER recording team, summer 2009.

Description: The waste weir is located on the south bank of the canal and consists of a fixed-crest concrete spillway with three sluice gates and steel operating stands.¹ Pipe railings line the concrete operating trestle. The spillway crest is equipped with a steel flashboard. The waste weir is in good condition.

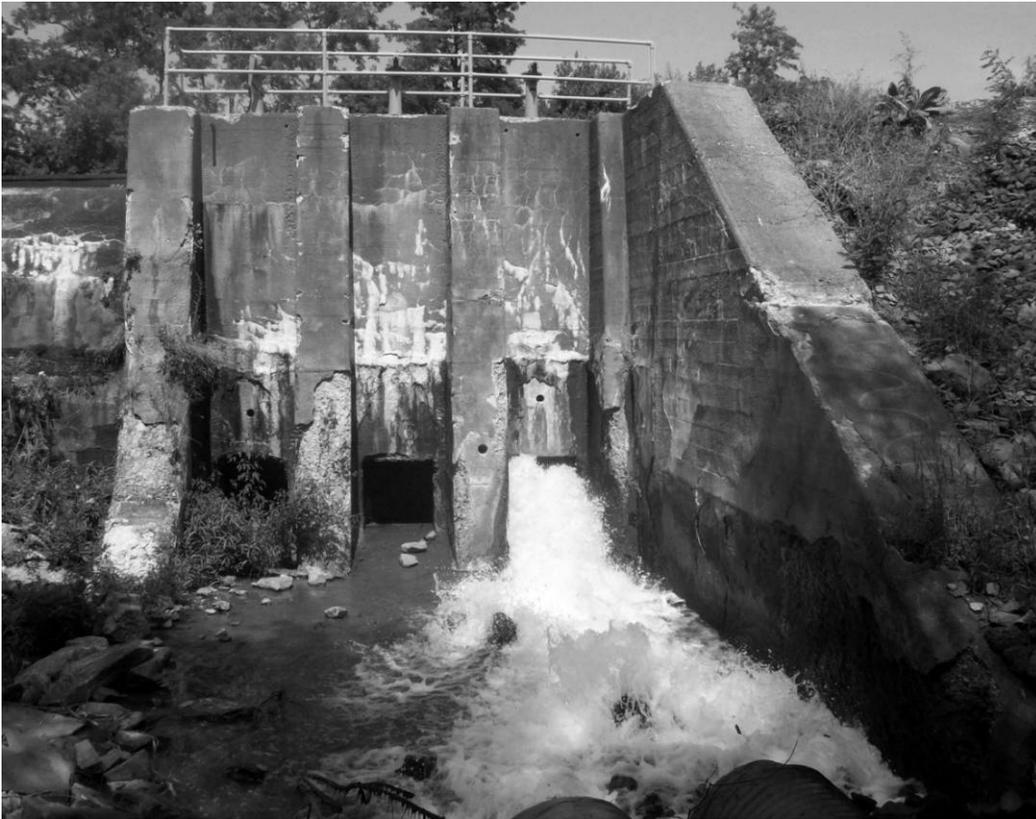
Image 2: Waste weir showing sluice gate openings. Field photograph taken by HAER recording team, summer 2009.
