NEW YORK STATE BARGE CANAL, EXCHANGE STREET LIFT
BRIDGE
(Erie Canal, Exchange Street Lift Bridge)
Exchange Street
Lockport
Niagara County
New York

WRITTEN HISTORICAL AND DESCRIPTIVE DATA

HAER No. NY-511

Location: Exchange Street, Lockport, Niagara County, New York

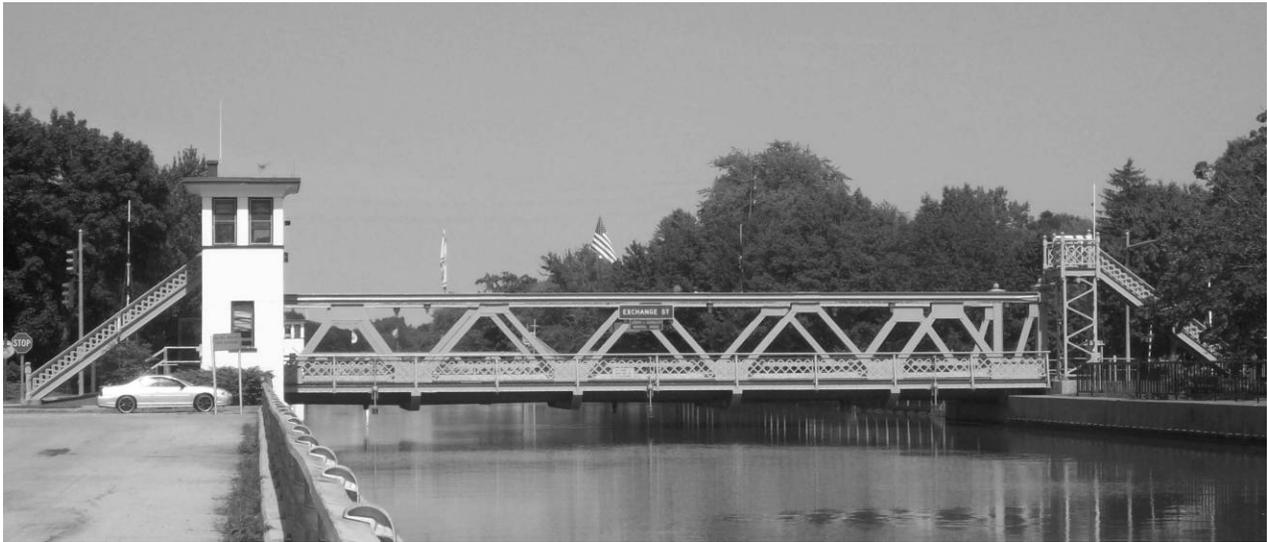
Image 1: Exchange Street Lift Bridge elevation. Field photograph taken by HAER recording team, summer 2009.

The vertical-lift bridge carries Exchange Street over the Erie Canal.² The steel Warren pony truss with decorative end posts sits on concrete abutments. It measures 133' long and 23.8' between curbs. The bridge has an open-grate deck for vehicular traffic and wood decking on the pedestrian walkways, which flank the truss and are lined with steel lattice. Steel stairways at either end of the west side of the bridge have cross-hatch treads and steel lattice railings. The machinery pits behind the concrete abutments are covered with cross-hatch plates. The bridge plate reads “McMyler-Interstate Co. Cleveland, Ohio, 1915.” The bridge is in good condition.

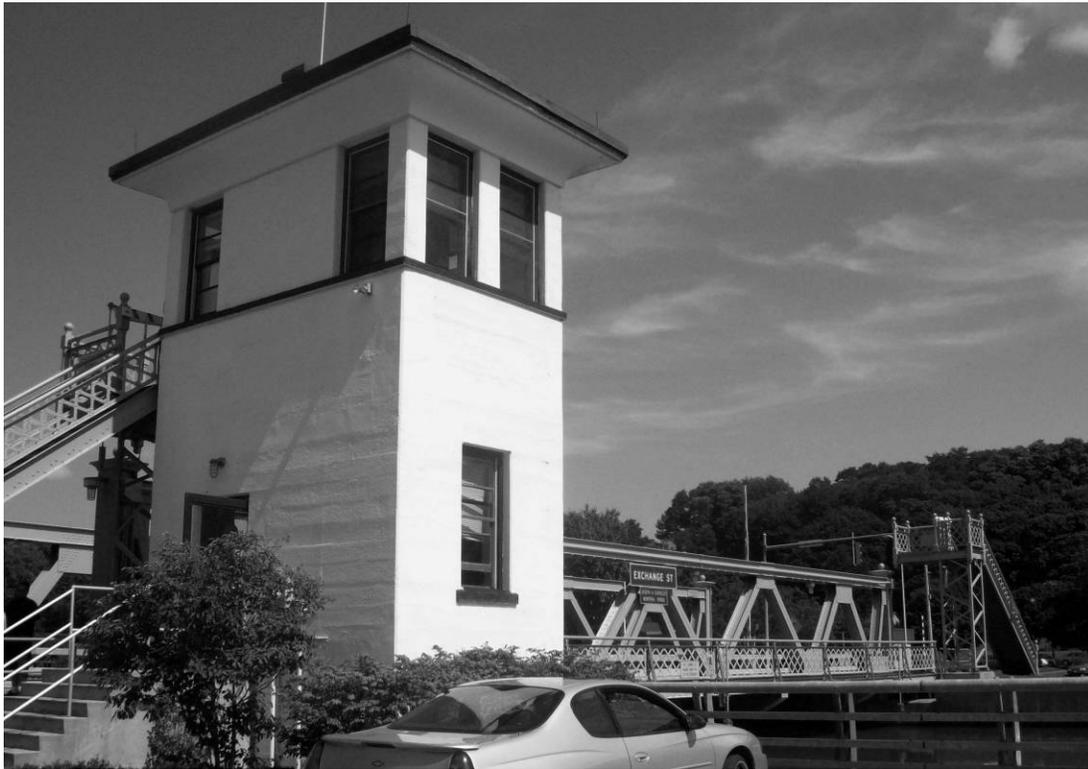
Image 2: Control tower. Field photograph taken by HAER recording team, summer 2009.

The control tower, located on the north bank of the west side of the bridge, is a two-story concrete building with a flat roof. The fenestration consists of two-over-two-light wood windows, and there is a pane-and-panel door. It is in good condition.
