NEW YORK STATE BARGE CANAL, GUARD GATE 18
(PENDLETON)
(Erie Canal, Guard Gate 18 (Pendleton))
Access off Bear Ridge Road
Pendleton
Niagara County
New York

HAER NY-518
HAER NY-518

WRITTEN HISTORICAL AND DESCRIPTIVE DATA

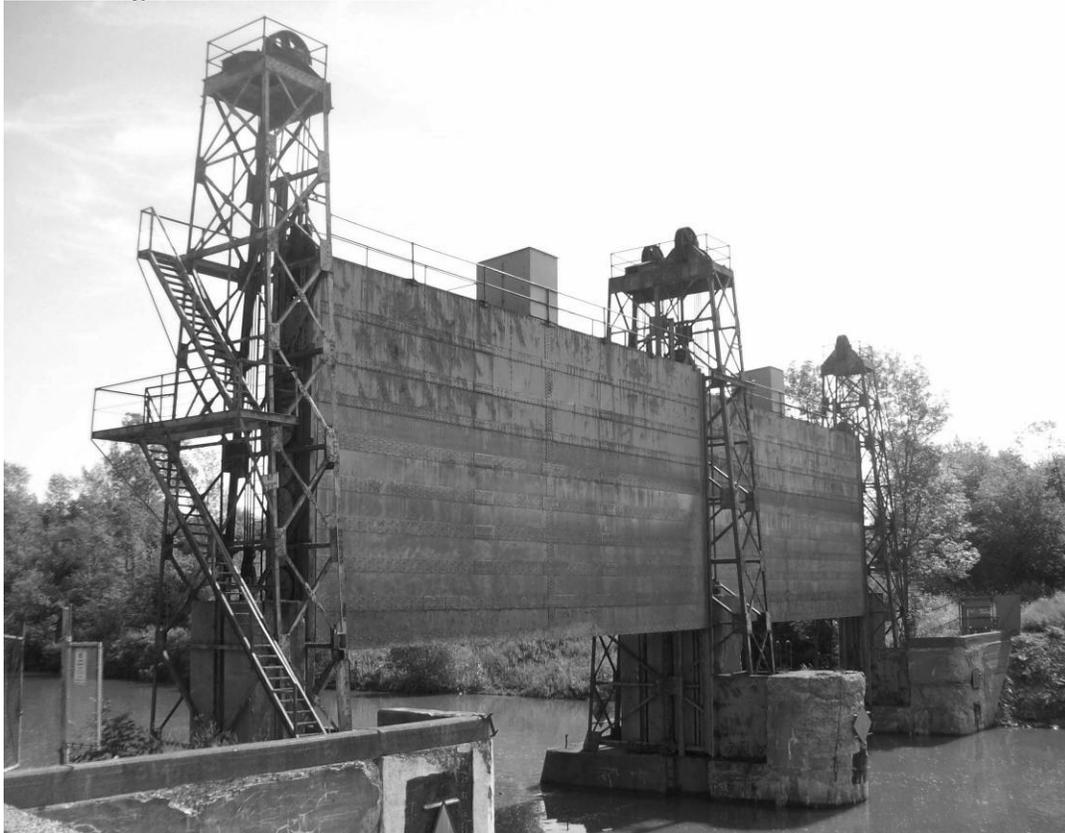
Image 1: Guard Gate 18. Field photograph taken by HAER recording team, summer 2009.

Description: Guard Gate 18 spans the Erie Canal and is typical of the guard gates on the Barge Canal.¹ It is accessed by a gravel driveway extending from Bear Ridge Road. The guard gate consists of a two-span, riveted-steel superstructure on concrete center piers and abutments. The 55'-wide steel gates are frame with steel skin plates on the upstream side. The guard gate operates with cables and steel and reinforced-concrete counterweights running over sheaves on steel lattice towers. A modern steel mechanical cabinet sits on top of each gate. There is a tall concrete bulkhead on the upstream (west) side of the guard gate, which was probably installed to protect the Lockport cut from surges in the Niagara River and Tonawanda Creek. Guard Gate 18 is in fair condition, due to rusting of the superstructure and heavy spalling on the abutments and piers.

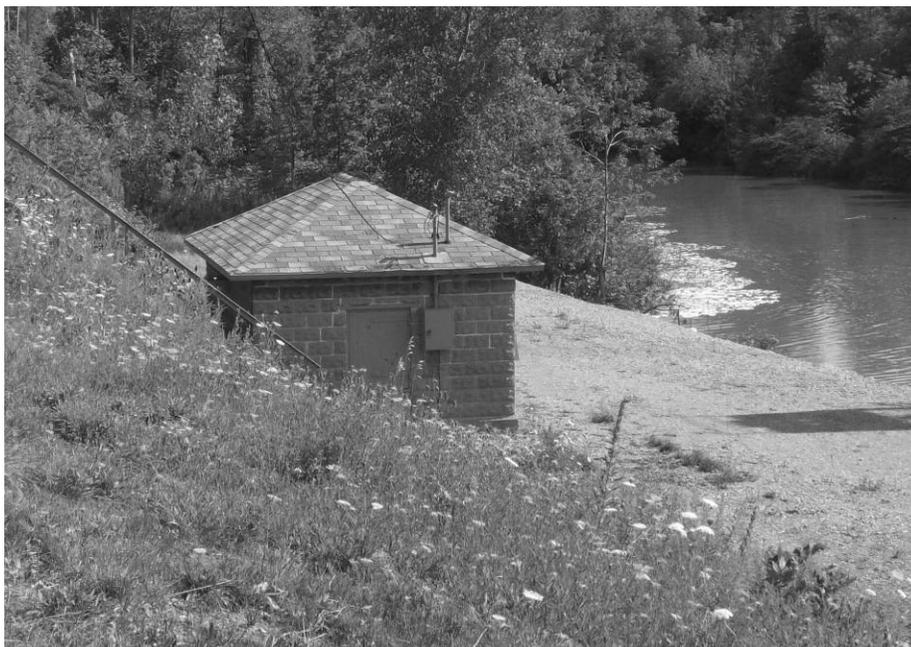
Image 2: Control house. Field photograph taken by HAER recording team, summer 2009.

The guard gate is somewhat unusual in that there is a control house at the site. The single-story rock-faced concrete block building sits on a concrete foundation. The hipped roof is covered with asphalt shingles. There are hinged steel window coverings and hinged steel doors. The control house is in good condition.
