THE HORSE RANCH, CHICKEN HOUSE
Wallowa-Whitman National Forest
Joseph vicinity *Eagle Cap Wilderness Area*
Wallowa County
Oregon

HABS No. OR-165-E

HISTORIC AMERICAN BUILDINGS SURVEY
THE HORSE RANCH (Red's Horse Ranch), Chicken House

HABS NO. OR-165-E

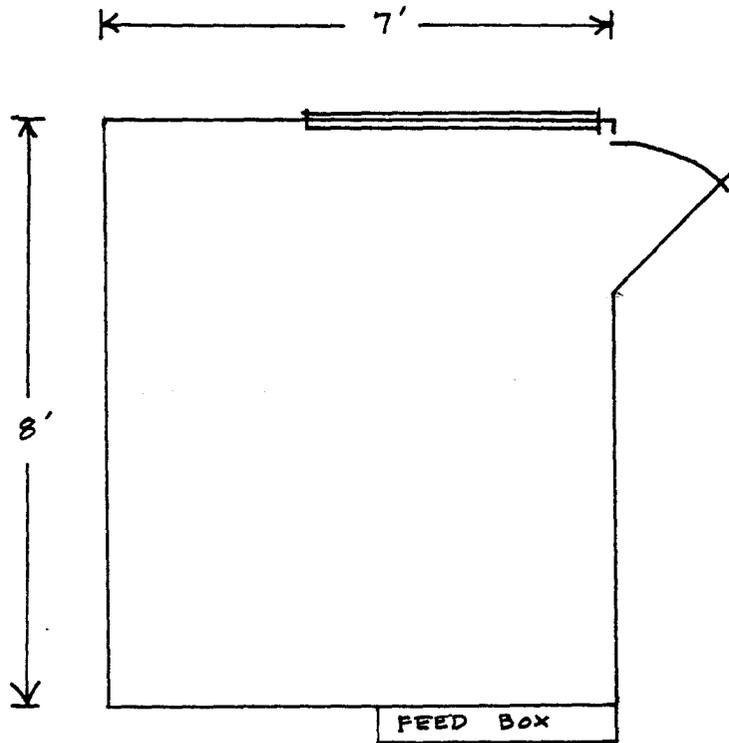
CHICKEN HOUSE

Description: The chicken house, measuring approximately 8' N.S. x 7' E.W., is a pole frame structure covered with a shed roof. The roof is supported by small peeled logs. The walls are sheathed with wide machine-sawn vertical and horizontal wood planks. A hinged door is on the east elevation and an off-centered window, covered with chicken wire, is on the north elevation. A small opening is located at the base of the building on the west elevation. The shed roof is comprised of three sapling purlins covered with corrugated metal. The foundation system consists of three small logs extending north-south that support the structure. The chicken house has a wood floor. The building is in fair condition.
