ISABELLA SCOTT HOUSE
683 Park Avenue
Meadville
Crawford County
Pennsylvania

HABS No. PA-5928

HISTORIC AMERICAN BUILDINGS SURVEY

ISABELLA SCOTT HOUSE

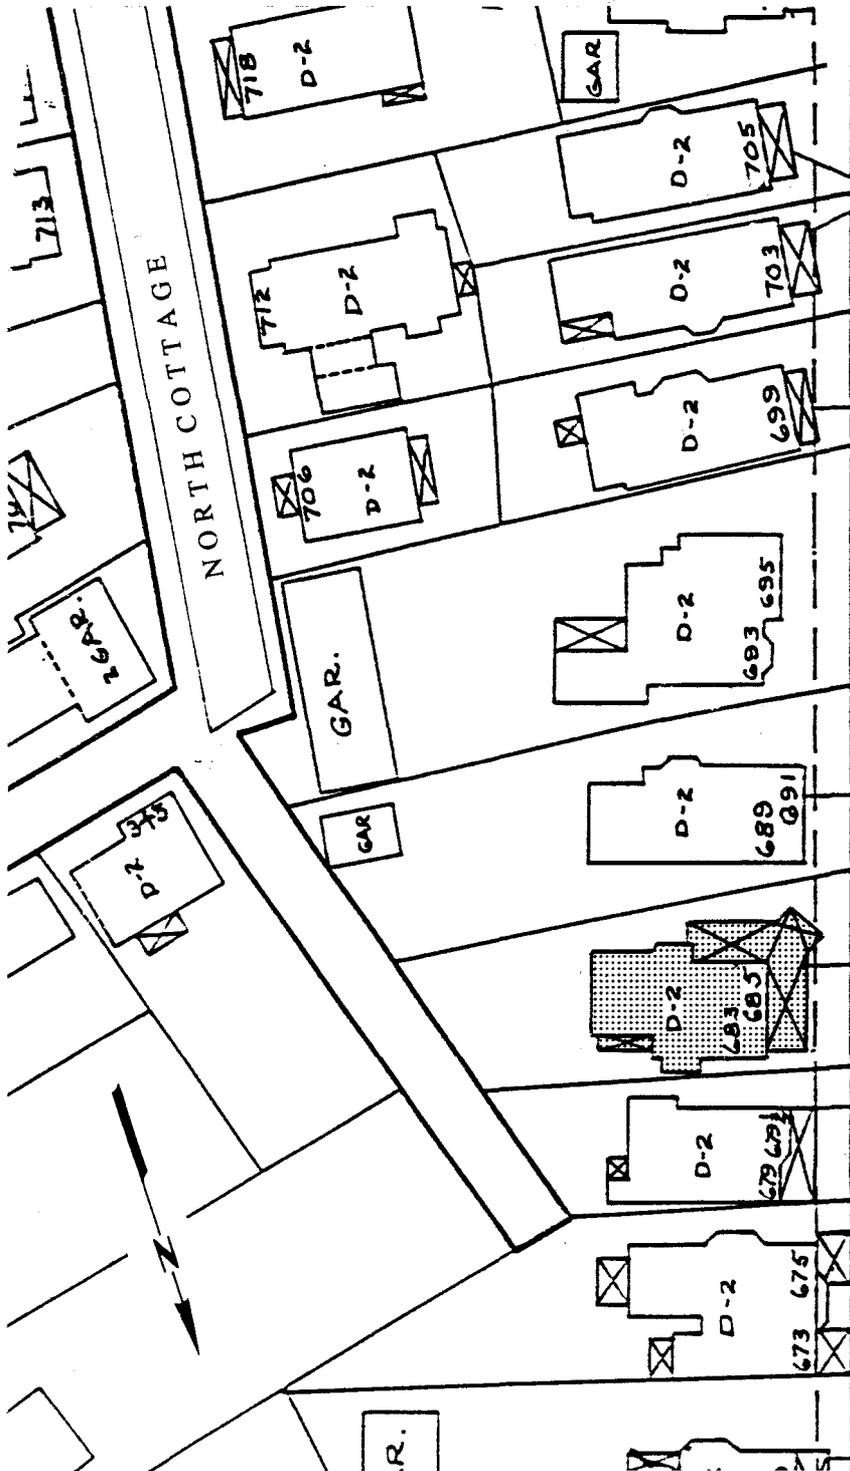
PARK AVE.

Immediate Setting of House on Park Avenue, July 1992
Source of Map: Water Line Map, June 1992, Technical Support Services,
City of Meadville, PA

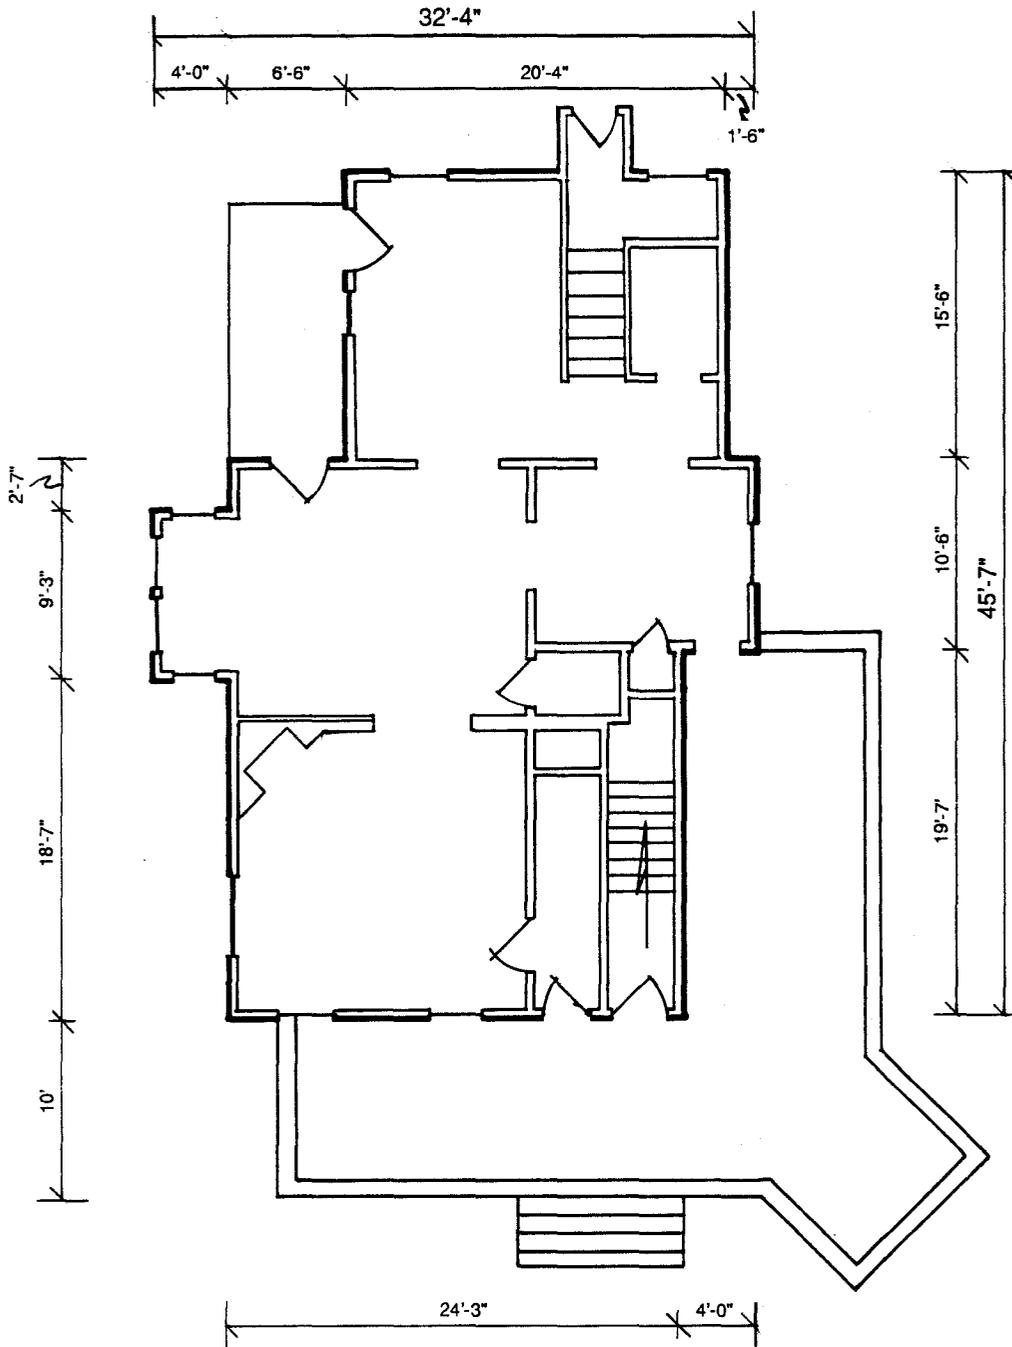
First Floor Plan
July 1992

The interior layout is basically unchanged, although it was converted to a two-family residence around 1902. The interior elements include wood trim around doors and windows with a floral motif in the corner blocks, a marbleized slate and cast iron mantel in the first floor front room, and the original balustrade and newel post of the front stairway.
