HABS No. TX-3358

HISTORIC AMERICAN BUILDINGS SURVEY
GANN HOUSE

PART I. INTRODUCTION

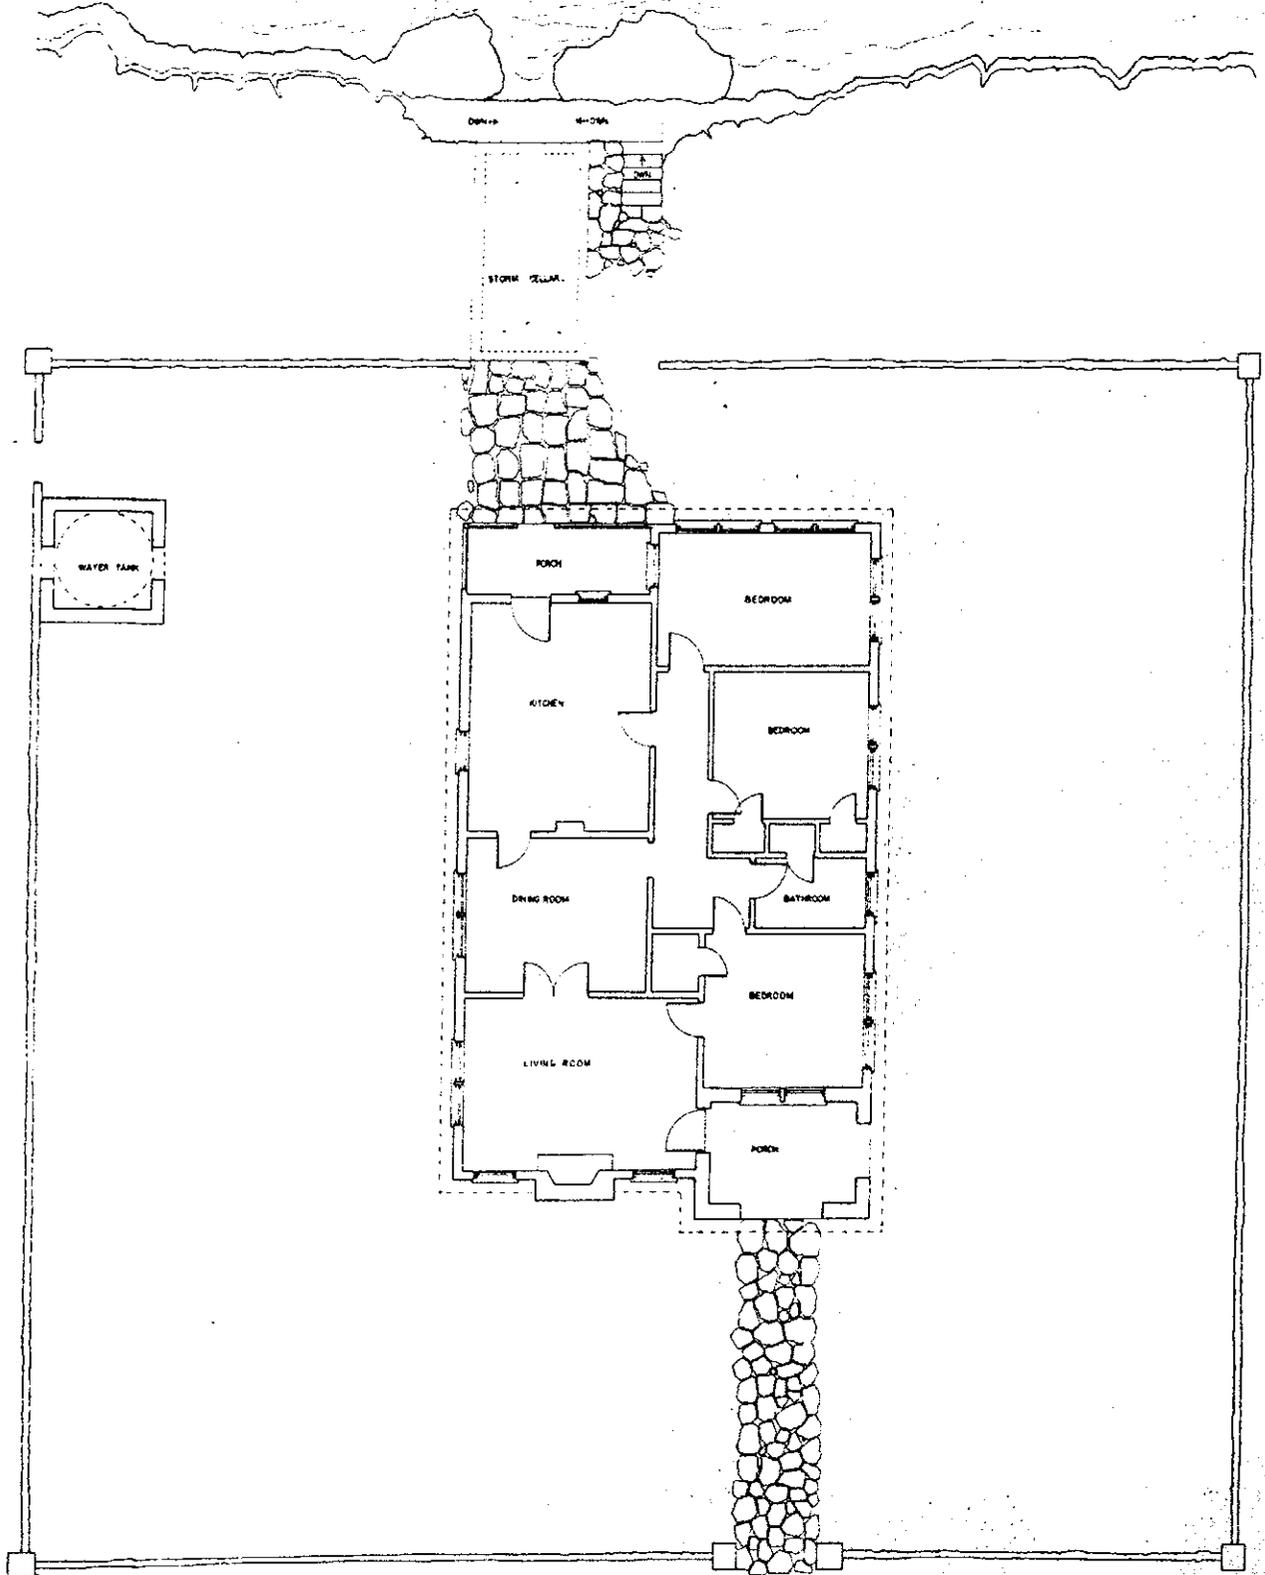
SITE PLAN

1. General setting: The house faces south, with its approach road from the east; the road continues on to the west toward the working part of the ranch. The little house compound is surrounded by a low fossiliferous limestone wall. On the north face of the house a concrete terrace provides a dramatic view of the river down the sharp bluff. The house, therefore, is located directly on the bluff with a wide flat plain to the south and east.
2. Outbuildings and other elements on the site: The little house compound, linked with the low stone wall, is composed of a stone-based watertower, approximately 10 feet square, and a storm cellar 12 feet directly north of the kitchen porch.

The roof of the stone-and-concrete cellar forms the top of a small terrace, and steps descend on its east side to its base and down beyond to a small terrace with a river view.
