KELLY AIR FORCE BASE, OIL RECLAMATION BUILDING
(Kelly Air Force Base, Hazardous Storage Facility)
(Kelly Air Force Base, Building 184)
Berman Road
San Antonio
Bexar County
Texas

HABS No. TX-3396-AI

KELLY AIR FORCE BASE, OIL RECLAMATION BUILDING
(Kelly Air Force Base, Hazardous Storage Facility)
(Kelly Air Force Base, Building 184)

Project Name: Oil Reclamation Building 184
Historic American Building Survey, Level II

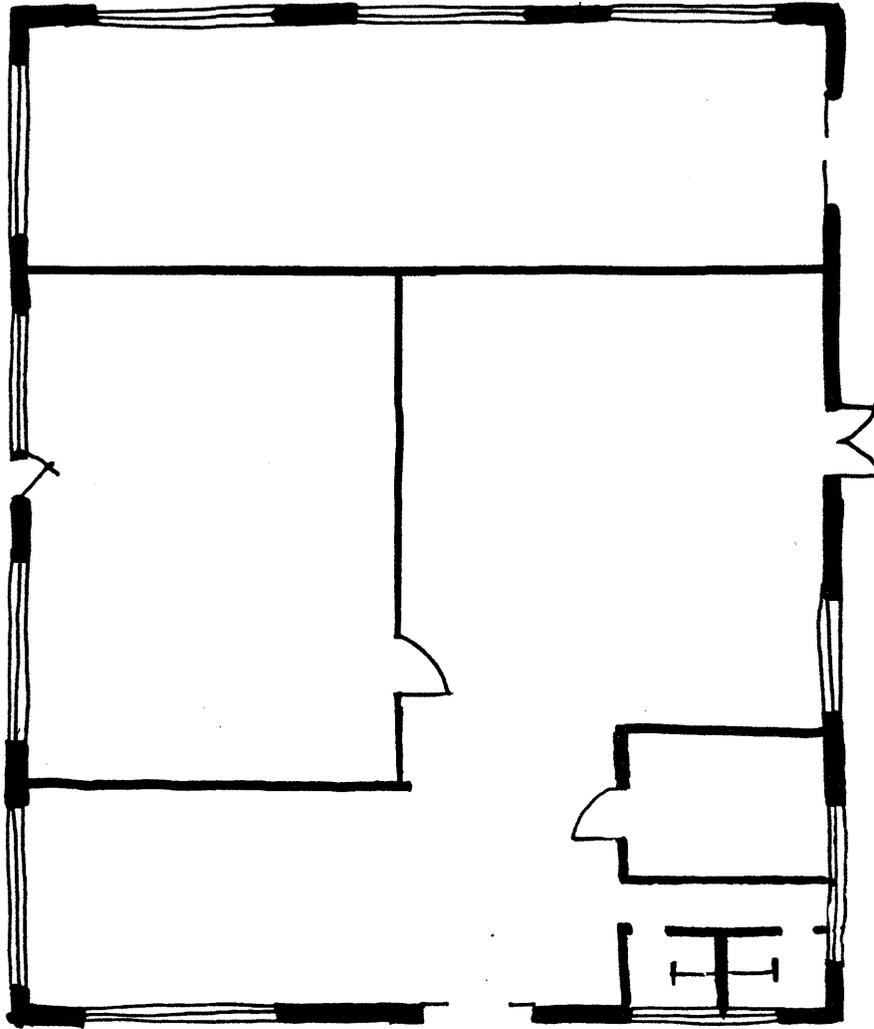
FLOOR PLAN

Building 184 retains most of its original interior configuration, that is, rectangular in shape and open. The small rectangular-shaped office and lavatory area located in the southeast corner of the building was expanded from approximately 16 feet by 10 feet to 16 feet by 22 feet. This modification now forms a larger square-shaped office and double restroom area. The original hollow clay tile room divider between the third and fourth bays is intact, though the large sliding door connecting the two rooms has been removed and in-filled with hollow clay tiles. A 20-foot-high firewall built of hollow clay tiles was installed on the west side of the structure, between the first and second bays in 1965. The elevated concrete platform (originally located on the east side of the building between the second and third bays has been removed (date unknown).
