Rosemary Inn, Lodge (Bldg. No. 372)
Olympic National Park
Barnes Point, Lake Crescent
Port Angeles Vicinity
Clallam County
Washington

HABS No. WA-185-A

HISTORIC AMERICAN BUILDING SURVEY
ARCHITECTURAL DATA FORM

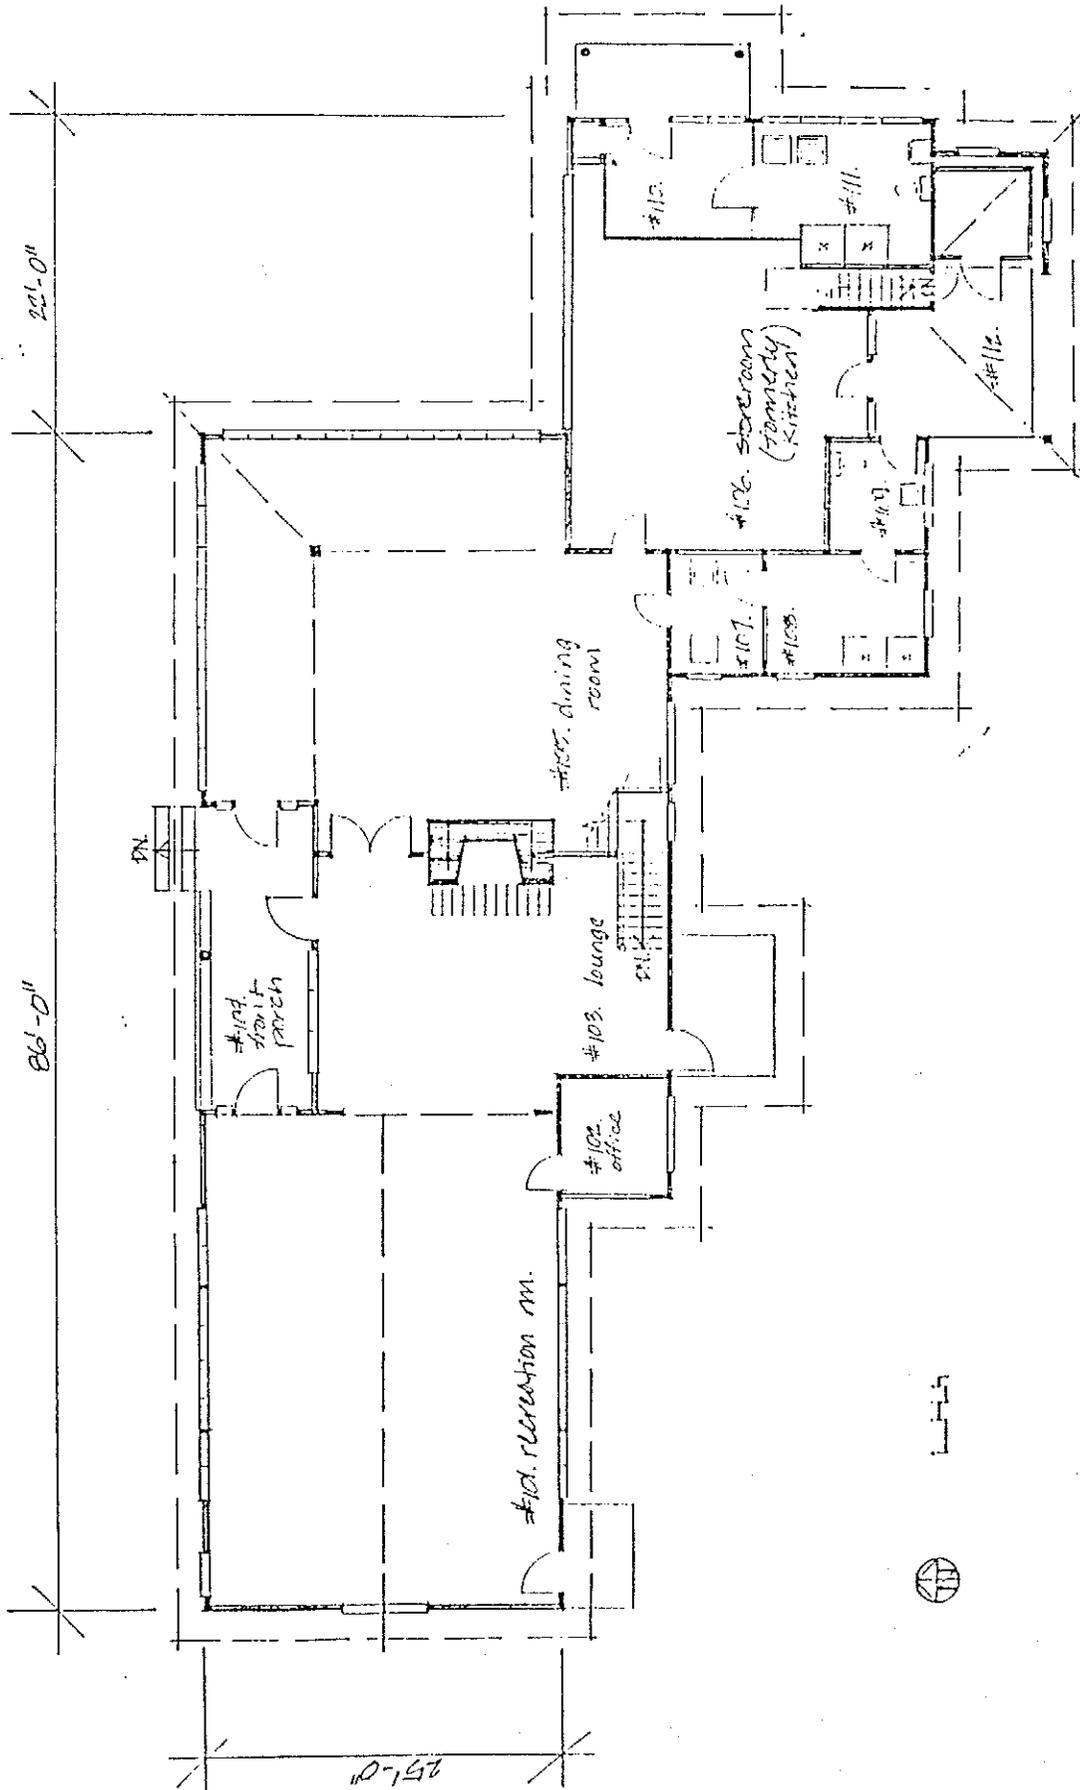
Rosemary Lodge Building #372 - First Floor

STYLE (if appropriate) "Craftsman-style" resort lodge		
MATERIAL OF CONSTRUCTION (include structural systems) Wood-frame construction set on post and pier foundation		
SHAPE AND DIMENSIONS OF STRUCTURE (sketched floor plans on separate sheet acceptable) Irregular shape: overall dimensions 86' x 34' with 41' x 38' extension on SE corner.		
EXTERIOR FEATURES OF NOTE 1 1/2 - stories; wood-shingled gable roof with shed roof dormers on north and south; slightly extended eaves with exposed rafters and plain fascia boards; wood shingle siding with vertical wood board siding above (at gable ends); corner boards; multi-paned double-hung and casement sash; numerous shed-roof porch overhangs extended from main body, supported by peeled logs and squared posts; vertical wood board skirting beneath plain wood sill board.		
INTERIOR FEATURES OF NOTE (describe floor plans if not sketched) Massive stone and mortar fireplace in lobby; hand-crafted twisted madrona baluster on first floor stairway; hardwood floors; wood wainscoting along walls in lobby with horizontal knotty pine boards above windows; wood ceiling on 1st floor.
