SCHOFIELD BARRACKS MILITARY RESERVATION,
ORDNANCE STOREHOUSE BUILDING 2107
South of intersection of Kolekole Avenue and Cadet Sheridan Road
Wahiawa Vicinity
Honolulu County
Hawaii

HABS No. HI-544-F

WRITTEN HISTORICAL AND DESCRIPTIVE DATA

HISTORIC AMERICAN BUILDINGS SURVEY
U.S. Department of the Interior
National Park Service
Oakland, California

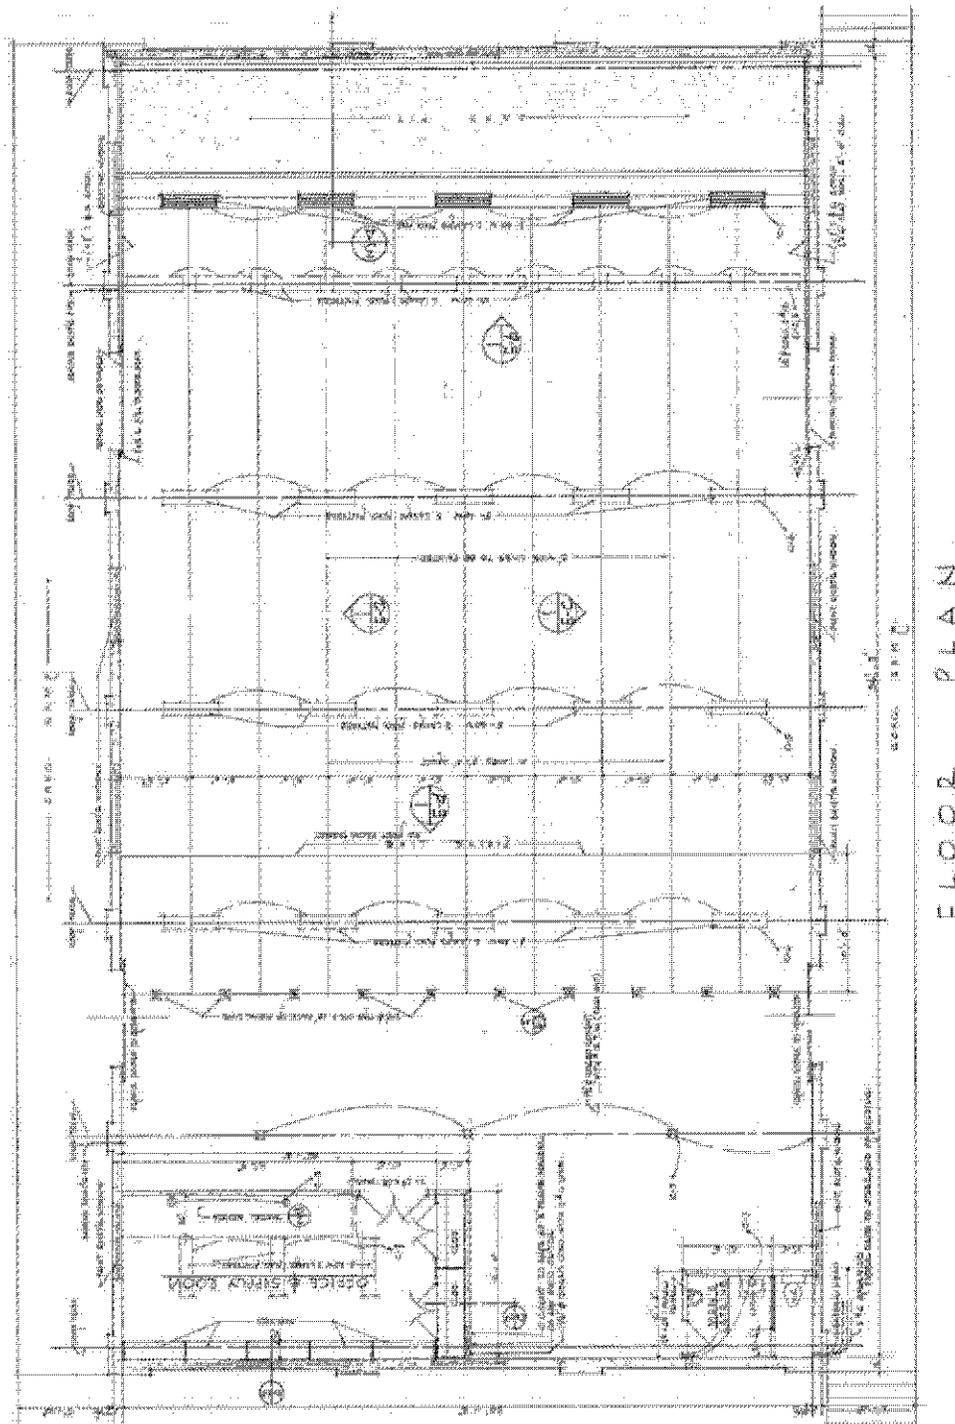
Portion of drawing dated January 26, 1955 showing the floor plan of the Ordnance Storehouse buildings. Note the footprint dimensions and location of original window and door openings. This drawing was prepared to convert Building 2104 into a .22 cal. pistol & rifle range. Schofield Barracks, Office of the Post Engineer, drawing 55004001. No scale.

Building 2107 is a single story storehouse building. Its original rectangular footprint measured 96'-9" x 52'-4". In addition to the footprint area covered by the original building are 6'-10" wide concrete loading platforms along the entire length of each long side. This original configuration has been augmented by a shed roof addition at the rear (southeast) side which extends out 8'-4" from the edge of the loading platform. This addition is 55'-2" long, from the south corner of the building. The addition has a foundation of hollow concrete tile supporting a concrete floor slab at the level of the loading dock. The addition's walls are vertical pattern exterior plywood and the shed roof is covered with corrugated metal.

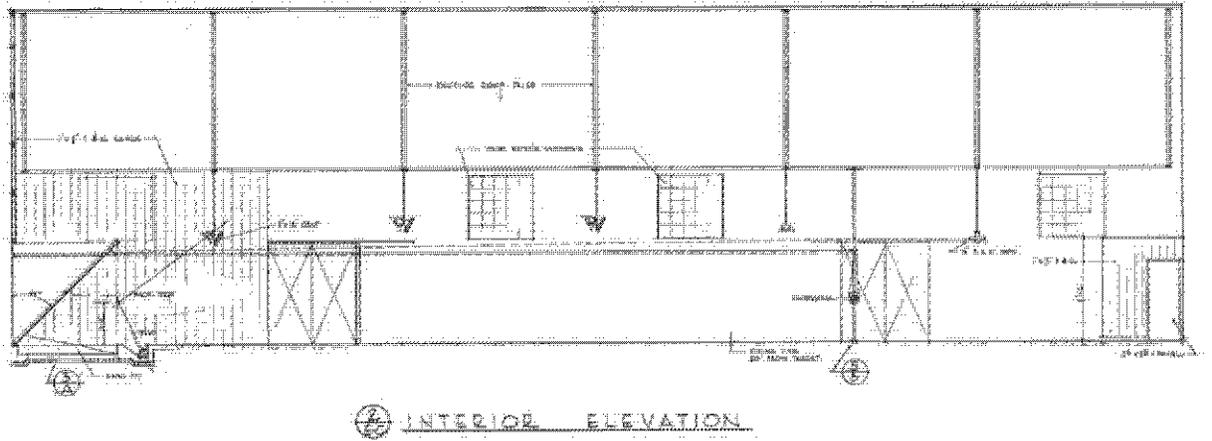
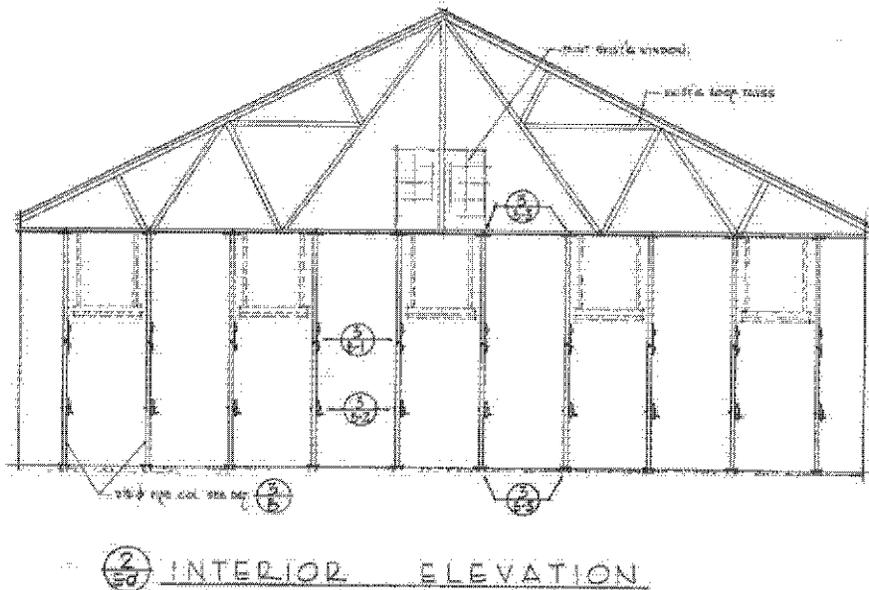
Portion of drawing dated January 26, 1955 showing typical interior configurations of the Ordnance Storehouse buildings. Note the position and configuration of roof trusses. This drawing was prepared to convert Building 2104 into a .22 cal. pistol & rifle range. Schofield Barracks, Office of the Post Engineer, drawing 55004002. No scale.

The roof of Building 2107 is covered with corrugated metal panels on purlins of channel-shape metal beams about 3" high and spaced 2'-4" apart. The eaves have a wide overhang of 4' on all sides of the building. The roof is supported on transverse metal trusses typically spaced 15'-6". Near the midpoint between each truss, the purlins are tied together with short sections of threaded metal rod. Two round metal vents are located at the ridge.

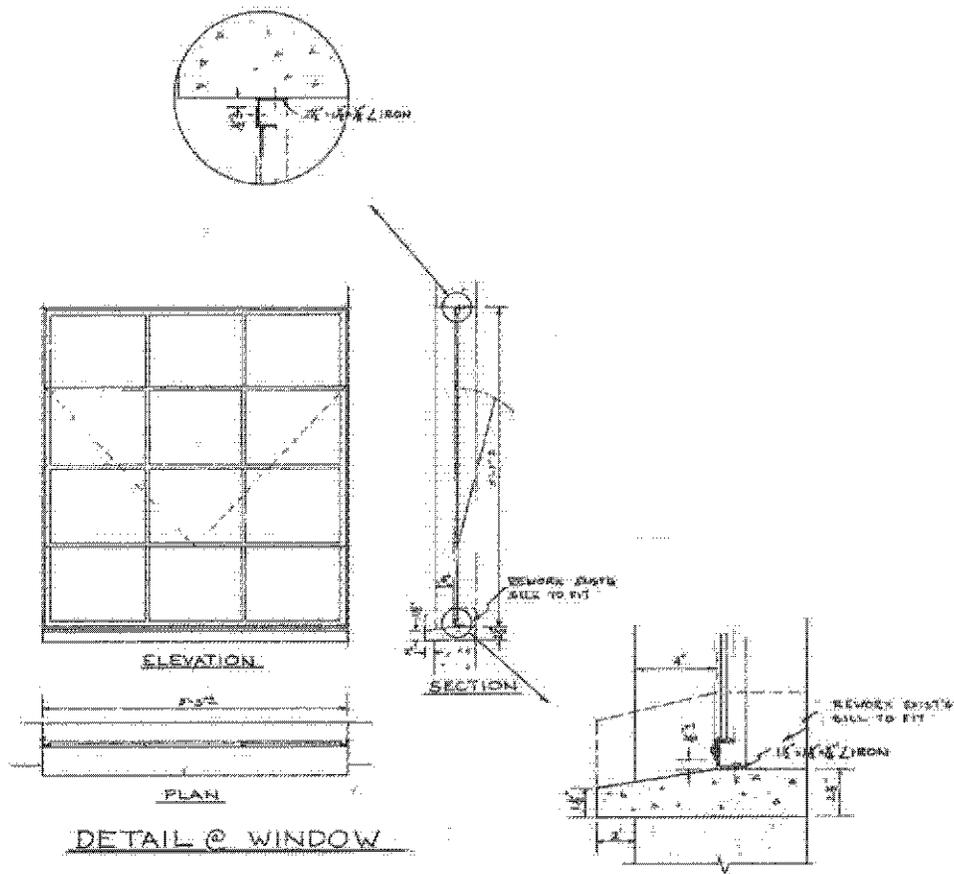
Portion of drawing dated April 10, 1967 showing typical original window construction of the Ordnance Storehouse buildings. This drawing was prepared for various repairs and alterations at Buildings 2101, 2102, 2104-2109. Schofield Barracks, Office of the Post Engineer, drawing 67019002. No scale.

The northwest side of the building is divided into six bays by plain pilasters (with no bases or capitals) that are typically spaced at 15'-6" on center. The pilasters at the corners of the building are each 3'-0" wide and the remaining five pilasters along the northwest side are 2'-0" wide. All pilasters project about 4" from the wall. The first, third, fourth, and sixth bays (for this report all bays are numbered left to right, facing the indicated side of the building) along the northwest side each have a single window opening that is 5'-3" wide x 5'-7" high with a sill 8'-0" above the floor. The openings are filled with a twelve-light steel sash window with a six light hopper section with added security screens of expanded metal mesh. This window arrangement was duplicated on the opposite (southeast) long side of the original building. The shed roof addition has blocked the windows at bays one and two and a part of the window at bay four. The window at bay six remains, it is identical to those on the northwest side. The short ends of the building (gable ends) are divided into three bays by pilasters. The center bay has a single window opening also measuring 5'-3" wide x 5'-7" high that is filled with a twelve-light steel sash window with a six-light hopper section. The sills of these windows are about 11' above the water table. All windows in the building have wire glass lights.

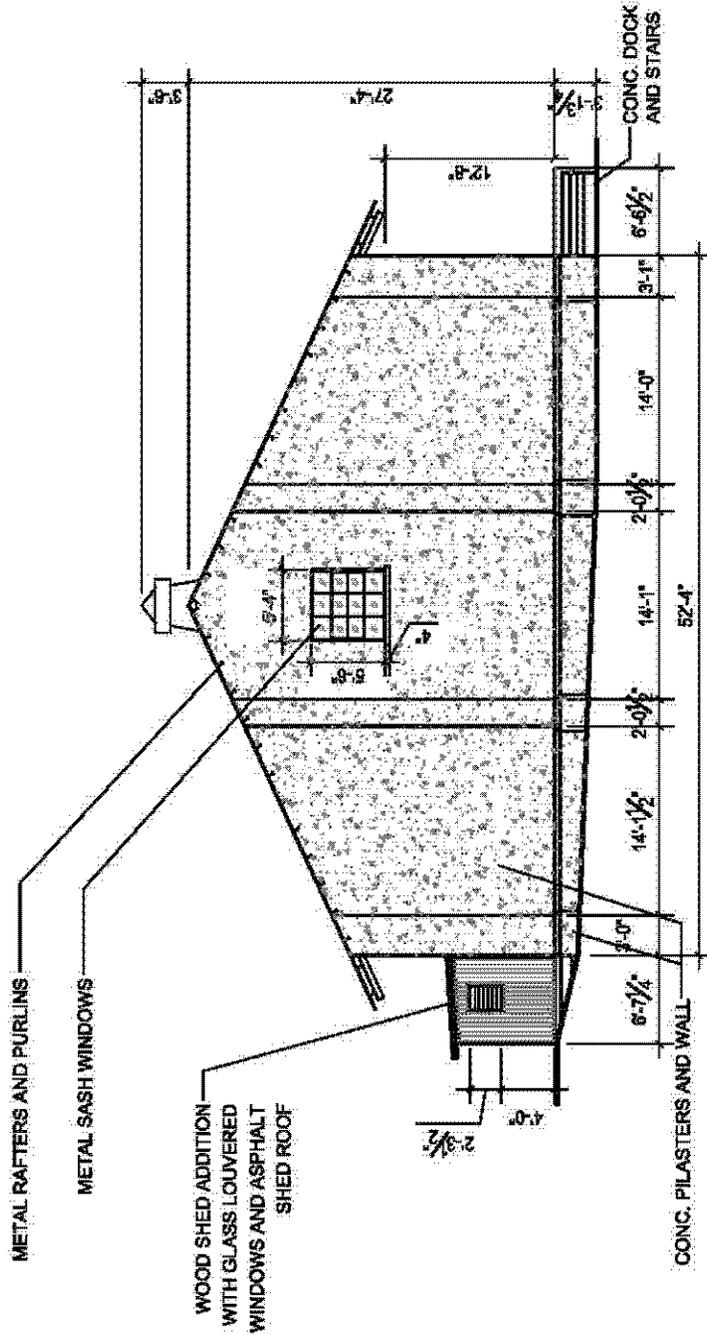
SOUTHWEST ELEVATION

Drawing of ordnance storehouse building dated June 28, 2010 showing the exterior southwest elevation, typical of ordnance storehouse buildings. Note that some of the original large door openings are now in-filled but the location of original window and door openings are evident. These drawings were prepared by Mason Architects. Not to scale.

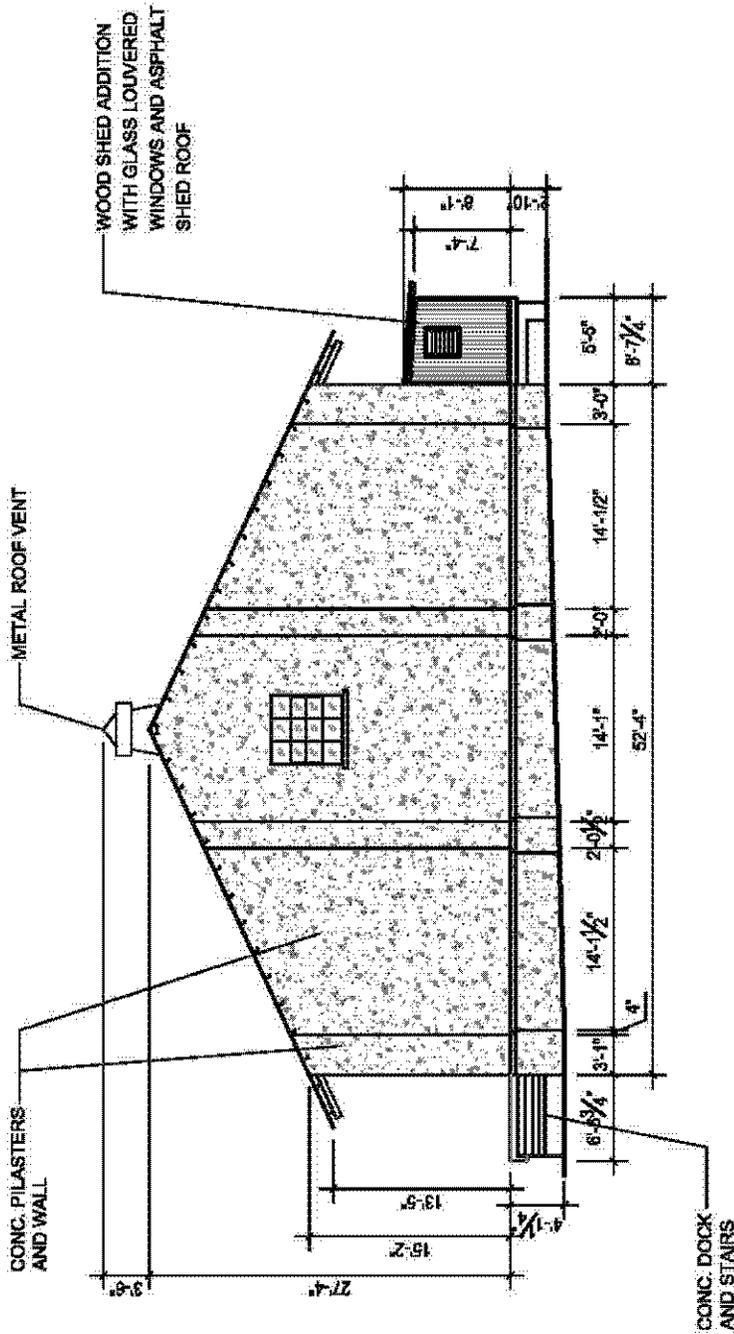
NORTHEAST ELEVATION

Drawing of ordnance storehouse building dated June 28, 2010 showing the exterior northeast elevation, typical of ordnance storehouse buildings. Note that some of the original large door openings are now in-filled but the location of original window and door openings are evident. These drawings were prepared by Mason Architects. Not to scale.

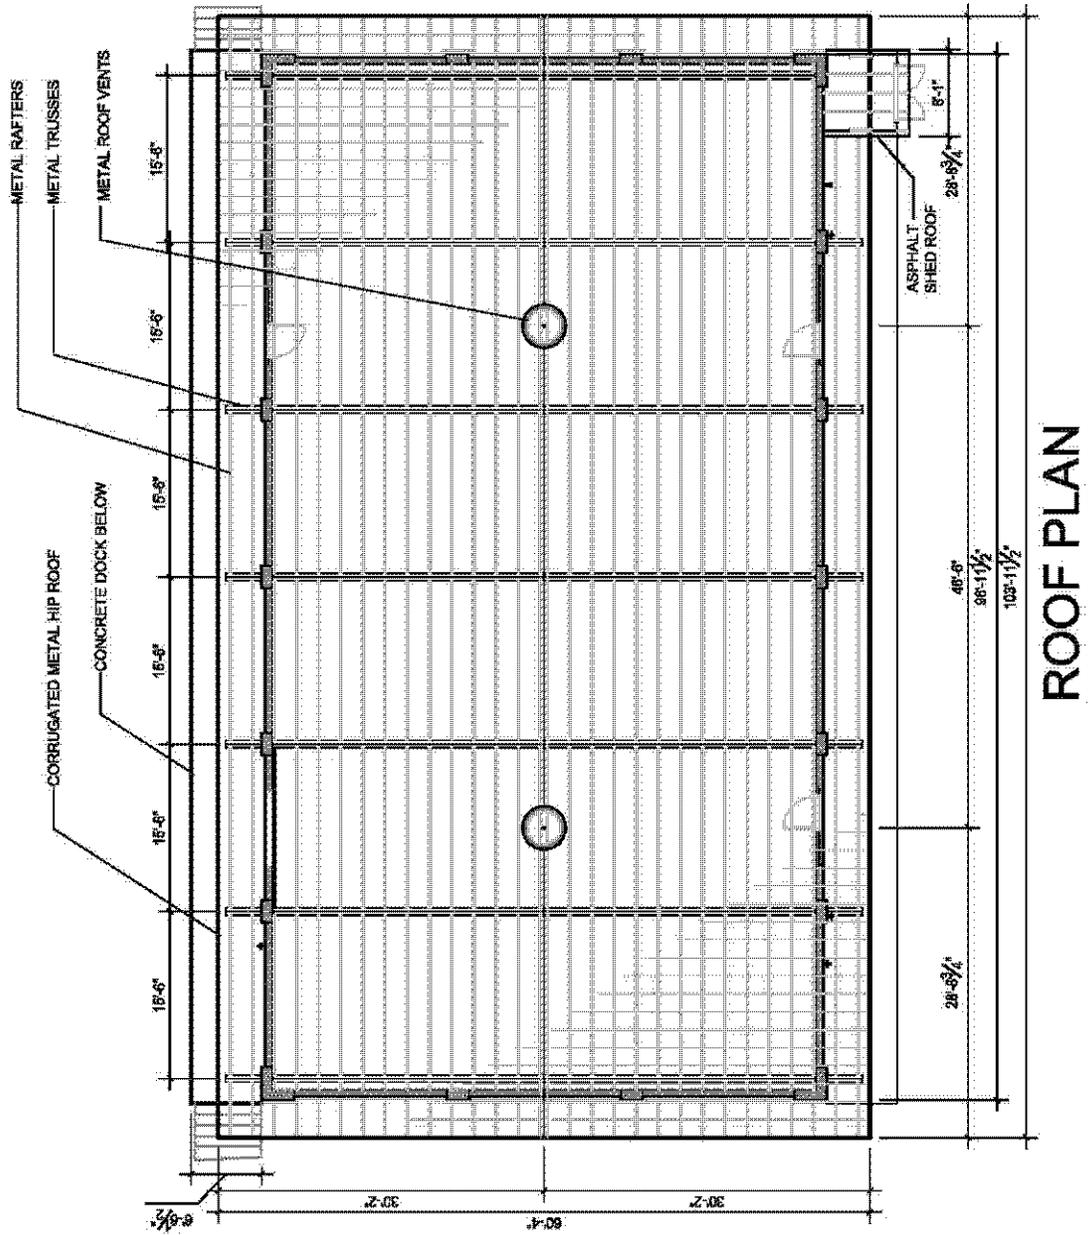
Drawing of ordnance storehouse building dated June 28, 2010 showing the exterior roof plan, typical of ordnance storehouse buildings. Note that some of the original large door openings are now in-filled but the location of original window and door openings are evident. These drawings were prepared by Mason Architects. Not to scale.
